Defect Listing

Pipe Segment Refere... D13-1_D-23	City Oliver Springs	Street Duncan Dr	Material Concrete Pipe (non-...	Location C... Light High...	Sewer Use Sanitary
Upstream MH D13-1	Total Length 212.7	Year Laid	Shape Circular	Location Details	
DS Manhole D-23	Length surveyed 212.7	Year Renewed	Height 8	Width 8	Pipe Joint... 4

SPR 10	MPR 4	PO Number 4397-03	Customer GRW
SPRI 5	MPRI 2	Work Order 4397-02	Purpose Pre-Rehabilitation Survey
QSR 5200	QMR 2200		
OPR 14	Surveyed By Barry Rogers	Direction Downstream	Date 20150623
OPRI 3.5	Certificate Number U-1012-16405	Pre-Cleaning Jetting	Time 12:47
	Date Cleaned 20150623	End Time 12:57	Weather Very Dry
			Media label
			Additional Info

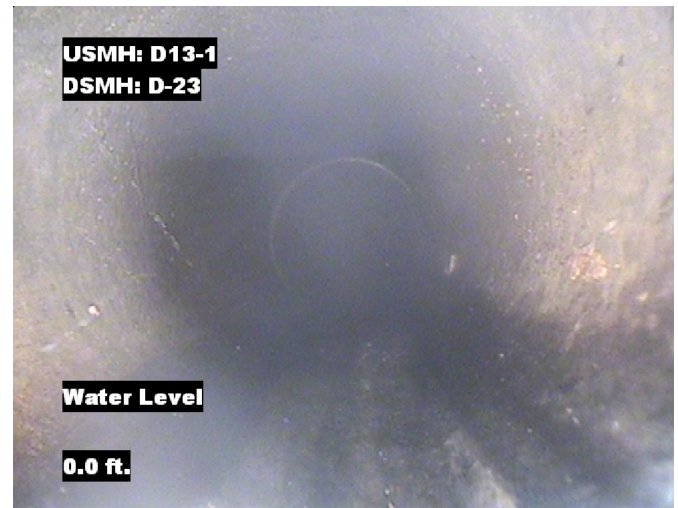
Distance: 0.0 ft. Grade: 0
Condition: Water Level
Remarks: N/A

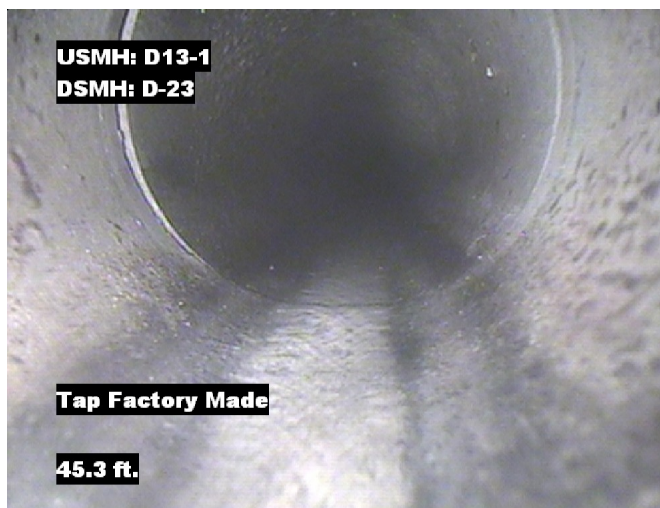
Distance: 45.3 ft. Grade: 0
Condition: Tap Factory Made
Remarks: N/A

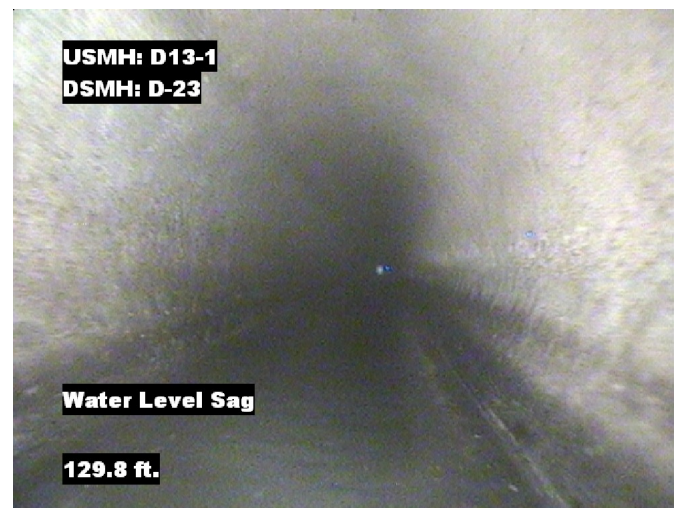
Distance: 129.8 ft. Grade: 2
Condition: Water Level Sag
Remarks: N/A

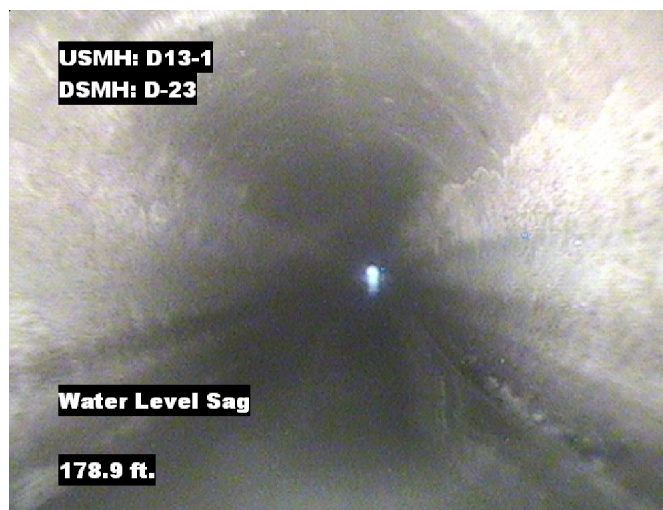
Distance: 178.9 ft. Grade: 2
Condition: Water Level Sag
Remarks: N/A

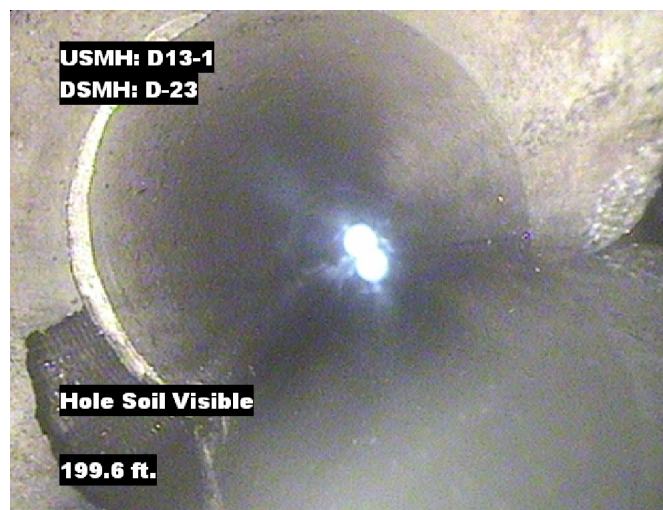
Distance: 199.6 ft. Grade: 5
Condition: Hole Soil Visible
Remarks: N/A

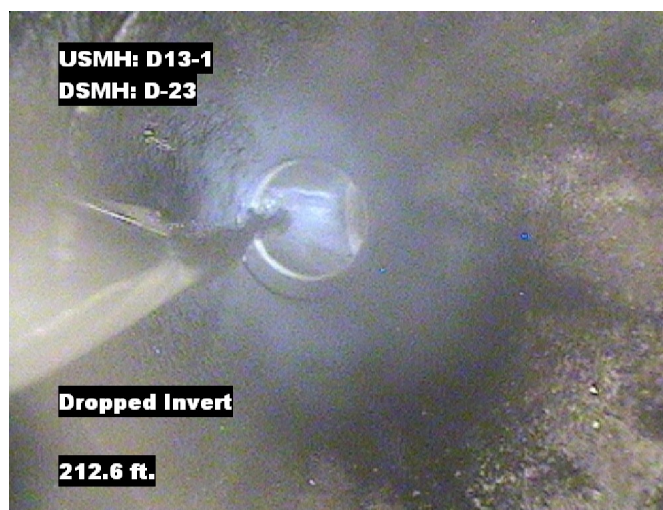
Distance: 212.6 ft. Grade: 5
Condition: Dropped Invert
Remarks: N/A

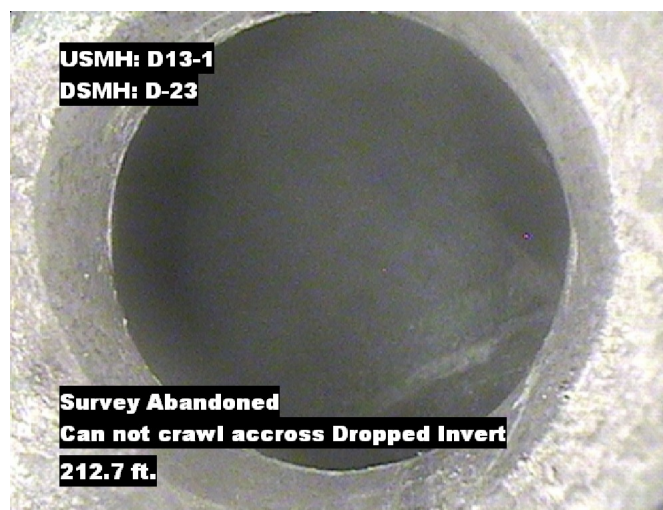
Distance: 212.7 ft. Grade: 0
Condition: Survey Abandoned
Remarks: Can not crawl across Dropped Invert
