## Defect Listing

Pipe Segment Refere... <b>D14-1_D11-7</b>	City <b>Oliver Springs</b>	Street <b>First Norway</b>	Material <b>PolyVinyl Chloride</b>		Location C... <b>Easement/R...</b>	Sewer Use <b>Sanitary</b>
Upstream MH <b>D14-1</b>	Total Length <b>298</b>	Year Laid	Shape <b>Circular</b>		Location Details	
DS Manhole <b>D11-7</b>	Length surveyed <b>298</b>	Year Renewed	Height <b>8</b>	Width <b>8</b>	Pipe Joint... <b>13</b>

## Image Report 4/Page

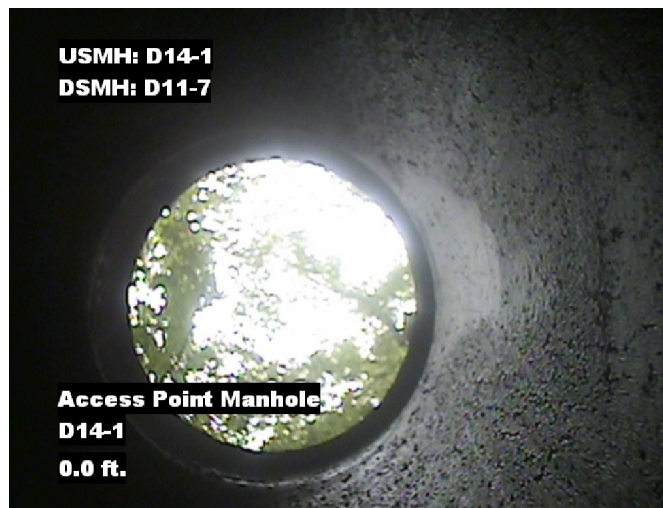
Distance: 0.0 ft. Grade: 0  
Condition: Access Point Manhole  
Remarks: D14-1

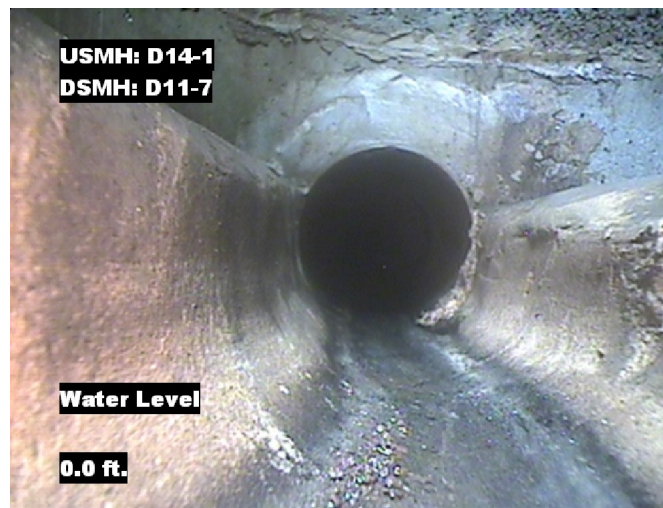
Distance: 0.0 ft. Grade: 0  
Condition: Water Level  
Remarks: N/A

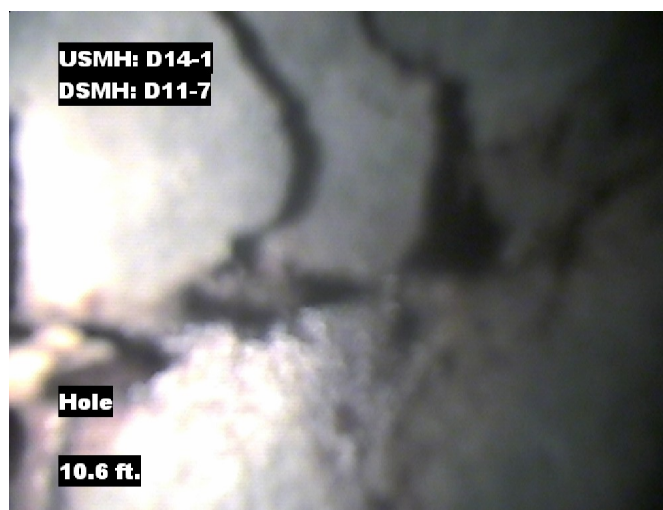
Distance: 10.6 ft. Grade: 3  
Condition: Hole  
Remarks: N/A

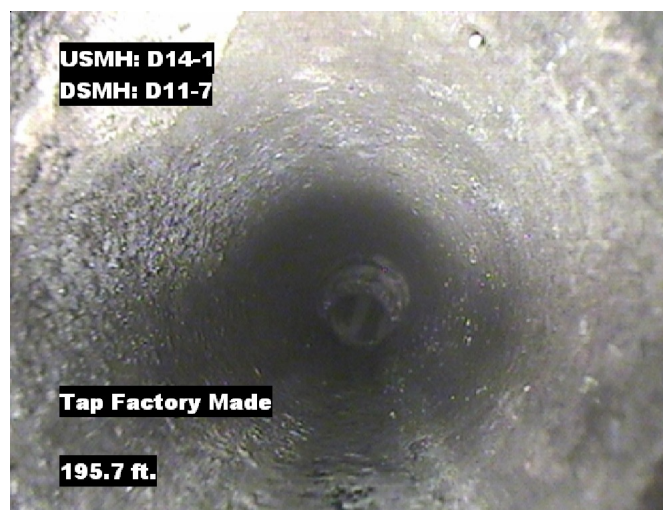
Distance: 195.7 ft. Grade: 0  
Condition: Tap Factory Made  
Remarks: N/A

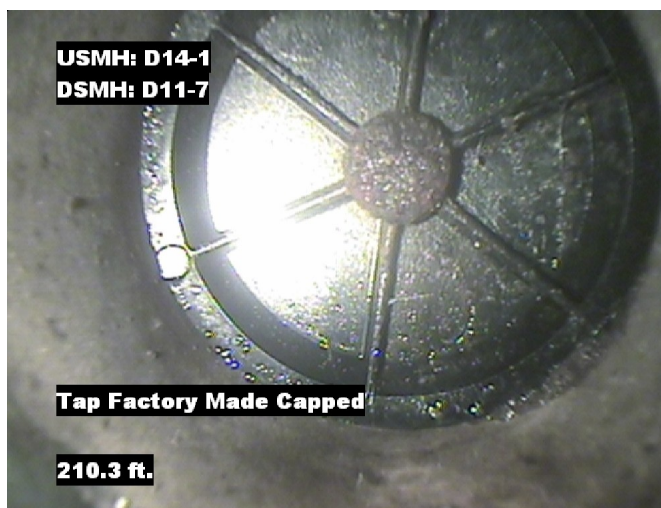
Distance: 210.3 ft. Grade: 0  
Condition: Tap Factory Made Capped  
Remarks: N/A

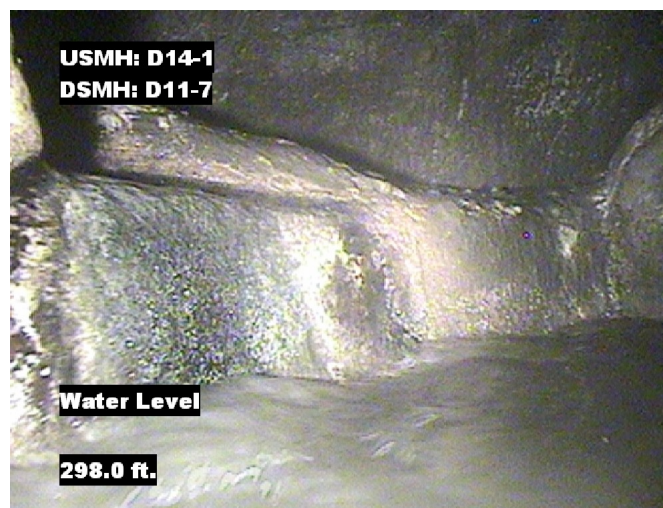
Distance: 298.0 ft. Grade: 0  
Condition: Water Level  
Remarks: N/A

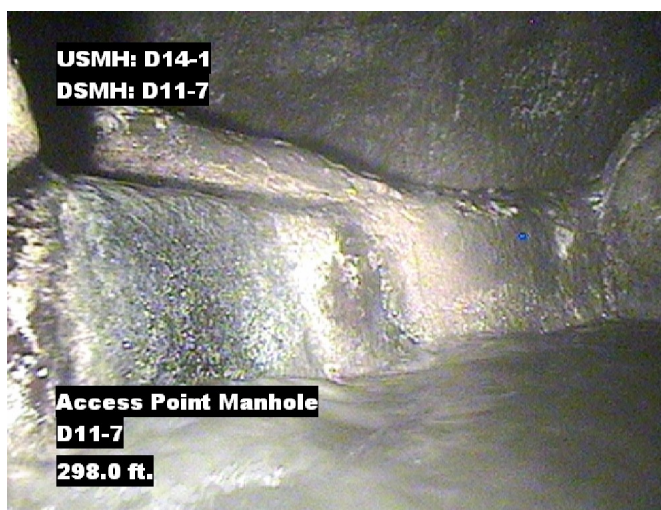
Distance: 298.0 ft. Grade: 0  
Condition: Access Point Manhole  
Remarks: D11-7
