Defect Listing

Pipe Segment Refere... D14-2_D14-1	City Oliver Springs	Street First Norway	Material Concrete Pipe (non-...	Location C... Easement/R...	Sewer Use Sanitary
Upstream MH D14-2	Total Length 176.6	Year Laid	Shape Circular	Location Details	
DS Manhole D14-1	Length surveyed 176.6	Year Renewed	Height 8	Width 8	Pipe Joint... 4

SPR N/A	MPR N/A	PO Number 4397-03		Customer GRW	
SPRI N/A	MPRI N/A	Work Order 4397-02		Purpose Pre-Rehabilitation Survey	
QSR N/A	QMR N/A				
OPR N/A	Surveyed By Barry Rogers	Direction Downstream	Date 20150623	Media label	
OPRI N/A	Certificate Number U-1012-16405	Pre-Cleaning Jetting	Time 10:02	Weather Very Dry	
Date Cleaned 20150623			End Time 10:11	Additional Info

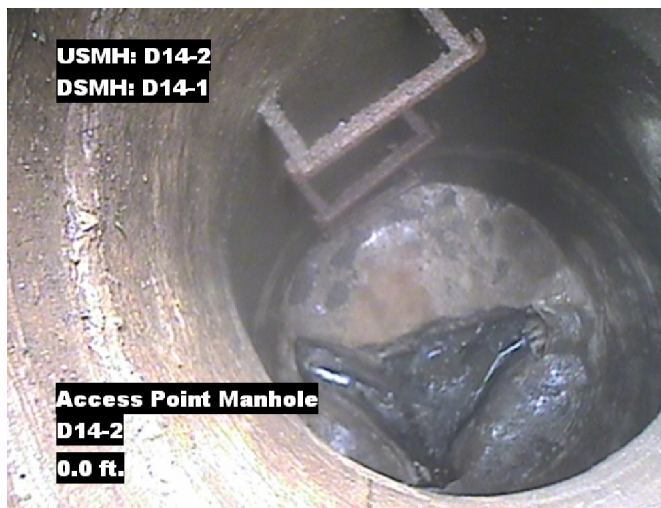
Distance: 0.0 ft. Grade: 0
Condition: Access Point Manhole
Remarks: D14-2

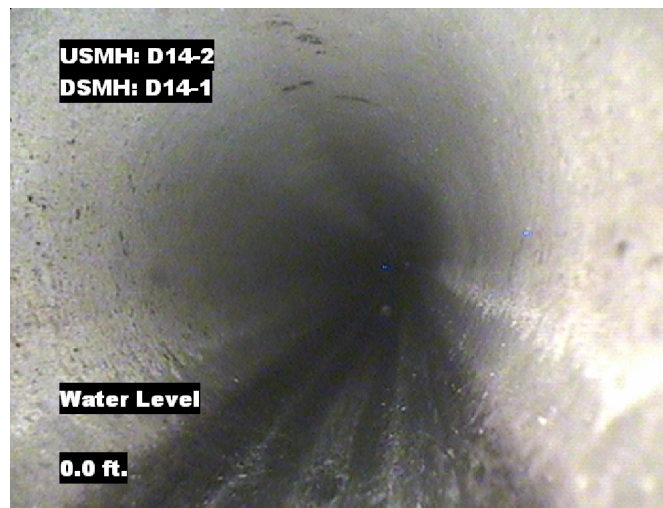
Distance: 0.0 ft. Grade: 0
Condition: Water Level
Remarks: N/A

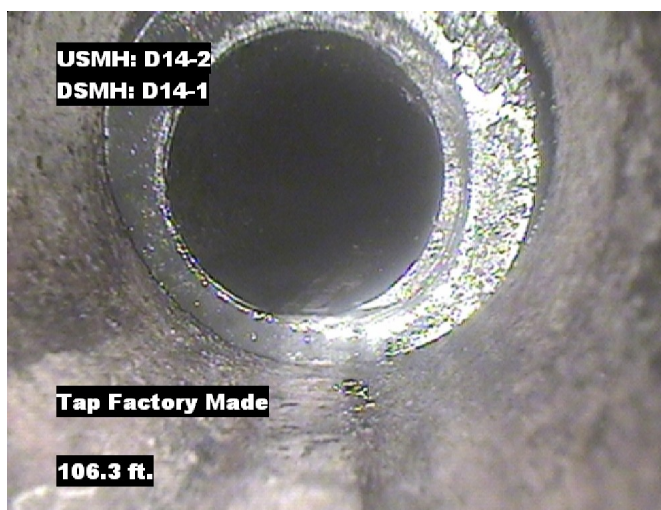
Distance: 106.3 ft. Grade: 0
Condition: Tap Factory Made
Remarks: N/A

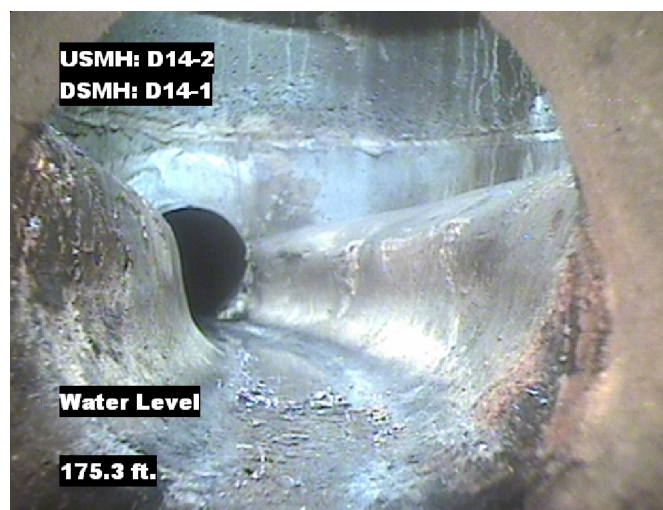
Distance: 175.3 ft. Grade: 0
Condition: Water Level
Remarks: N/A

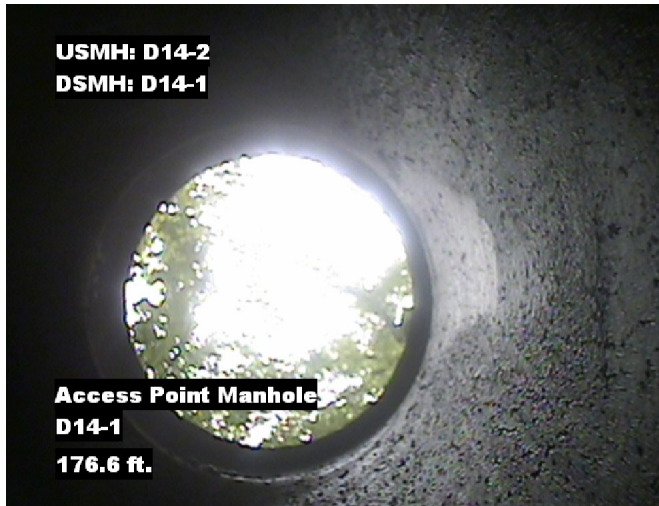
Distance: 176.6 ft. Grade: 0
Condition: Access Point Manhole
Remarks: D14-1
