Defect Listing

Pipe Segment Refere... D14-2A_D14-2	City Oliver Springs	Street First Norway	Material Concrete Pipe (non-...	Location C... Light High...	Sewer Use Sanitary
Upstream MH D14-2A	Total Length 154.5	Year Laid	Shape Circular	Location Details	
DS Manhole D14-2	Length surveyed 154.5	Year Renewed	Height 8	Width 8	Pipe Joint... 4

SPR N/A	MPR N/A	PO Number 4397-03	Customer GRW
SPRI N/A	MPRI N/A	Work Order 4397-02	Purpose Pre-Rehabilitation Survey
QSR N/A	QMR N/A		
OPR N/A	Surveyed By Barry Rogers	Direction Downstream	Date 20150623
OPRI N/A	Certificate Number U-1012-16405	Pre-Cleaning Jetting	Time 09:01
	Date Cleaned 20150623	End Time 09:06	Weather Very Dry
			Media label
			Additional Info

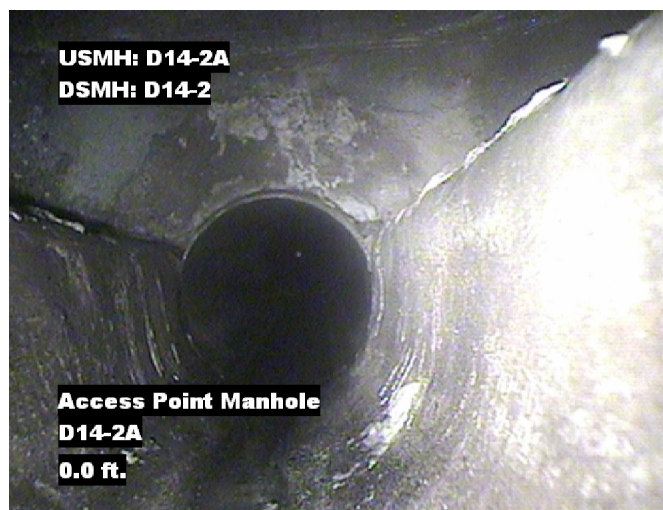
Distance: 0.0 ft. Grade: 0
Condition: Access Point Manhole
Remarks: D14-2A

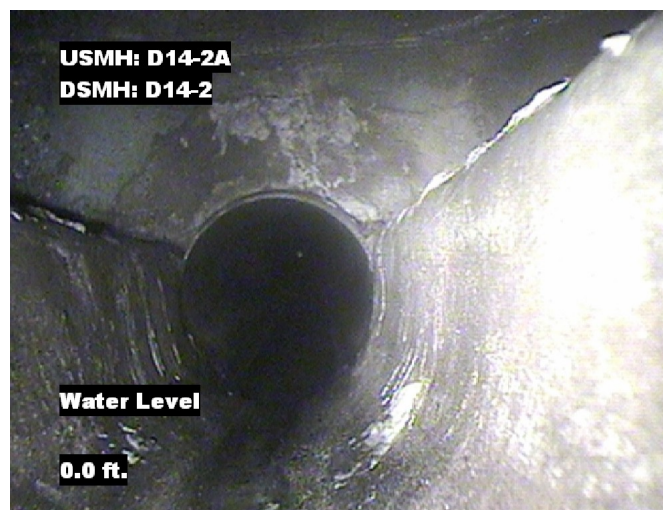
Distance: 0.0 ft. Grade: 0
Condition: Water Level
Remarks: N/A

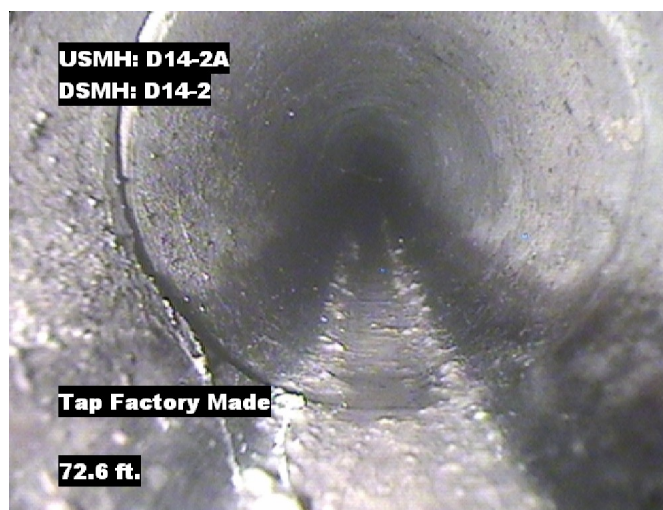
Distance: 72.6 ft. Grade: 0
Condition: Tap Factory Made
Remarks: N/A

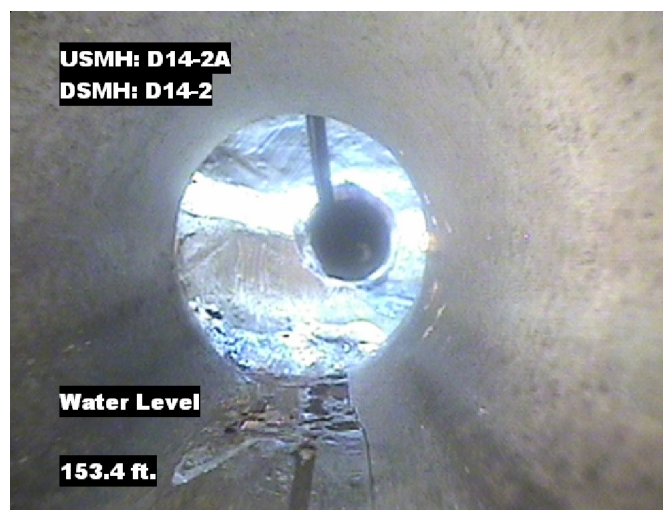
Distance: 153.4 ft. Grade: 0
Condition: Water Level
Remarks: N/A

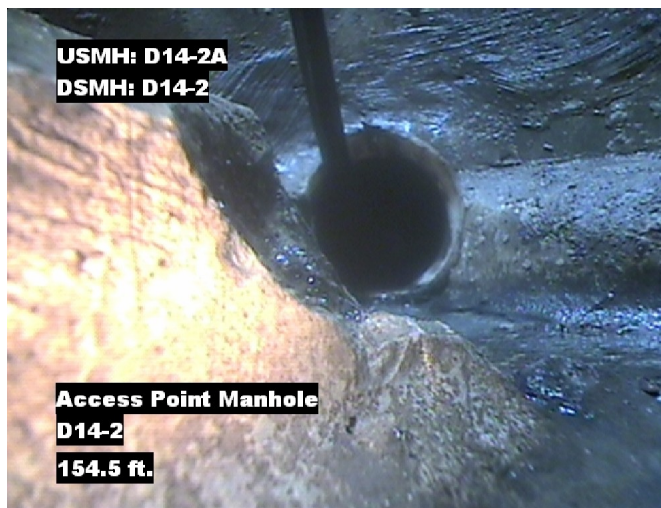
Distance: 154.5 ft. Grade: 0
Condition: Access Point Manhole
Remarks: D14-2
