Defect Listing

Pipe Segment Refere... D14-3_D14-2A	City Oliver Springs	Street First Norway	Material Concrete Pipe (non-...	Location C... Light High...	Sewer Use Sanitary
Upstream MH D14-3	Total Length 149.7	Year Laid	Shape Circular	Location Details	
DS Manhole D14-2A	Length surveyed 149.7	Year Renewed	Height 8	Width 8	Pipe Joint... 4

SPR N/A	MPR N/A	PO Number 4397-03	Customer GRW
SPRI N/A	MPRI N/A	Work Order 4397-02	Purpose Pre-Rehabilitation Survey
QSR N/A	QMR N/A		
OPR N/A	Surveyed By Barry Rogers	Direction Downstream	Date 20150623
OPRI N/A	Certificate Number U-1012-16405	Pre-Cleaning Jetting	Time 08:49
	Date Cleaned 20150623	End Time 08:58	Weather Very Dry
			Media label
			Additional Info

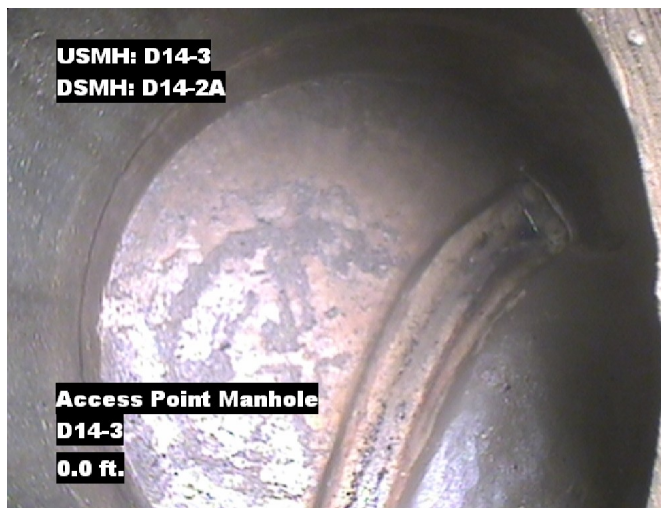
Distance: 0.0 ft. Grade: 0
Condition: Access Point Manhole
Remarks: D14-3

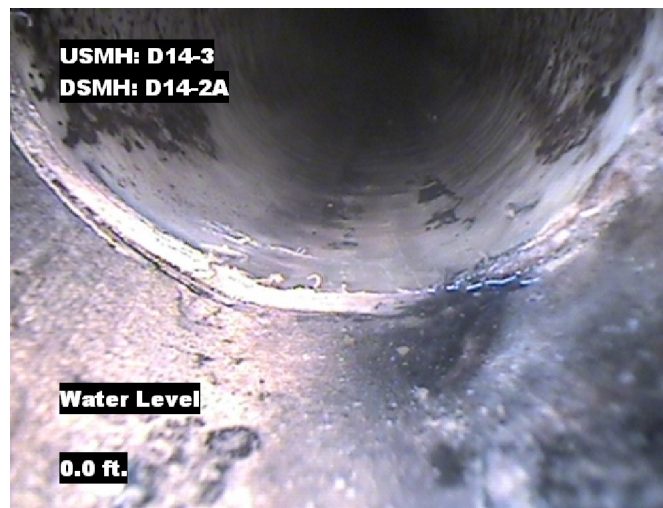
Distance: 0.0 ft. Grade: 0
Condition: Water Level
Remarks: N/A

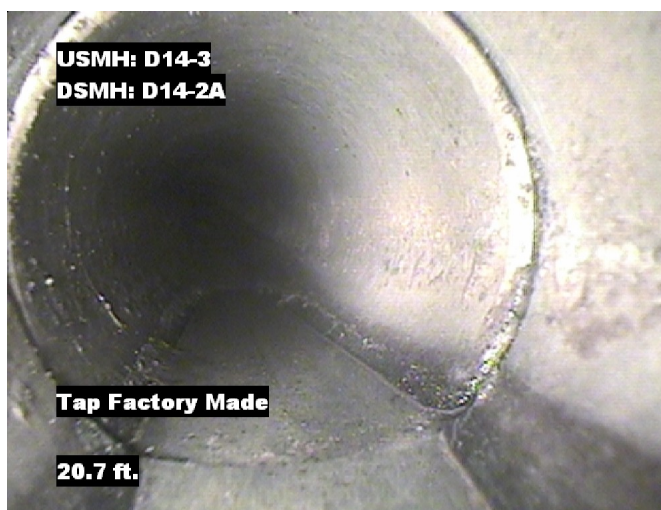
Distance: 20.7 ft. Grade: 0
Condition: Tap Factory Made
Remarks: N/A

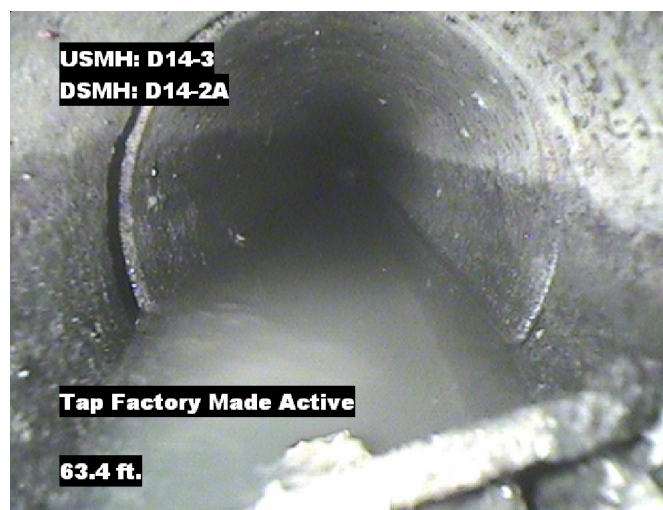
Distance: 63.4 ft. Grade: 0
Condition: Tap Factory Made Active
Remarks: N/A

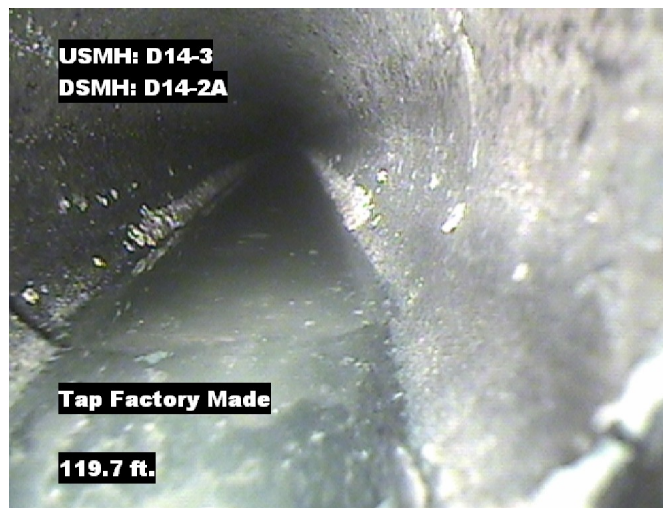
Distance: 119.7 ft. Grade: 0
Condition: Tap Factory Made
Remarks: N/A

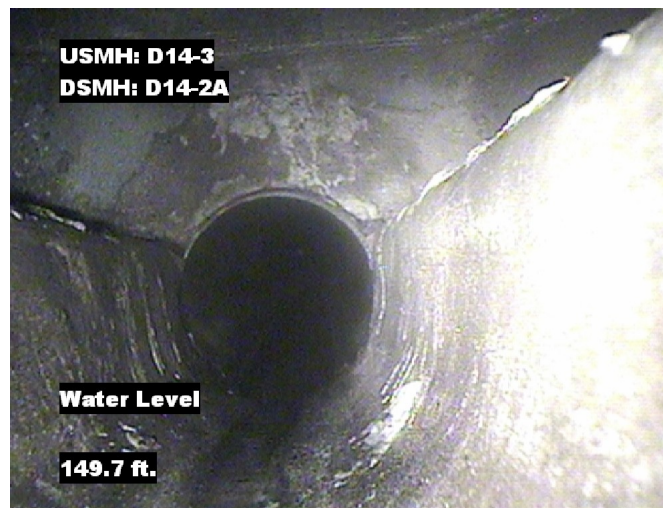
Distance: 149.7 ft. Grade: 0
Condition: Water Level
Remarks: N/A

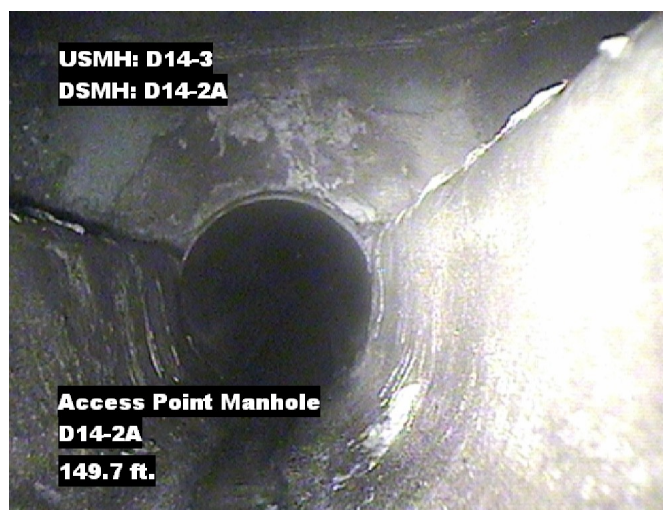
Distance: 149.7 ft. Grade: 0
Condition: Access Point Manhole
Remarks: D14-2A
