Defect Listing

Pipe Segment Refere... D15-1_D14-2	City Oliver Springs	Street First Norway	Material Concrete Pipe (non-...	Location C... Light High...	Sewer Use Sanitary
Upstream MH D15-1	Total Length 190.2	Year Laid	Shape Circular	Location Details	
DS Manhole D14-2	Length surveyed 190.2	Year Renewed	Height 8	Width 8	Pipe Joint... 4

SPR 3	MPR N/A	PO Number 4397-03	Customer GRW
SPRI 3	MPRI N/A	Work Order 4397-02	Purpose Pre-Rehabilitation Survey
QSR 3100	QMR N/A		
OPR 3	Surveyed By Barry Rogers	Direction Upstream	Date 20150623
OPRI 3	Certificate Number U-1012-16405	Pre-Cleaning Jetting	Time 09:21
	Date Cleaned 20150623	End Time 09:33	Weather Very Dry
			Media label
			Additional Info

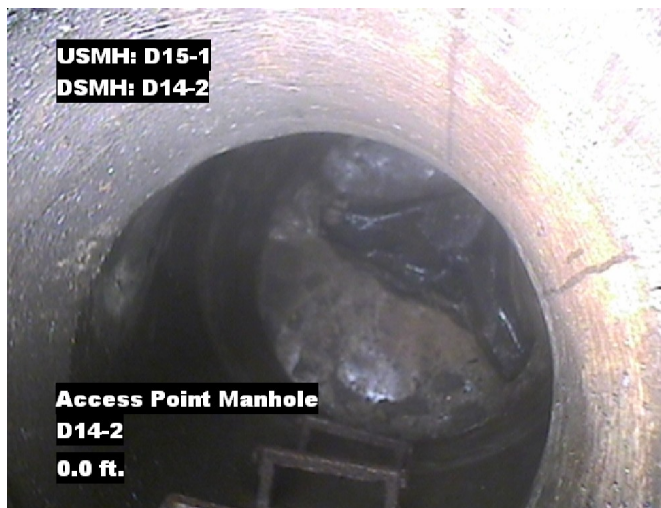
Distance: 0.0 ft. Grade: 0
Condition: Access Point Manhole
Remarks: D14-2

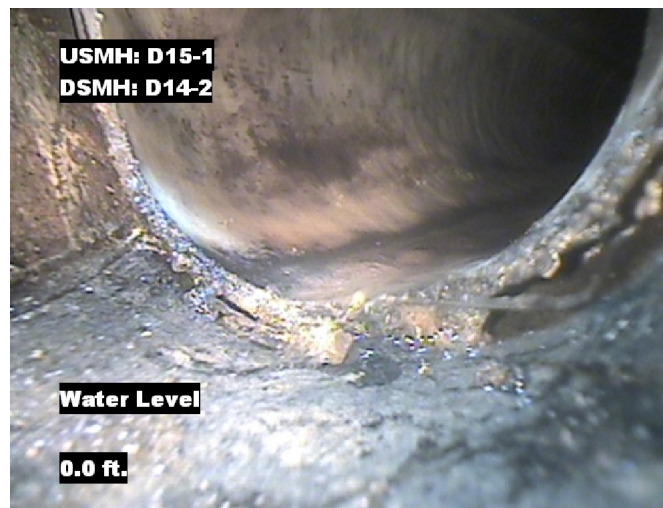
Distance: 0.0 ft. Grade: 0
Condition: Water Level
Remarks: N/A

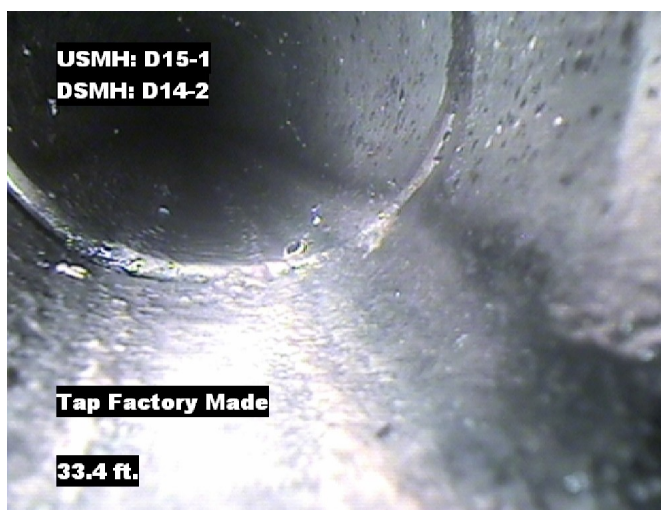
Distance: 33.4 ft. Grade: 0
Condition: Tap Factory Made
Remarks: N/A

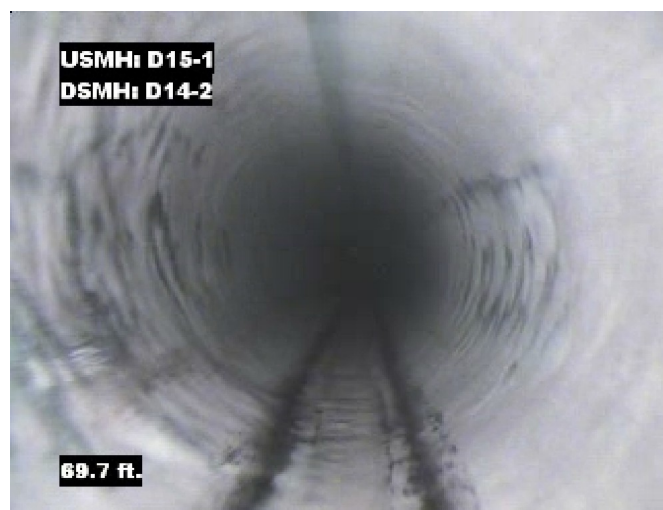
Distance: 69.8 ft. Grade: 3
Condition: Lining Failure Buckled
Remarks: N/A

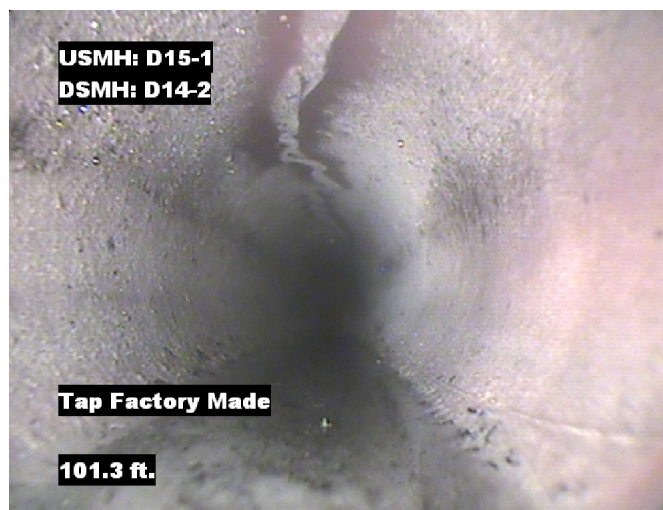
Distance: 101.3 ft. Grade: 0
Condition: Tap Factory Made
Remarks: N/A

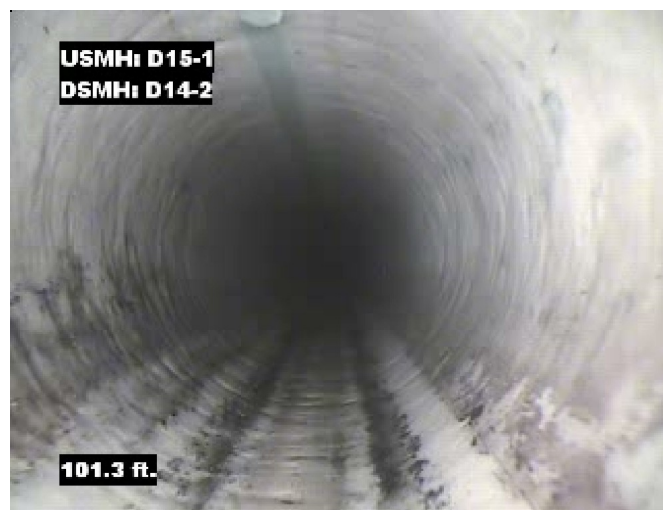
Distance: 101.3 ft. Grade: 0
Condition: Lining Failure Other
Remarks: liner strip starting to peel

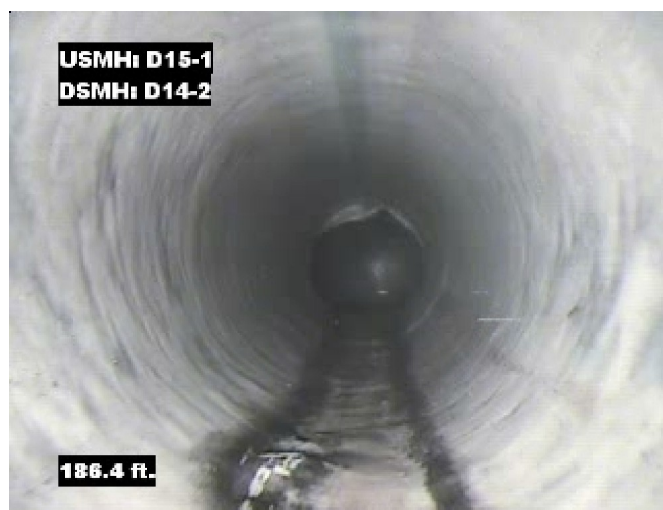
Distance: 186.5 ft. Grade: 0
Condition: Lining Failure Other
Remarks: liner is bubbled up

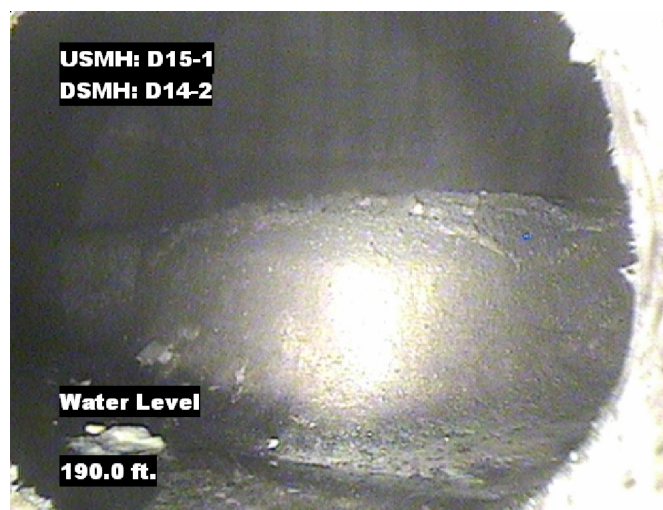
Distance: 190.0 ft. Grade: 0
Condition: Water Level
Remarks: N/A

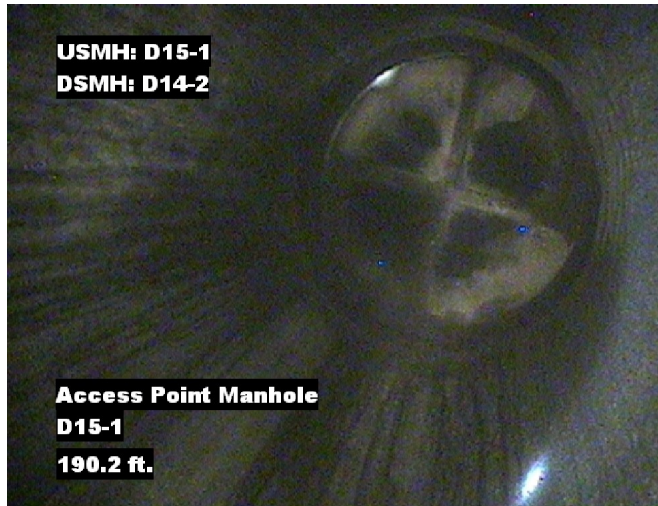
Distance: 190.2 ft. Grade: 0
Condition: Access Point Manhole
Remarks: D15-1
