## Defect Listing

Pipe Segment Refere... <b>D16-1_D11-4</b>	City <b>Oliver Springs</b>	Street <b>First Norway Lane</b>	Material <b>Concrete Pipe (non-...</b>	Location C... <b>Yard</b>	Sewer Use <b>Sanitary</b>
Upstream MH <b>D16-1</b>	Total Length <b>282.7</b>	Year Laid	Shape <b>Circular</b>	Location Details	
DS Manhole <b>D11-4</b>	Length surveyed <b>282.7</b>	Year Renewed	Height <b>8</b>	Width <b>8</b>	Pipe Joint... <b>4</b>

SPR <b>N/A</b>	MPR <b>16</b>	PO Number <b>4397-03</b>	Customer <b>GRW</b>
SPRI <b>N/A</b>	MPRI <b>2.3</b>	Work Order <b>4397-02</b>	Purpose <b>Pre-Rehabilitation Survey</b>
QSR <b>N/A</b>	QMR <b>4126</b>		
OPR <b>16</b>	Surveyed By <b>Barry Rogers</b>	Direction <b>Downstream</b>	Date <b>20150626</b>
OPRI <b>2.3</b>	Certificate Number <b>U-1012-16405</b>	Pre-Cleaning <b>Jetting</b>	Time <b>09:31</b>
	Date Cleaned <b>20150626</b>	End Time <b>09:55</b>	Weather <b>Dry</b>
			Media label
			Additional Info

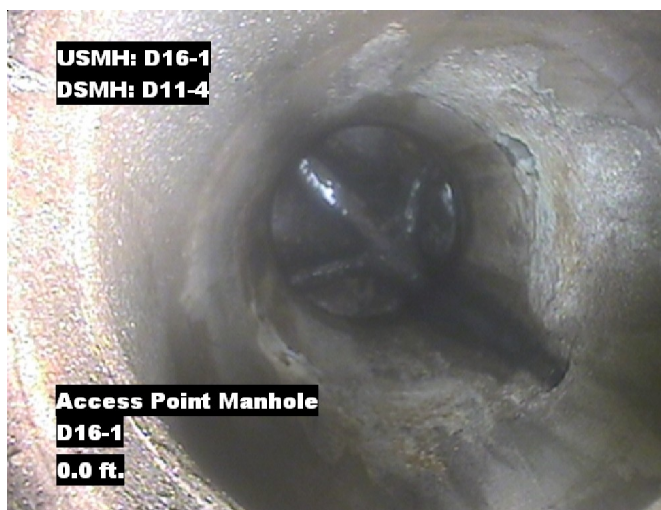
Distance: 0.0 ft. Grade: 0  
Condition: Access Point Manhole  
Remarks: D16-1

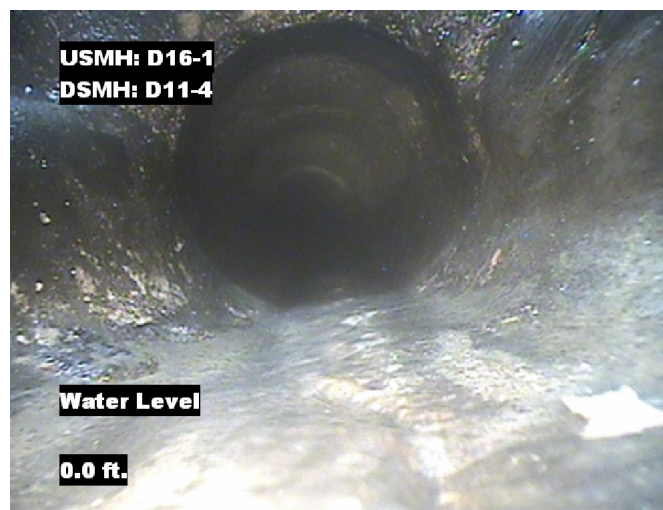
Distance: 0.0 ft. Grade: 0  
Condition: Water Level  
Remarks: N/A

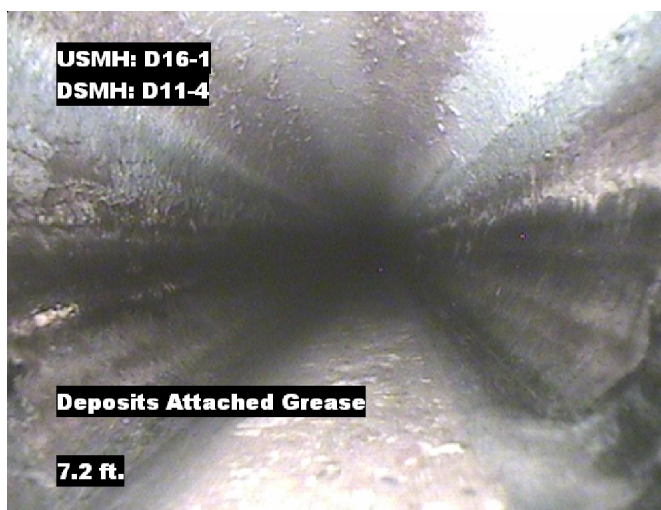
Distance: 7.2 ft. Grade: 2  
Condition: Deposits Attached Grease  
Remarks: N/A

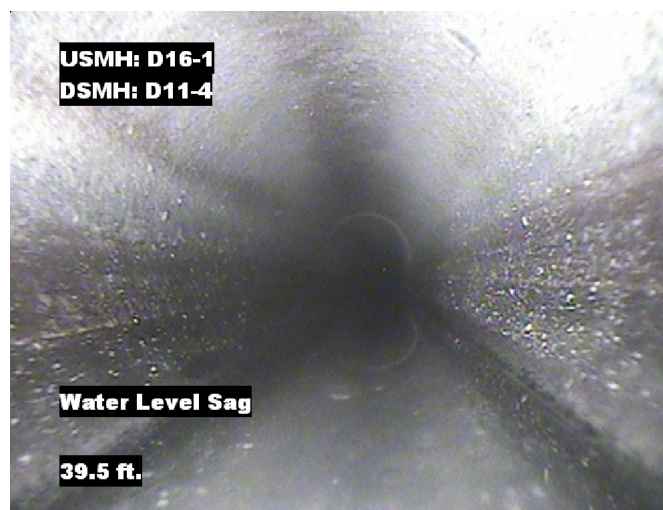
Distance: 39.5 ft. Grade: 2  
Condition: Water Level Sag  
Remarks: N/A

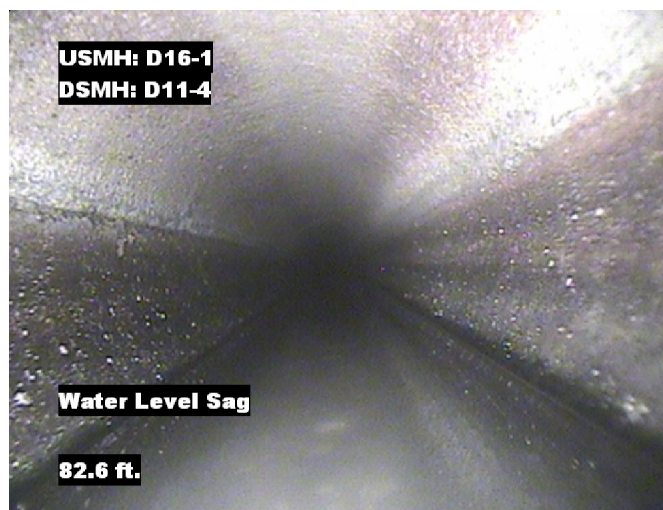
Distance: 82.6 ft. Grade: 2  
Condition: Water Level Sag  
Remarks: N/A

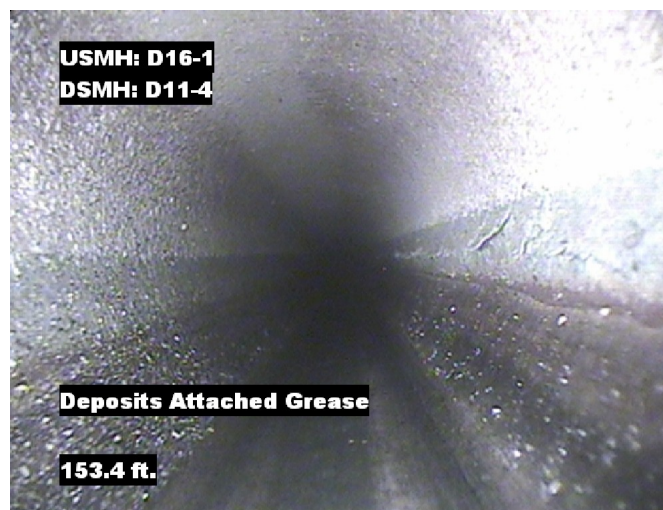
Distance: 153.4 ft. Grade: 2  
Condition: Deposits Attached Grease  
Remarks: N/A

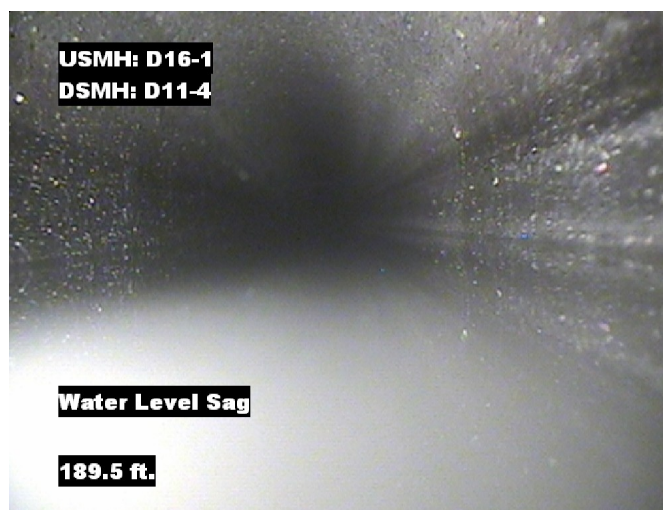
Distance: 189.5 ft. Grade: 2  
Condition: Water Level Sag  
Remarks: N/A

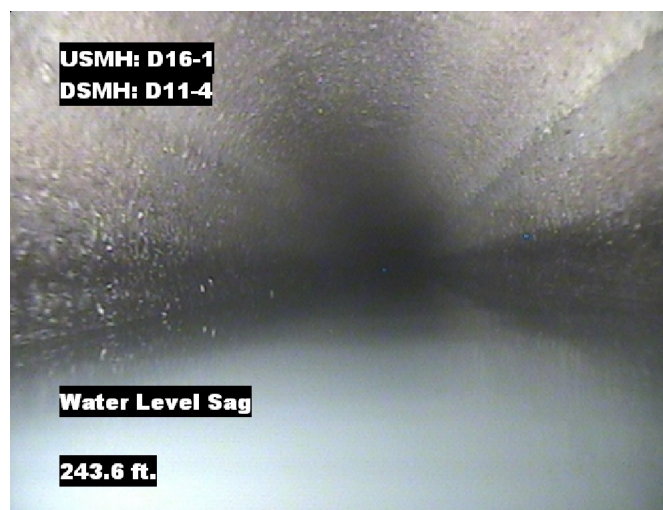
Distance: 243.6 ft. Grade: 2  
Condition: Water Level Sag  
Remarks: N/A

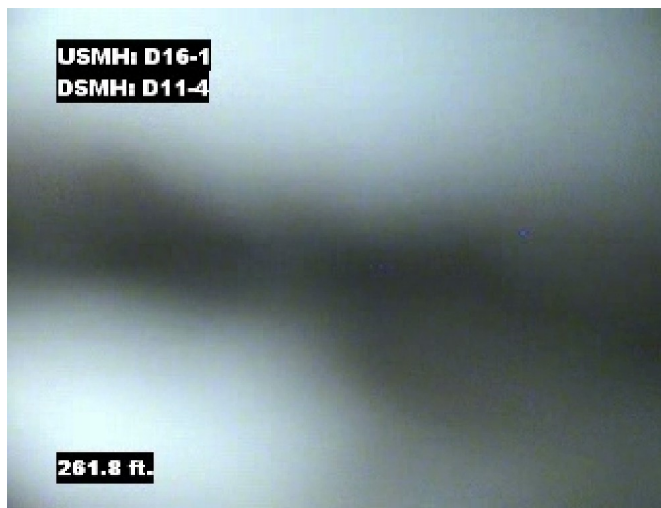
Distance: 261.8 ft. Grade: 4  
Condition: Camera Underwater  
Remarks: N/A

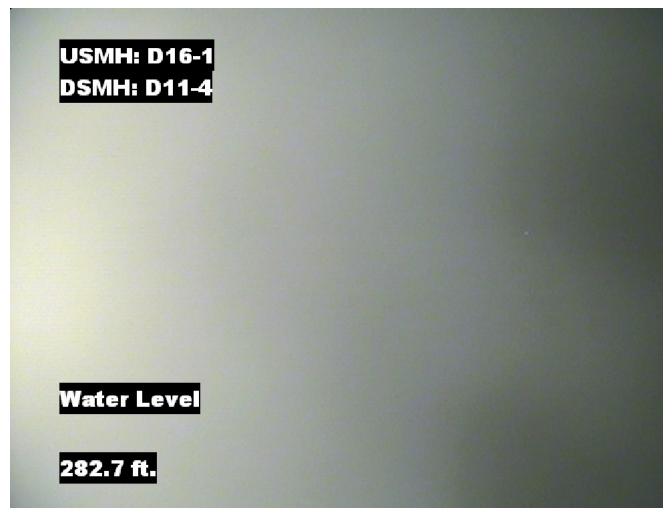
Distance: 282.7 ft. Grade: 0  
Condition: Water Level  
Remarks: N/A

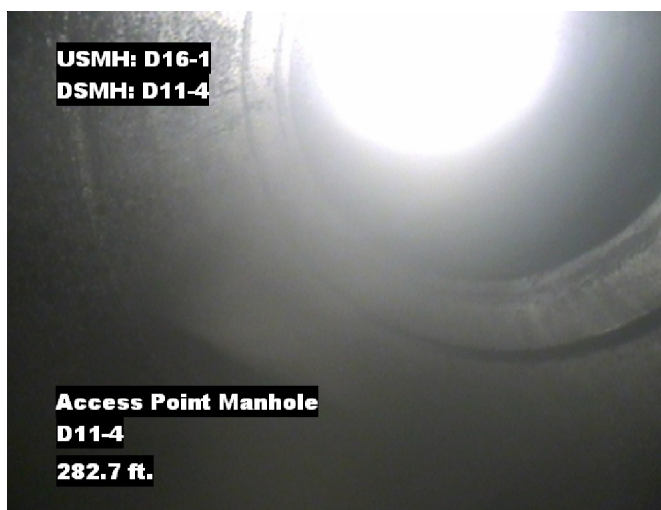
Distance: 282.7 ft. Grade: 0  
Condition: Access Point Manhole  
Remarks: D11-4
