Defect Listing

Pipe Segment Refere... D16-2_D16-1	City Oliver Springs	Street First Norway	Material Concrete Pipe (non-...	Location C... Light High...	Sewer Use Sanitary
Upstream MH D16-2	Total Length 276.6	Year Laid	Shape Circular	Location Details	
DS Manhole D16-1	Length surveyed 276.6	Year Renewed	Height 8	Width 8	Pipe Joint... 4

SPR 5	MPR N/A	PO Number 4397-03	Customer GRW
SPRI 5	MPRI N/A	Work Order 4397-02	Purpose Pre-Rehabilitation Survey
QSR 5100	QMR N/A		
OPR 5	Surveyed By Barry Rogers	Direction Downstream	Date 20150626
OPRI 5	Certificate Number U-1012-16405	Pre-Cleaning Jetting	Time 08:26
	Date Cleaned 20150626	End Time 08:40	Weather Dry
			Media label
			Additional Info

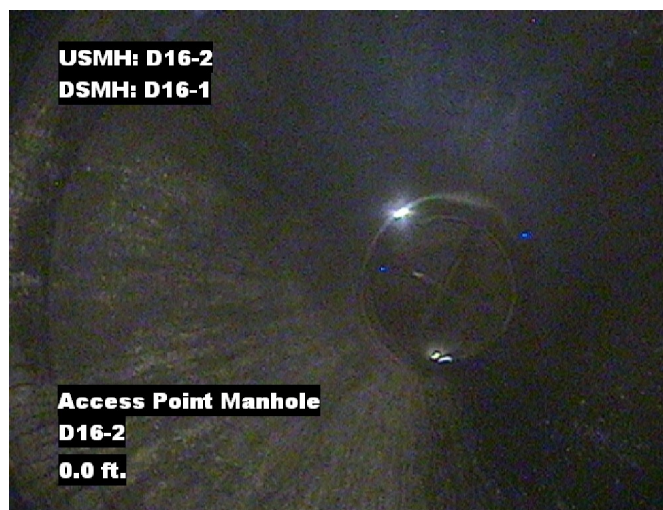
Distance: 0.0 ft. Grade: 0
Condition: Access Point Manhole
Remarks: D16-2

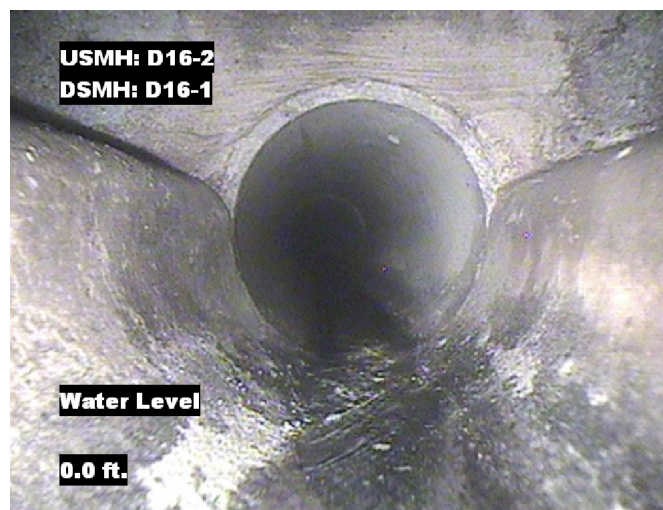
Distance: 0.0 ft. Grade: 0
Condition: Water Level
Remarks: N/A

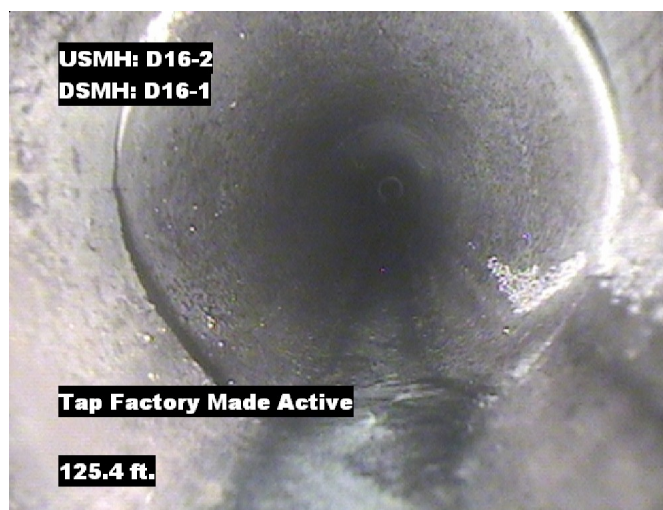
Distance: 125.4 ft. Grade: 0
Condition: Tap Factory Made Active
Remarks: N/A

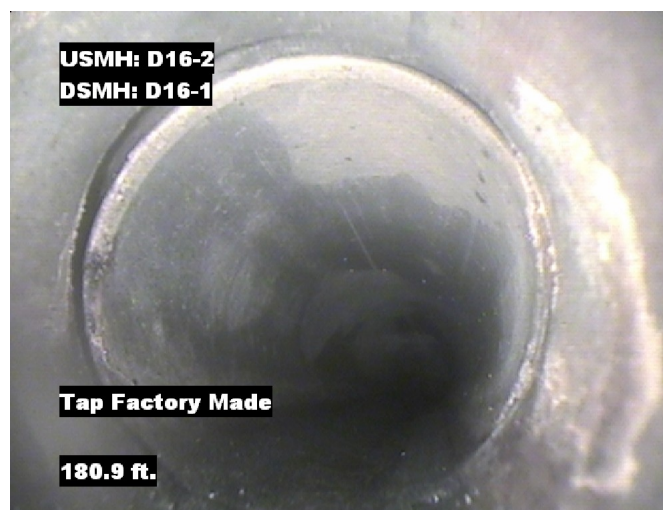
Distance: 180.9 ft. Grade: 0
Condition: Tap Factory Made
Remarks: N/A

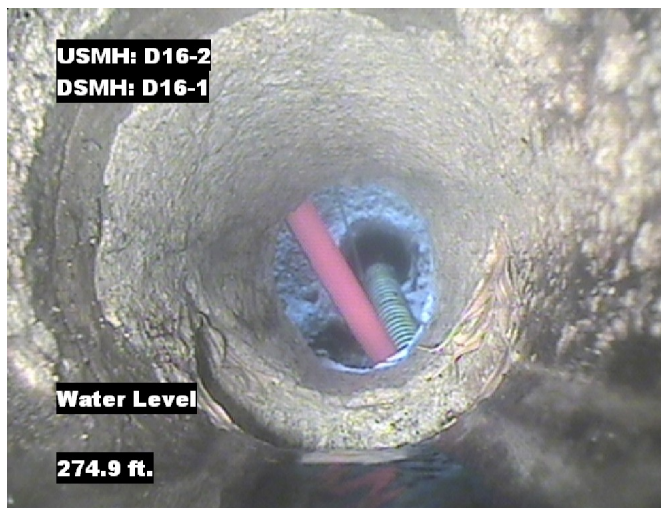
Distance: 274.9 ft. Grade: 0
Condition: Water Level
Remarks: N/A

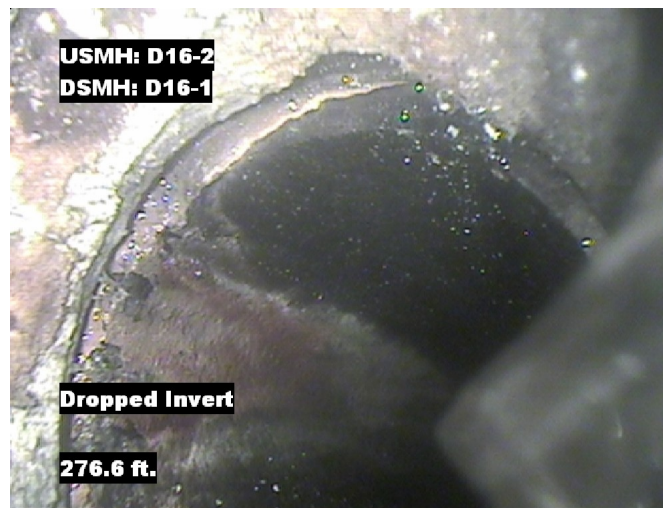
Distance: 276.6 ft. Grade: 5
Condition: Dropped Invert
Remarks: N/A

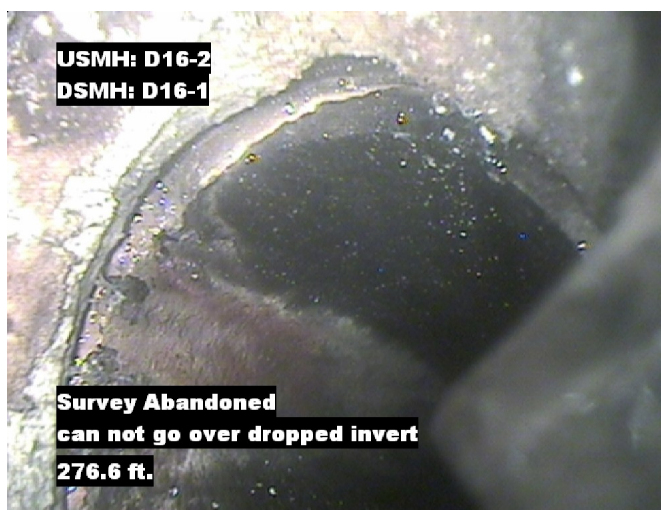
Distance: 276.6 ft. Grade: 0
Condition: Survey Abandoned
Remarks: can not go over dropped invert
