Defect Listing

Pipe Segment Refere... D16-3_D16-2	City Oliver Springs	Street First Norway Ln	Material Concrete Pipe (non-...	Location C... Light High...	Sewer Use Sanitary
Upstream MH D16-3	Total Length 207.5	Year Laid	Shape Circular	Location Details	
DS Manhole D16-2	Length surveyed 207.5	Year Renewed	Height 8	Width 8	Pipe Joint... 4

SPR 1	MPR N/A	PO Number 4397-03	Customer GRW
SPRI 1	MPRI N/A	Work Order 4397-02	Purpose Pre-Rehabilitation Survey
QSR 1100	QMR N/A		
OPR 1	Surveyed By Barry Rogers	Direction Downstream	Date 20150626
OPRI 1	Certificate Number U-1012-16405	Pre-Cleaning Jetting	Time 08:05
	Date Cleaned 20150626	End Time 08:17	Weather Dry
		Additional Info

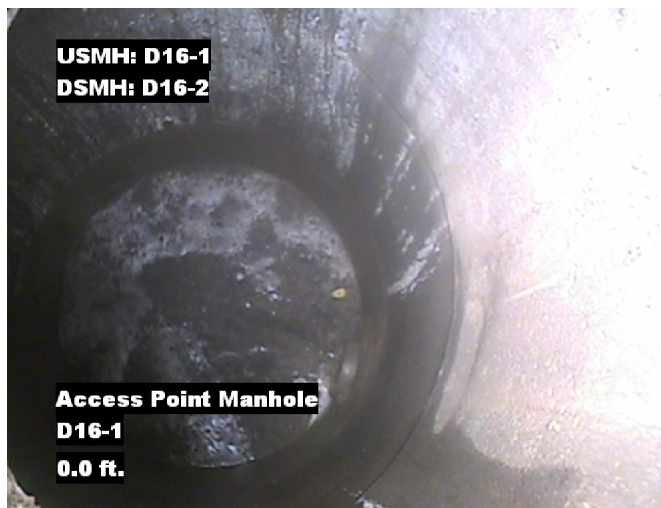
Distance: 0.0 ft. Grade: 0
Condition: Access Point Manhole
Remarks: D16-1

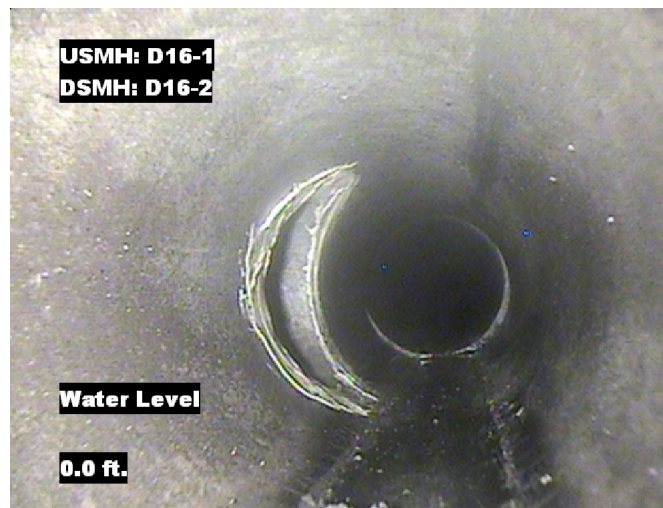
Distance: 0.0 ft. Grade: 0
Condition: Water Level
Remarks: N/A

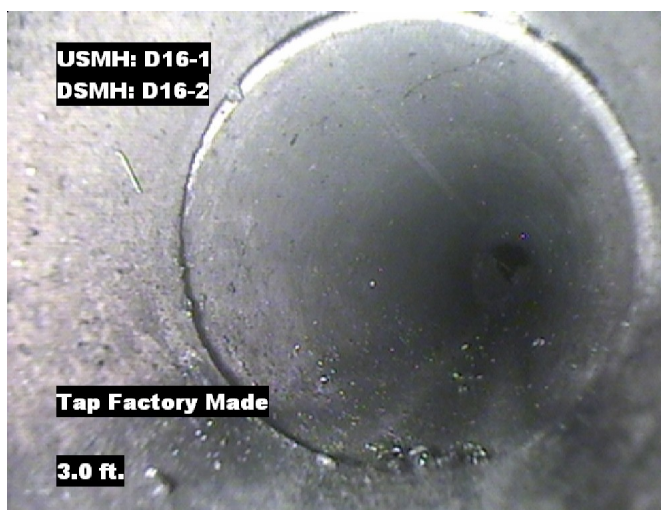
Distance: 3.0 ft. Grade: 0
Condition: Tap Factory Made
Remarks: N/A

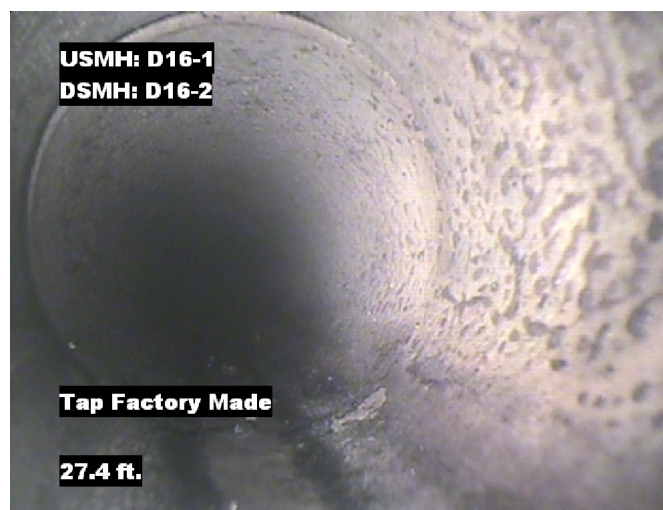
Distance: 27.4 ft. Grade: 0
Condition: Tap Factory Made
Remarks: N/A

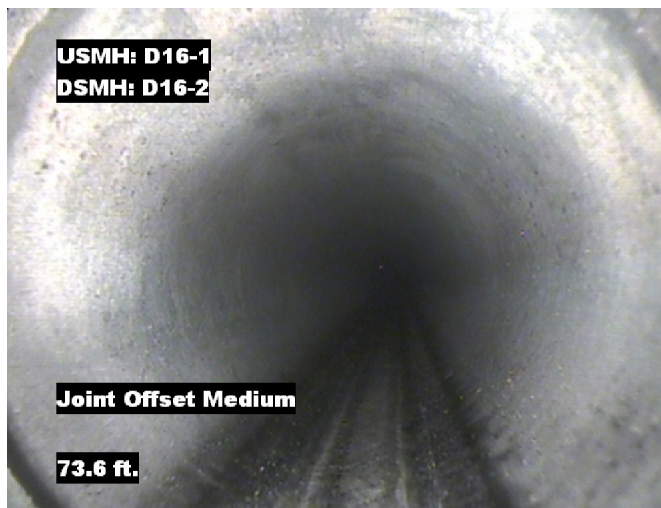
Distance: 73.6 ft. Grade: 1
Condition: Joint Offset Medium
Remarks: N/A

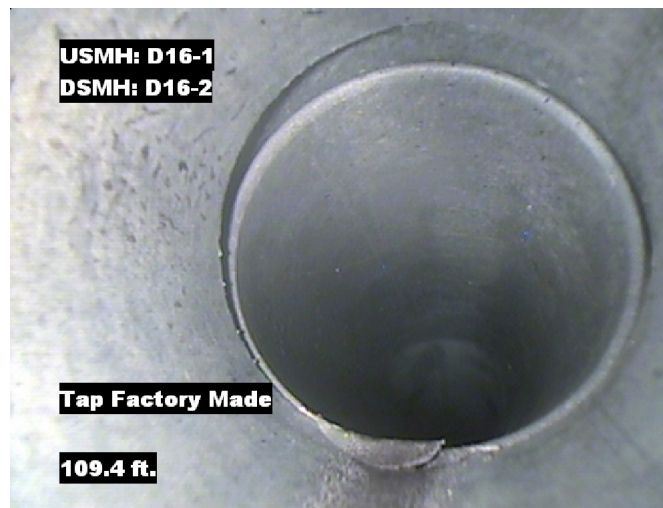
Distance: 109.4 ft. Grade: 0
Condition: Tap Factory Made
Remarks: N/A

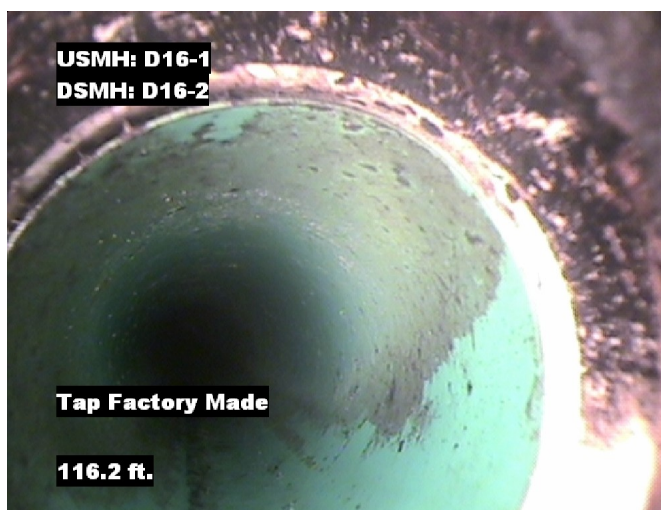
Distance: 116.2 ft. Grade: 0
Condition: Tap Factory Made
Remarks: N/A

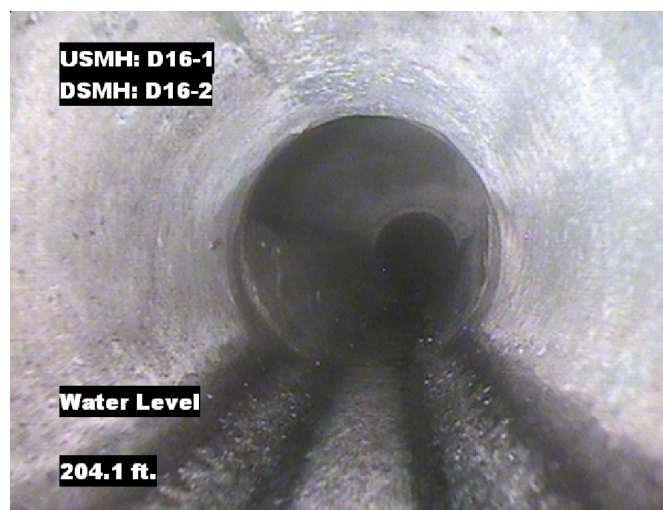
Distance: 204.1 ft. Grade: 0
Condition: Water Level
Remarks: N/A

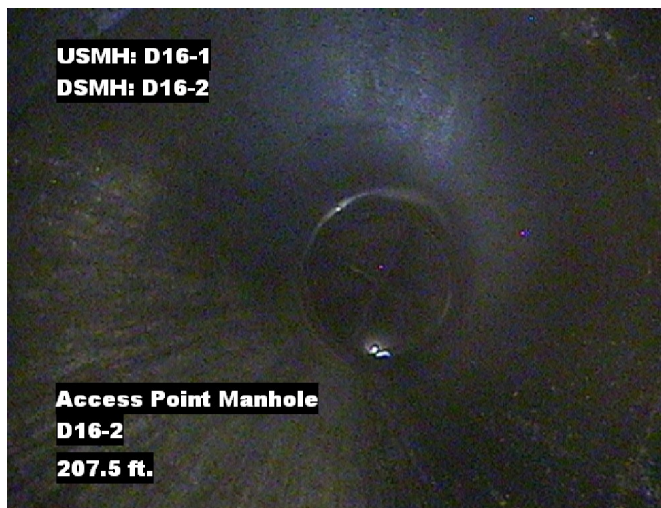
Distance: 207.5 ft. Grade: 0
Condition: Access Point Manhole
Remarks: D16-2
