Defect Listing

Pipe Segment Refere... D17-1_D16-1	City Oliver Springs	Street Wall ST	Material Concrete Pipe (non-...	Location C... Yard	Sewer Use Sanitary
Upstream MH D17-1	Total Length 351	Year Laid	Shape Circular	Location Details	
DS Manhole D16-1	Length surveyed 351	Year Renewed	Height 8	Width 8	Pipe Joint... 4

SPR N/A	MPR N/A	PO Number 4397-03		Customer GRW	
SPRI N/A	MPRI N/A	Work Order 4397-02		Purpose Pre-Rehabilitation Survey	
QSR N/A	QMR N/A				
OPR N/A	Surveyed By Barry Rogers	Direction Downstream	Date 20150625	Media label	
OPRI N/A	Certificate Number U-1012-16405	Pre-Cleaning Jetting	Time 15:36	Weather Dry	
Date Cleaned 20150625			End Time 15:50	Additional Info

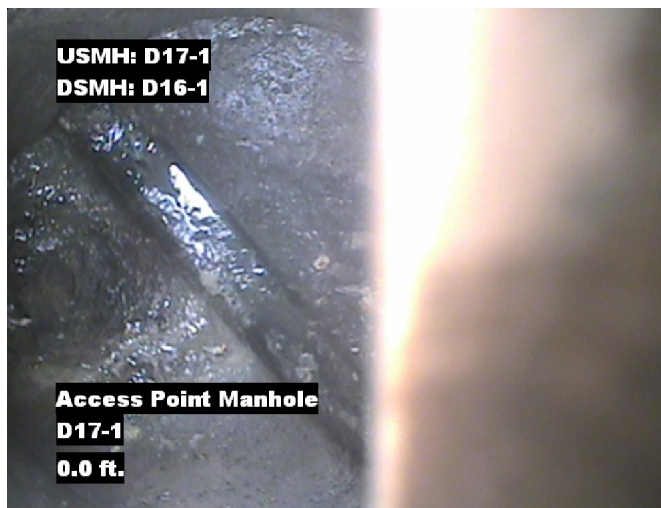
Distance: 0.0 ft. Grade: 0
Condition: Access Point Manhole
Remarks: D17-1

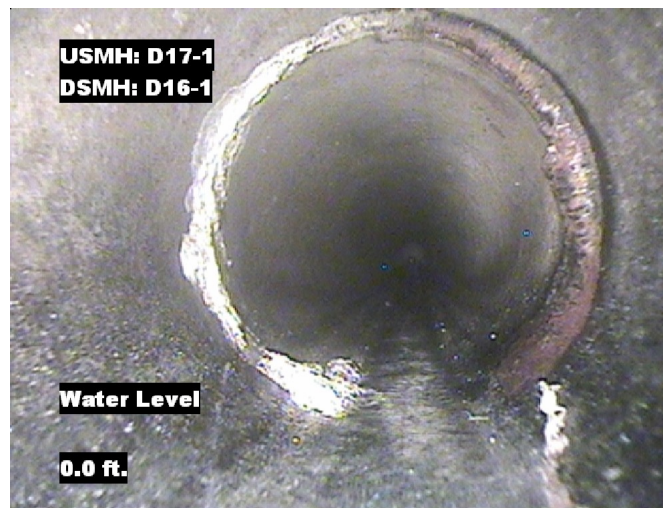
Distance: 0.0 ft. Grade: 0
Condition: Water Level
Remarks: N/A

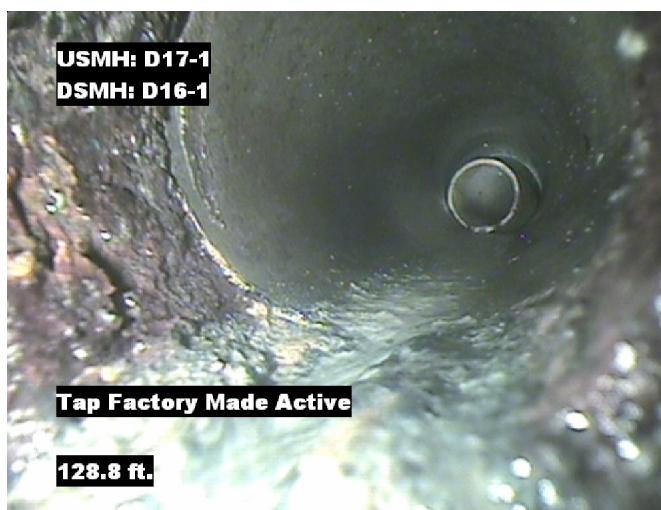
Distance: 128.8 ft. Grade: 0
Condition: Tap Factory Made Active
Remarks: N/A

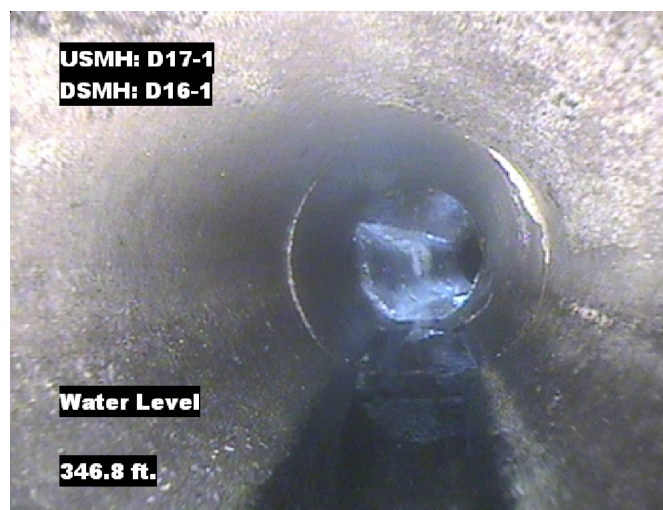
Distance: 346.8 ft. Grade: 0
Condition: Water Level
Remarks: N/A

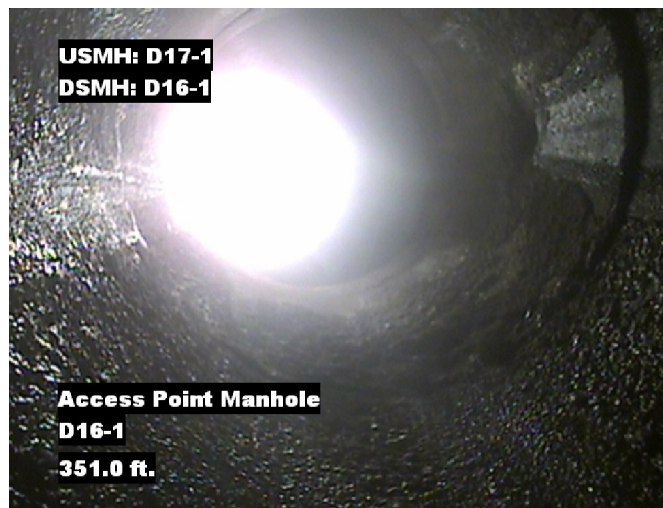
Distance: 351.0 ft. Grade: 0
Condition: Access Point Manhole
Remarks: D16-1
