## Defect Listing

Pipe Segment Refere... <b>D18-1_D16-1</b>	City <b>Oliver Springs</b>	Street <b>First Norway</b>	Material <b>Concrete Pipe (non-...</b>	Location C... <b>Light High...</b>	Sewer Use <b>Sanitary</b>
Upstream MH <b>D18-1</b>	Total Length <b>171.4</b>	Year Laid	Shape <b>Circular</b>	Location Details	
DS Manhole <b>D16-1</b>	Length surveyed <b>171.4</b>	Year Renewed	Height <b>8</b>	Width <b>8</b>	Pipe Joint... <b>4</b>

SPR <b>5</b>	MPR <b>68</b>	PO Number <b>4397-03</b>	Customer <b>GRW</b>
SPRI <b>5</b>	MPRI <b>2</b>	Work Order <b>4397-02</b>	Purpose <b>Pre-Rehabilitation Survey</b>
QSR <b>5100</b>	QMR <b>2E00</b>		
OPR <b>73</b>	Surveyed By <b>Barry Rogers</b>	Direction <b>Upstream</b>	Date <b>20150626</b>
OPRI <b>2.1</b>	Certificate Number <b>U-1012-16405</b>	Pre-Cleaning <b>Jetting</b>	Time <b>08:59</b>
	Date Cleaned <b>20150626</b>	End Time <b>09:15</b>	Weather <b>Dry</b>
			Media label
			Additional Info

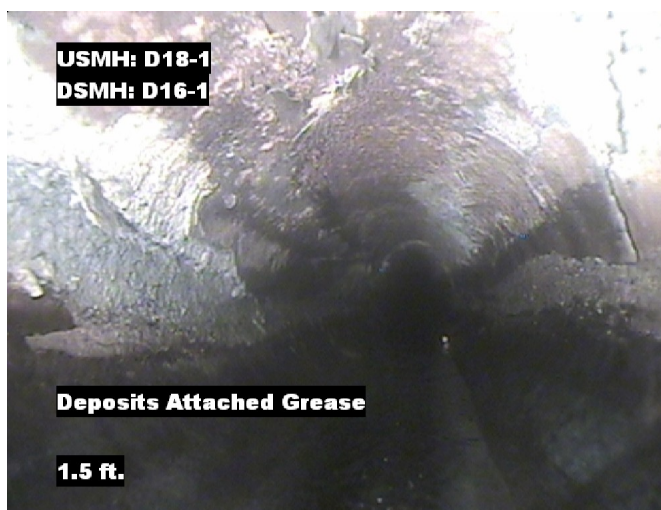
Distance: 1.5 ft. Grade: 2  
Condition: Deposits Attached Grease  
Remarks: N/A

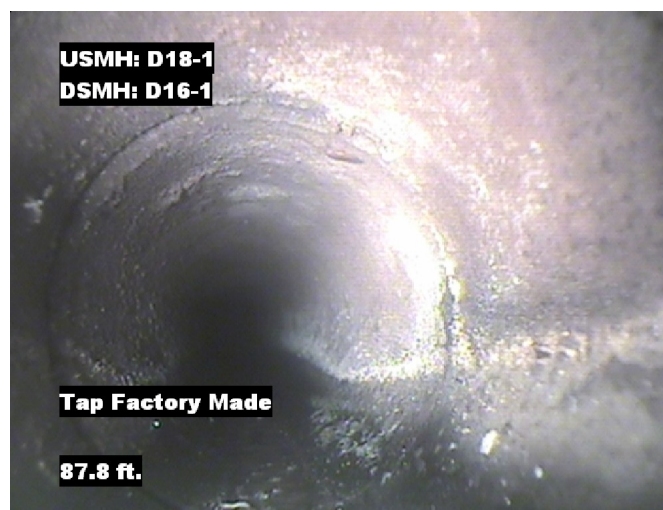
Distance: 87.8 ft. Grade: 0  
Condition: Tap Factory Made  
Remarks: N/A

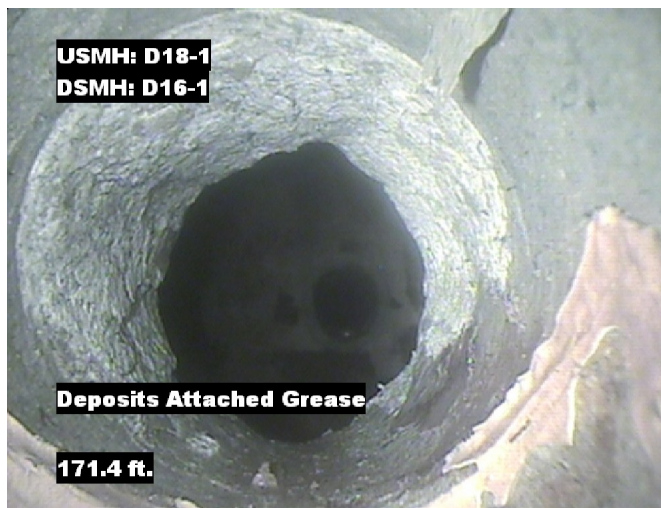
Distance: 171.4 ft. Grade: 2  
Condition: Deposits Attached Grease  
Remarks: N/A

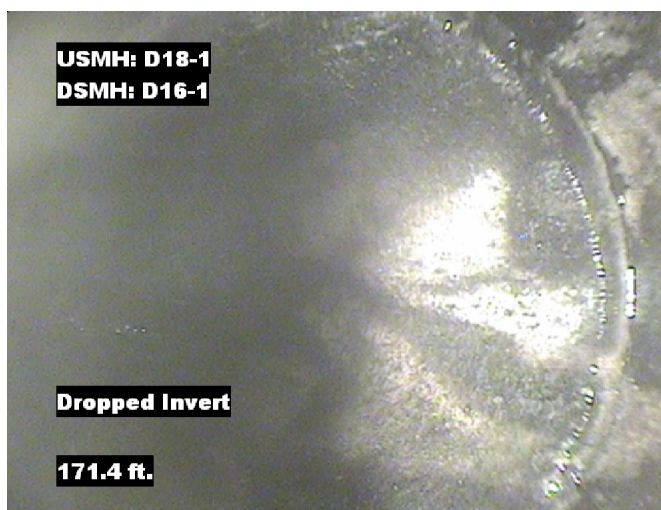
Distance: 171.4 ft. Grade: 5  
Condition: Dropped Invert  
Remarks: N/A

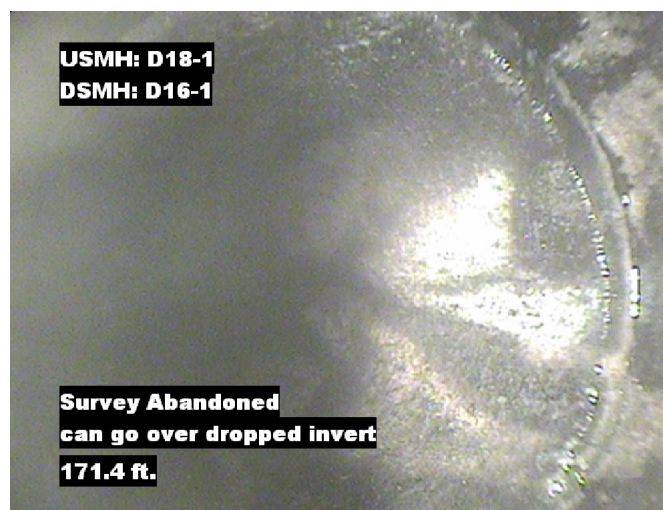
Distance: 171.4 ft. Grade: 0  
Condition: Survey Abandoned  
Remarks: can go over dropped invert
