## Defect Listing

Pipe Segment Refere... <b>D19-1_D11-2</b>	City <b>Oliver Springs</b>	Street <b>Sycamore</b>	Material <b>Concrete Pipe (non-...</b>	Location C... <b>Easement/R...</b>	Sewer Use <b>Sanitary</b>
Upstream MH <b>D19-1</b>	Total Length <b>342.1</b>	Year Laid	Shape <b>Circular</b>	Location Details	
DS Manhole <b>D11-2</b>	Length surveyed <b>342.1</b>	Year Renewed	Height <b>8</b>	Width <b>8</b>	Pipe Joint... <b>4</b>

SPR <b>N/A</b>	MPR <b>2</b>	PO Number <b>4397-03</b>	Customer <b>GRW</b>
SPRI <b>N/A</b>	MPRI <b>2</b>	Work Order <b>4397-02</b>	Purpose <b>Pre-Rehabilitation Survey</b>
QSR <b>N/A</b>	QMR <b>2100</b>		
OPR <b>2</b>	Surveyed By <b>Barry Rogers</b>	Direction <b>Downstream</b>	Date <b>20150701</b>
OPRI <b>2</b>	Certificate Number <b>U-1012-16405</b>	Pre-Cleaning <b>Jetting</b>	Time <b>07:21</b>
	Date Cleaned <b>20150701</b>	End Time <b>07:34</b>	Weather <b>Damp</b>
			Media label
			Additional Info

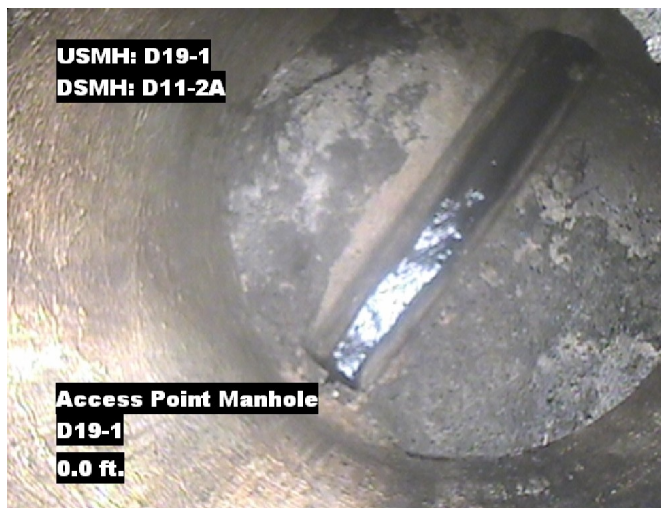
Distance: 0.0 ft. Grade: 0  
Condition: Access Point Manhole  
Remarks: D19-1

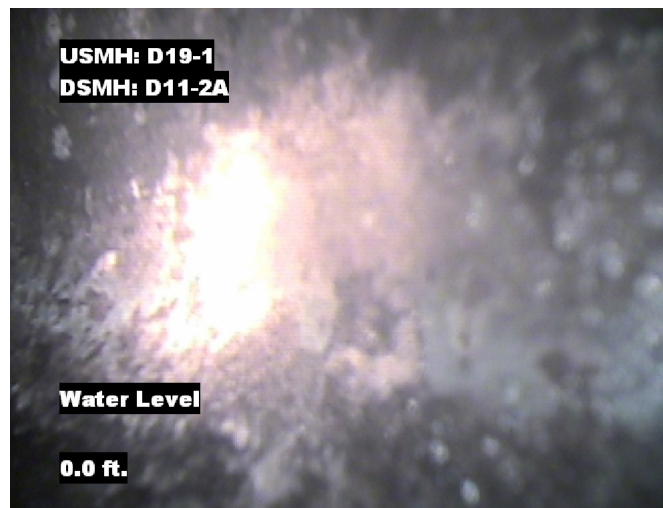
Distance: 0.0 ft. Grade: 0  
Condition: Water Level  
Remarks: N/A

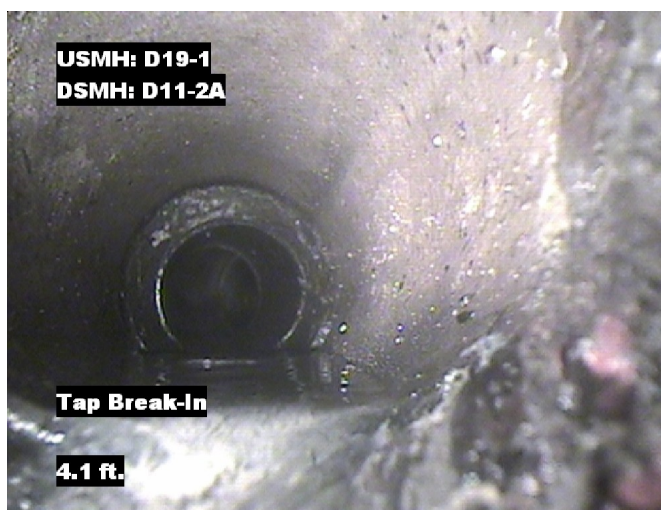
Distance: 4.1 ft. Grade: 0  
Condition: Tap Break-In  
Remarks: N/A

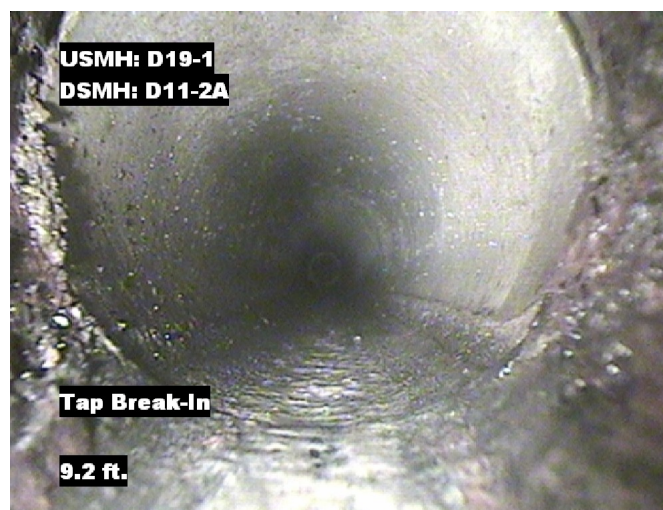
Distance: 9.2 ft. Grade: 0  
Condition: Tap Break-In  
Remarks: N/A

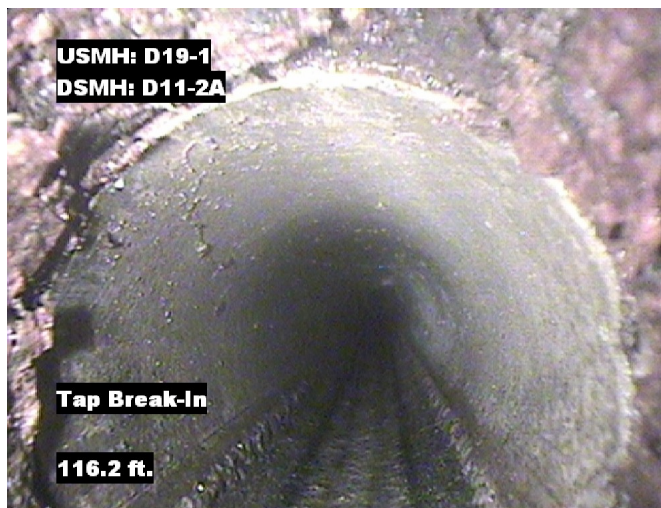
Distance: 116.2 ft. Grade: 0  
Condition: Tap Break-In  
Remarks: N/A

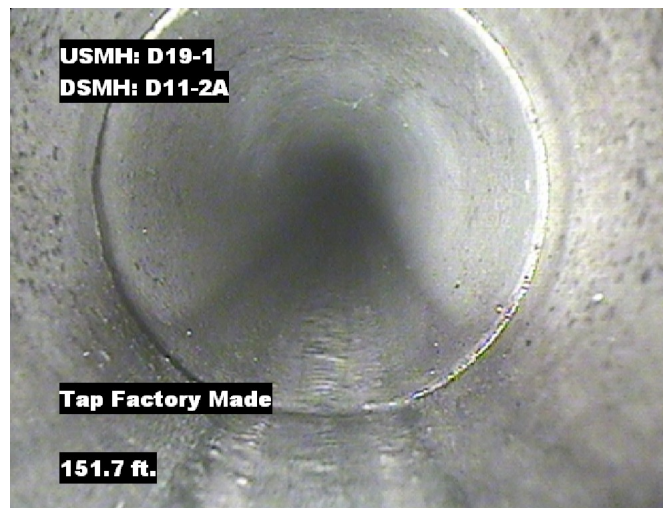
Distance: 151.7 ft. Grade: 0  
Condition: Tap Factory Made  
Remarks: N/A

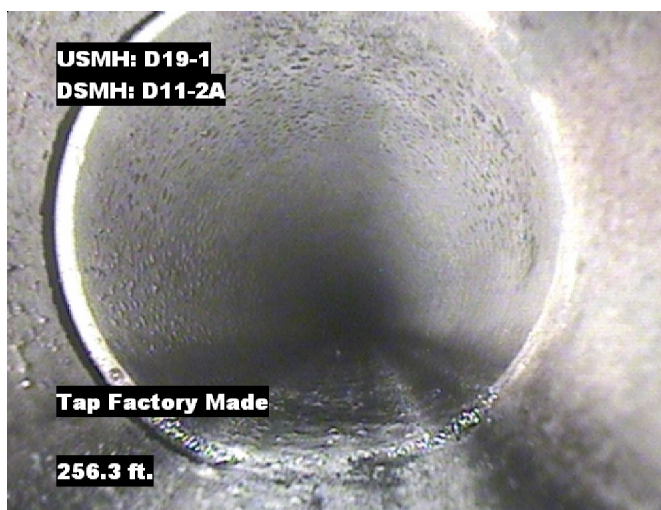
Distance: 256.3 ft. Grade: 0  
Condition: Tap Factory Made  
Remarks: N/A

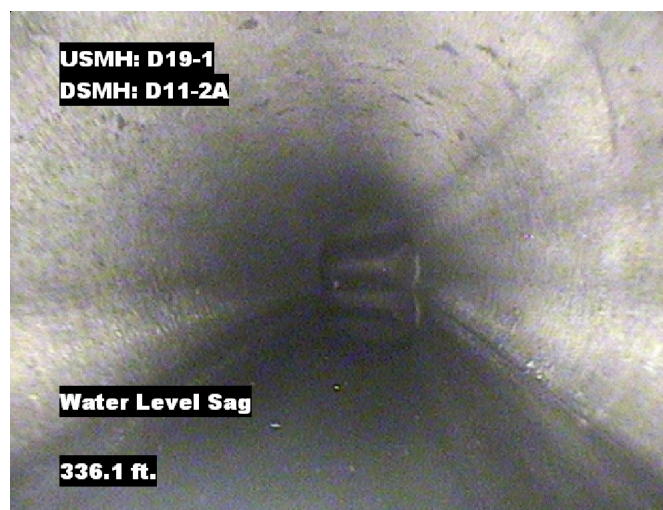
Distance: 336.0 ft. Grade: 2  
Condition: Water Level Sag  
Remarks: N/A

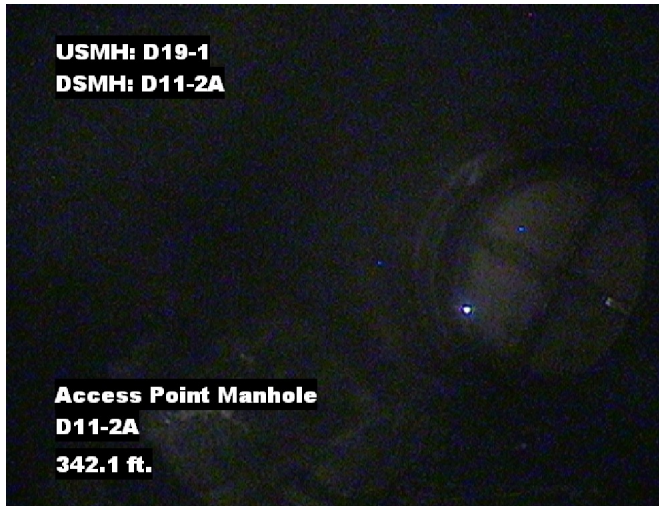
Distance: 342.1 ft. Grade: 0  
Condition: Access Point Manhole  
Remarks: D11-2
