## Defect Listing

Pipe Segment Refere... <b>D19-10_D19-9</b>	City <b>Oliver Springs</b>	Street <b>Chickapin lane</b>	Material <b>Concrete Pipe (non-...</b>	Location C... <b>Light High...</b>	Sewer Use <b>Sanitary</b>
Upstream MH <b>D19-10</b>	Total Length <b>280.3</b>	Year Laid	Shape <b>Circular</b>	Location Details	
DS Manhole <b>D19-9</b>	Length surveyed <b>280.3</b>	Year Renewed	Height <b>8</b>	Width <b>8</b>	Pipe Joint... <b>4</b>

SPR <b>N/A</b>	MPR <b>2</b>	PO Number <b>4397-03</b>		Customer <b>GRW</b>	
SPRI <b>N/A</b>	MPRI <b>2</b>	Work Order <b>4397-02</b>		Purpose <b>Pre-Rehabilitation Survey</b>	
QSR <b>N/A</b>	QMR <b>2100</b>				
OPR <b>2</b>	Surveyed By <b>Barry Rogers</b>	Direction <b>Downstream</b>	Date <b>20150626</b>	Media label	
OPRI <b>2</b>	Certificate Number <b>U-1012-16405</b>	Pre-Cleaning <b>No Pre-Cleaning</b>	Time <b>13:55</b>	Weather <b>Very Dry</b>	
Date Cleaned			End Time <b>14:20</b>	Additional Info

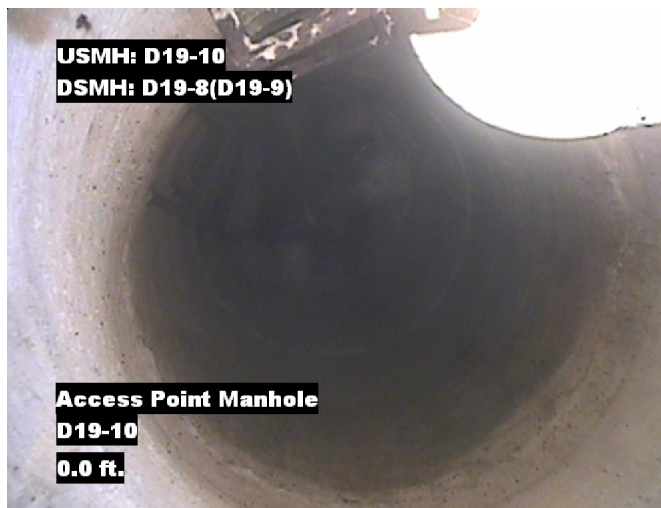
Distance: 0.0 ft. Grade: 0  
Condition: Access Point Manhole  
Remarks: D19-10

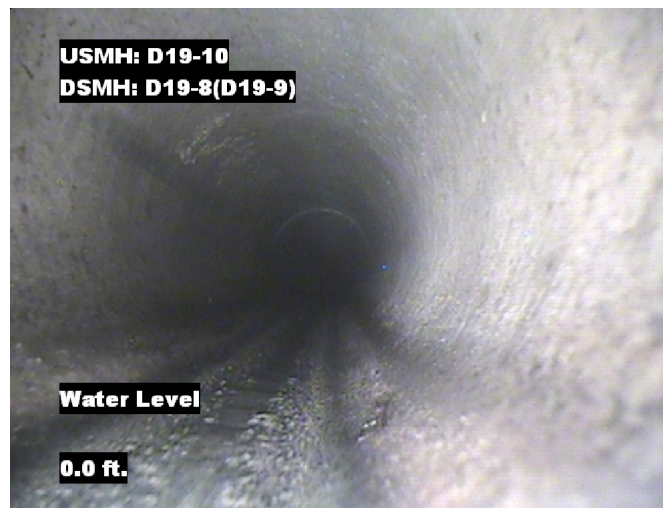
Distance: 0.0 ft. Grade: 0  
Condition: Water Level  
Remarks: N/A

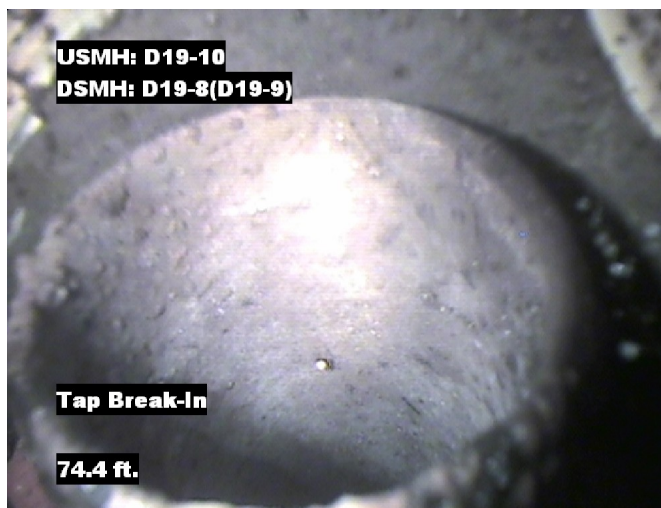
Distance: 74.4 ft. Grade: 0  
Condition: Tap Break-In  
Remarks: N/A

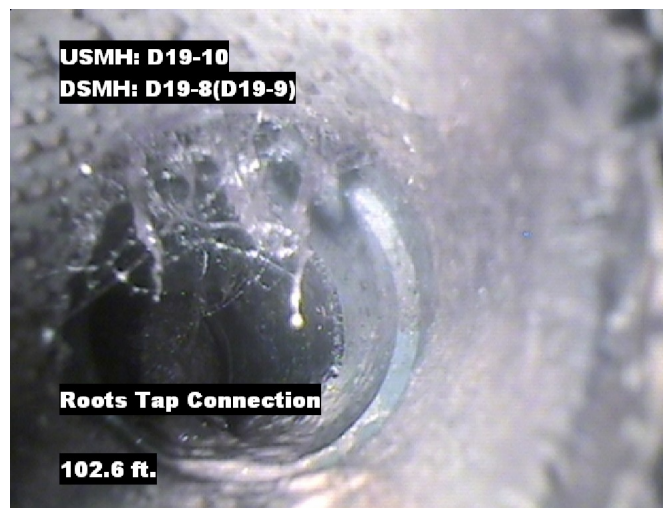
Distance: 102.6 ft. Grade: 2  
Condition: Roots Tap Connection  
Remarks: N/A

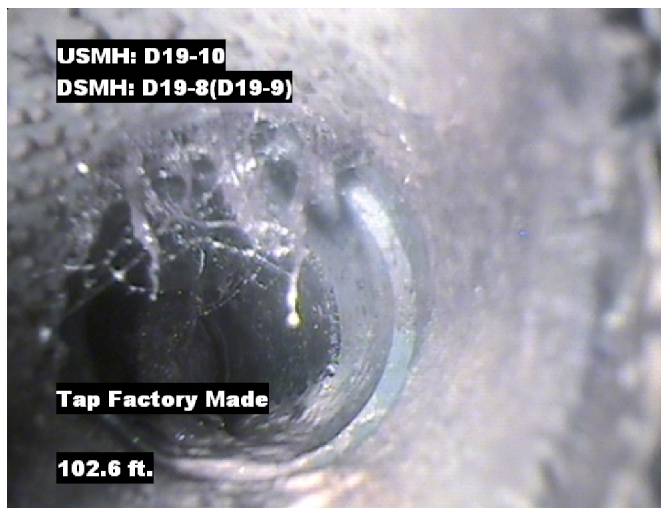
Distance: 102.6 ft. Grade: 0  
Condition: Tap Factory Made  
Remarks: N/A

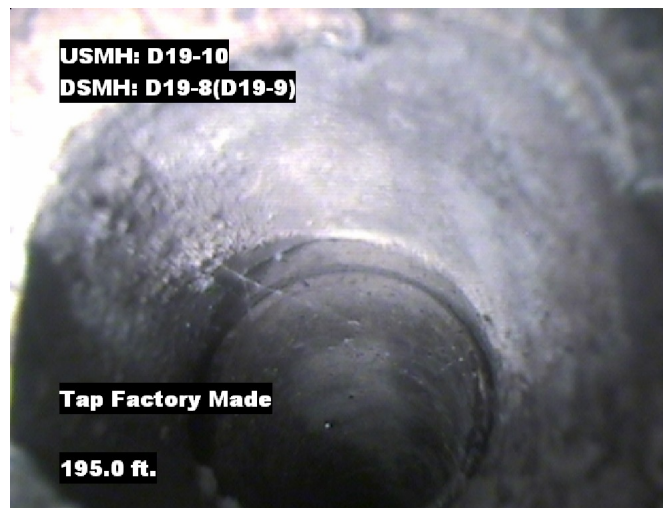
Distance: 195.0 ft. Grade: 0  
Condition: Tap Factory Made  
Remarks: N/A

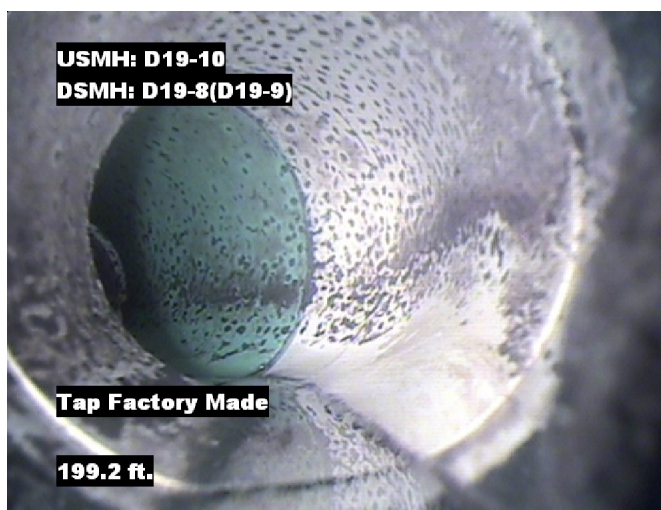
Distance: 199.2 ft. Grade: 0  
Condition: Tap Factory Made  
Remarks: N/A

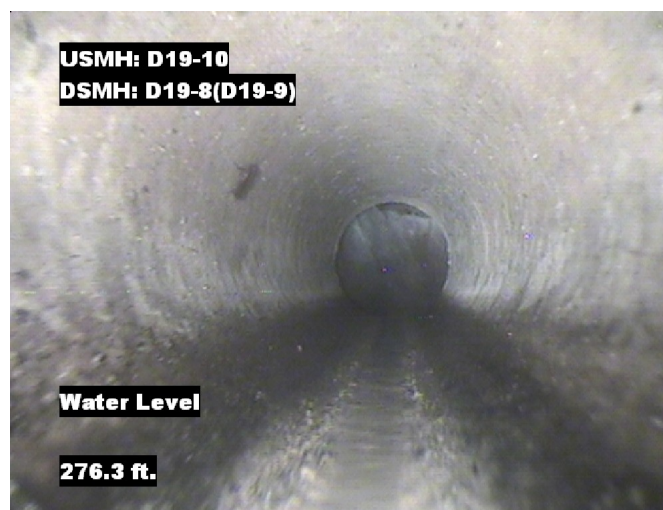
Distance: 276.3 ft. Grade: 0  
Condition: Water Level  
Remarks: N/A

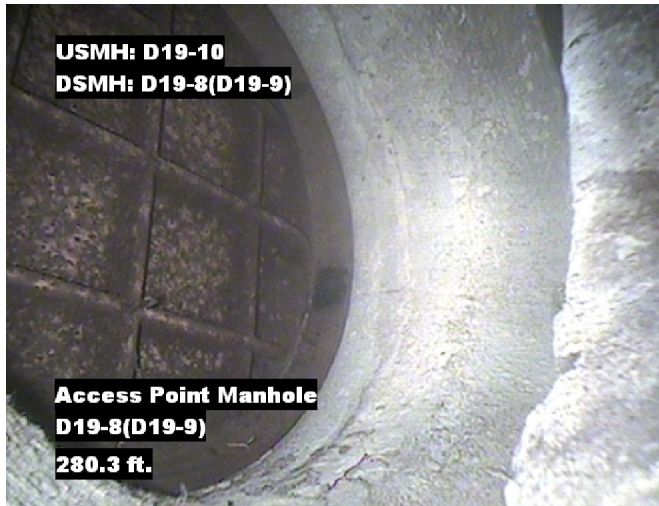
Distance: 280.3 ft.      Grade: 0  
Condition: Access Point Manhole  
Remarks: D19-8(D19-9)
