## Defect Listing

Pipe Segment Refere... <b>D19-2_D19-1</b>	City <b>Oliver Springs</b>	Street <b>Sycamore In</b>	Material <b>Concrete Pipe (non-...</b>	Location C... <b>Easement/R...</b>	Sewer Use <b>Sanitary</b>
Upstream MH <b>D19-2</b>	Total Length <b>263.3</b>	Year Laid	Shape <b>Circular</b>	Location Details	
DS Manhole <b>D19-1</b>	Length surveyed <b>263.3</b>	Year Renewed	Height <b>8</b>	Width <b>8</b>	Pipe Joint... <b>4</b>

SPR <b>N/A</b>	MPR <b>2</b>	PO Number <b>4397-03</b>	Customer <b>GRW</b>
SPRI <b>N/A</b>	MPRI <b>2</b>	Work Order <b>4397-02</b>	Purpose <b>Pre-Rehabilitation Survey</b>
QSR <b>N/A</b>	QMR <b>2100</b>		
OPR <b>2</b>	Surveyed By <b>Barry Rogers</b>	Direction <b>Downstream</b>	Date <b>20150701</b>
OPRI <b>2</b>	Certificate Number <b>U-1012-16405</b>	Pre-Cleaning <b>Jetting</b>	Time <b>06:51</b>
	Date Cleaned <b>20150701</b>	End Time <b>07:01</b>	Weather <b>Damp</b>
			Additional Info

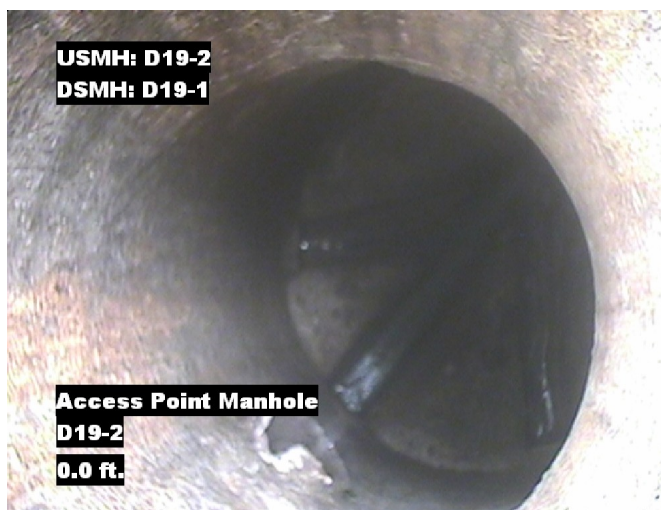
Distance: 0.0 ft. Grade: 0  
Condition: Access Point Manhole  
Remarks: D19-2

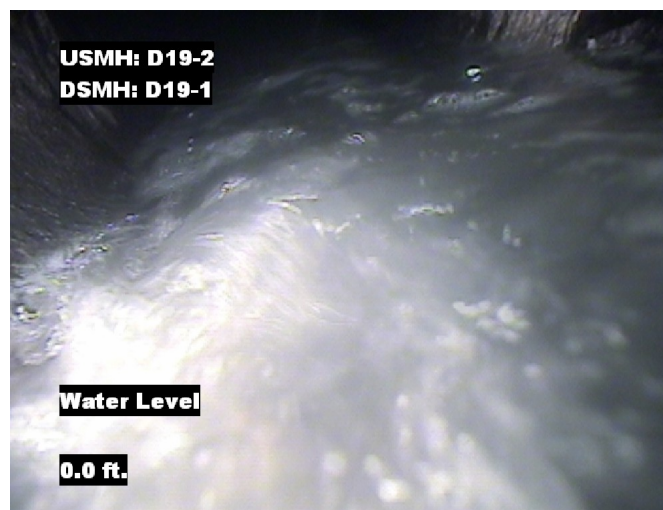
Distance: 0.0 ft. Grade: 0  
Condition: Water Level  
Remarks: N/A

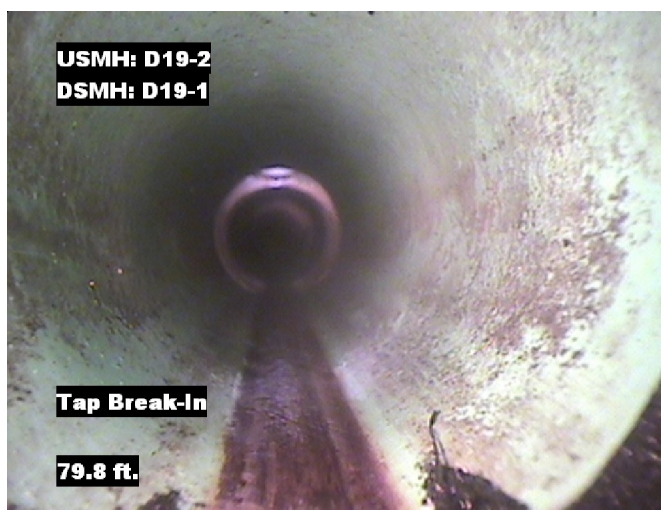
Distance: 79.8 ft. Grade: 0  
Condition: Tap Break-In  
Remarks: N/A

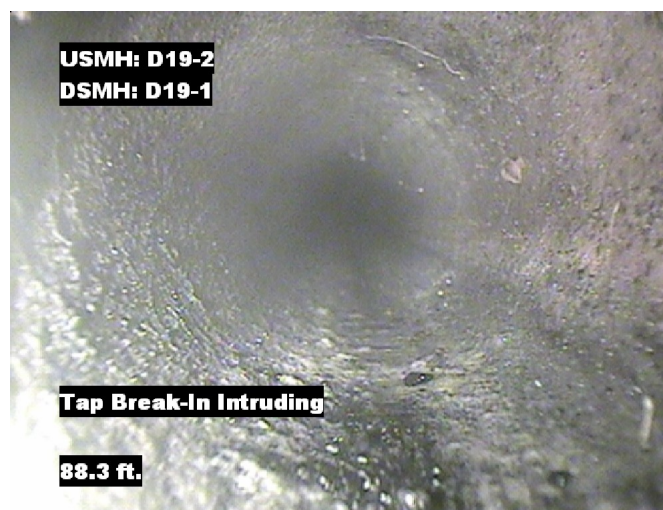
Distance: 88.3 ft. Grade: 2  
Condition: Tap Break-In Intruding  
Remarks: N/A

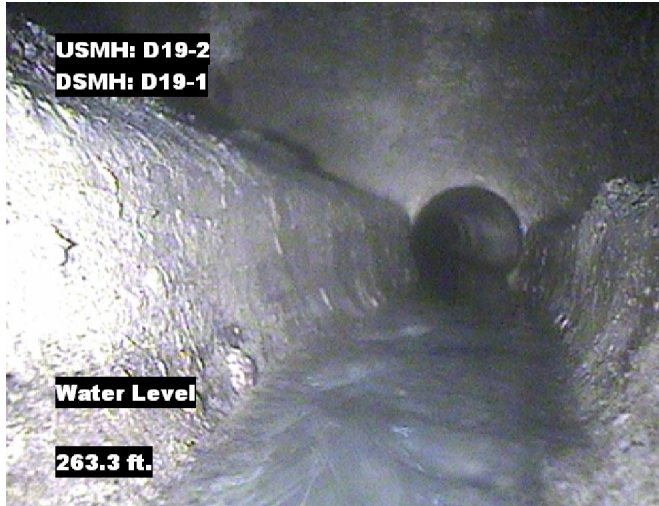
Distance: 263.3 ft. Grade: 0  
Condition: Water Level  
Remarks: N/A

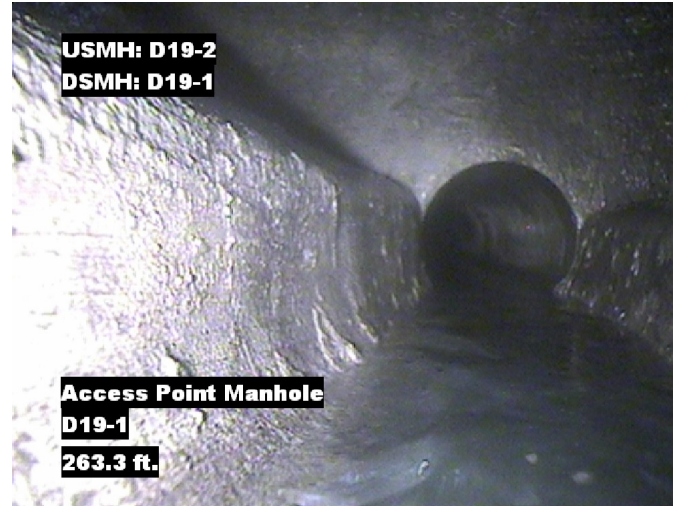
Distance: 263.3 ft. Grade: 0  
Condition: Access Point Manhole  
Remarks: D19-1
