Defect Listing

Pipe Segment Refere... D19-3_D19-2	City Oliver Springs	Street Sycamore	Material Concrete Pipe (non-...	Location C... Light High...	Sewer Use Sanitary
Upstream MH D19-3	Total Length 255.6	Year Laid	Shape Circular	Location Details	
DS Manhole D19-2	Length surveyed 255.6	Year Renewed	Height 8	Width 8	Pipe Joint... 4

SPR 5	MPR 10	PO Number 4397-03		Customer GRW	
SPRI 5	MPRI 2.5	Work Order 4397-02		Purpose Pre-Rehabilitation Survey	
QSR 5100	QMR 4131				
OPR 15	Surveyed By Barry Rogers	Direction Downstream	Date 20150630	Media label	
OPRI 3	Certificate Number U-1012-16405	Pre-Cleaning Jetting	Time 15:33	Weather Light Rain	
Date Cleaned 20150630			End Time 15:46	Additional Info

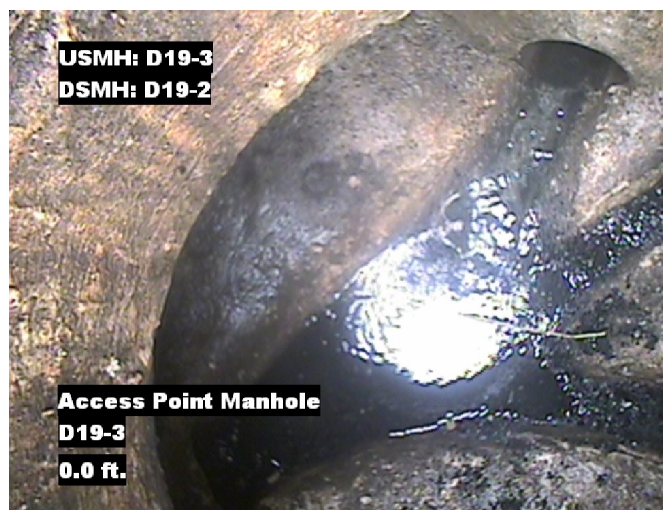
Distance: 0.0 ft. Grade: 0
Condition: Access Point Manhole
Remarks: D19-3

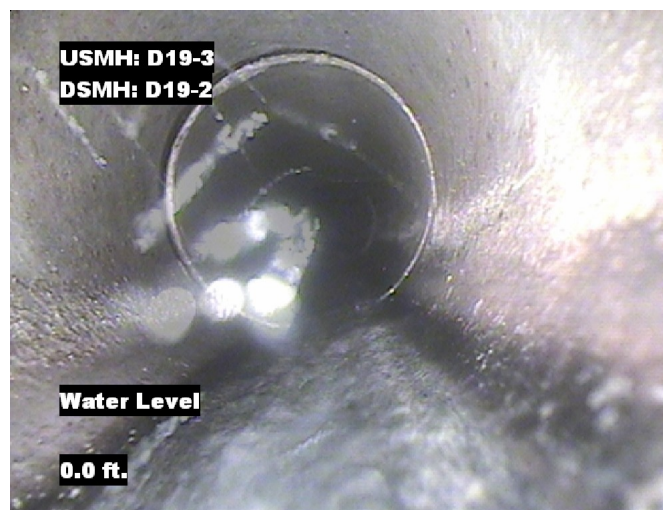
Distance: 0.0 ft. Grade: 0
Condition: Water Level
Remarks: N/A

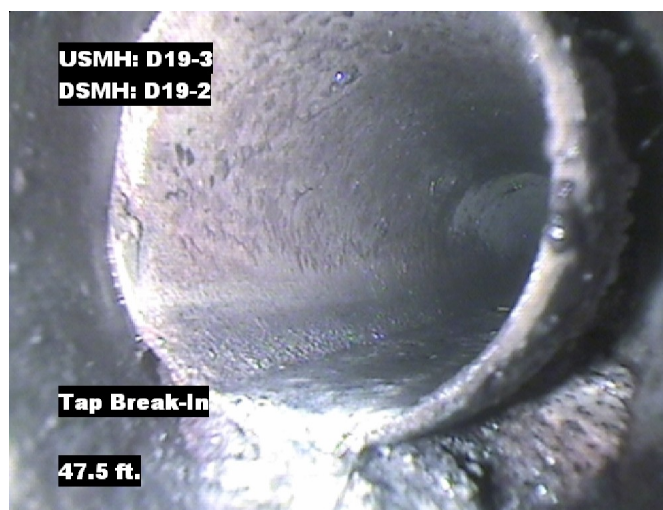
Distance: 47.5 ft. Grade: 0
Condition: Tap Break-In
Remarks: N/A

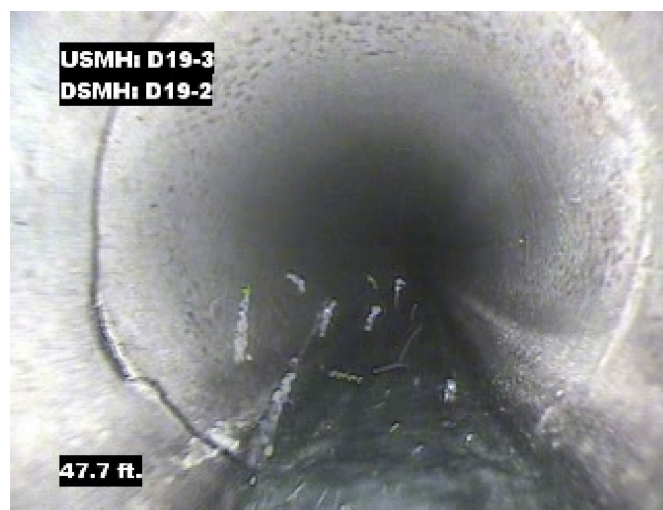
Distance: 47.9 ft. Grade: 5
Condition: Hole Void Visible
Remarks: N/A

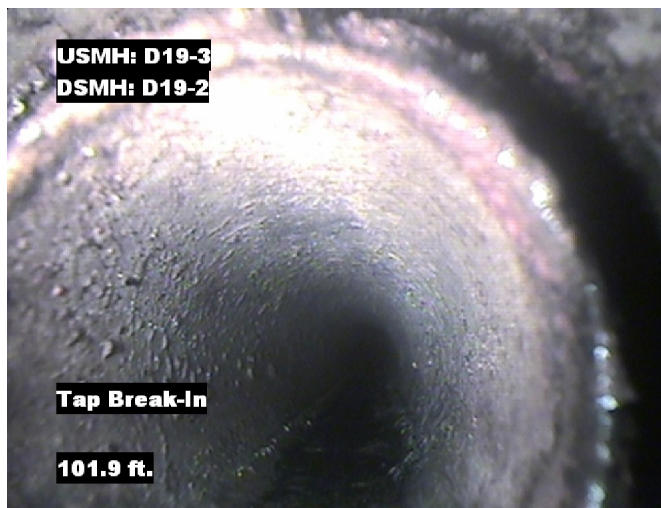
Distance: 101.9 ft. Grade: 0
Condition: Tap Break-In
Remarks: N/A

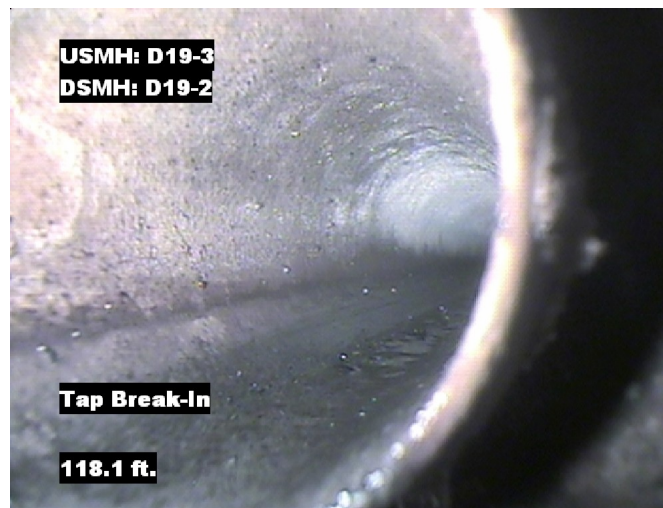
Distance: 118.1 ft. Grade: 0
Condition: Tap Break-In
Remarks: N/A

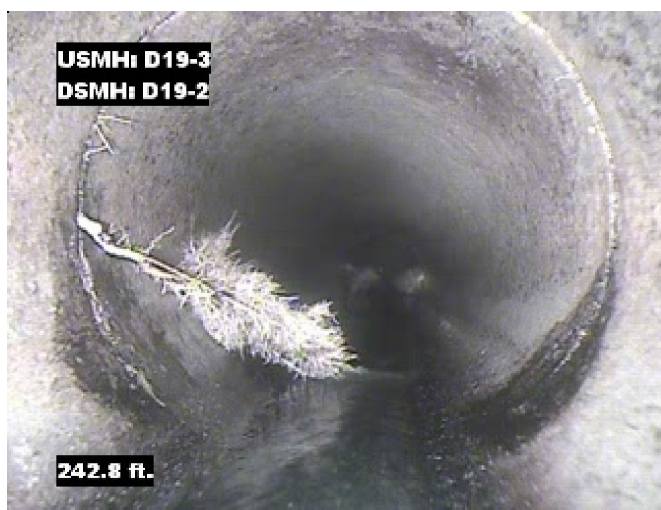
Distance: 242.8 ft. Grade: 2
Condition: Roots Tap Joint
Remarks: N/A

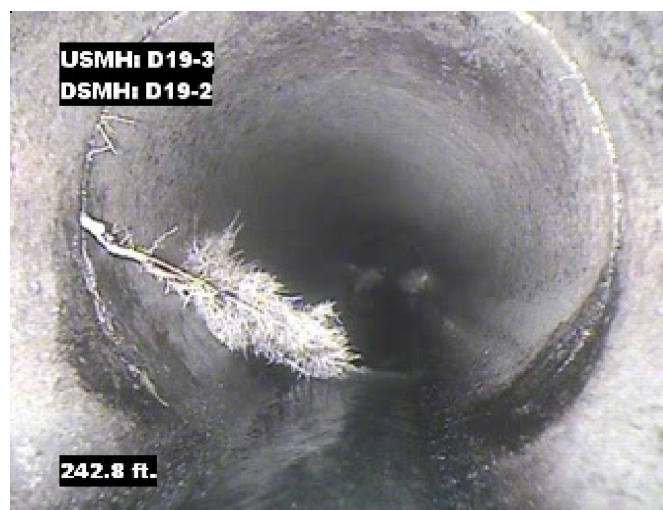
Distance: 242.8 ft. Grade: 1
Condition: Roots Fine Joint
Remarks: N/A

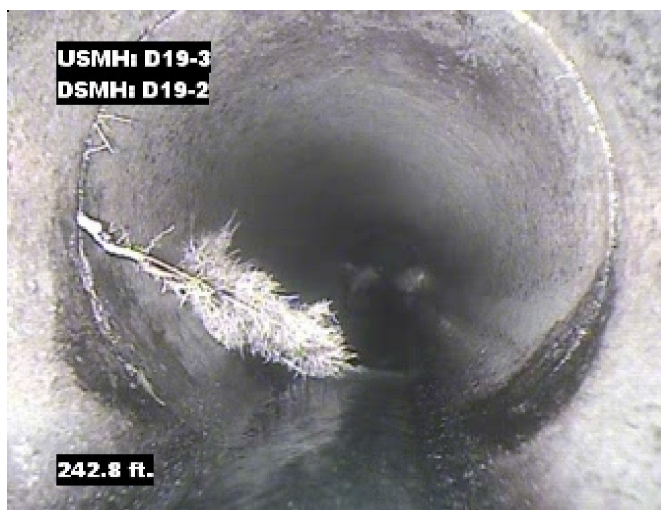
Distance: 242.8 ft. Grade: 0
Condition: Infiltration Stain
Remarks: N/A

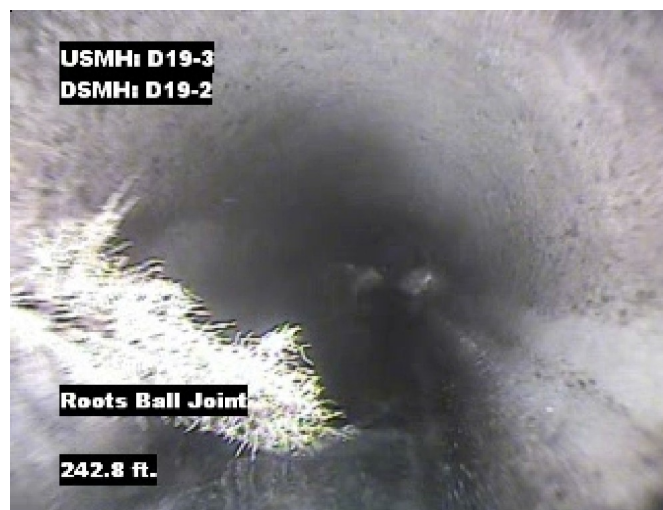
Distance: 242.9 ft. Grade: 3
Condition: Roots Tap Barrel
Remarks: N/A

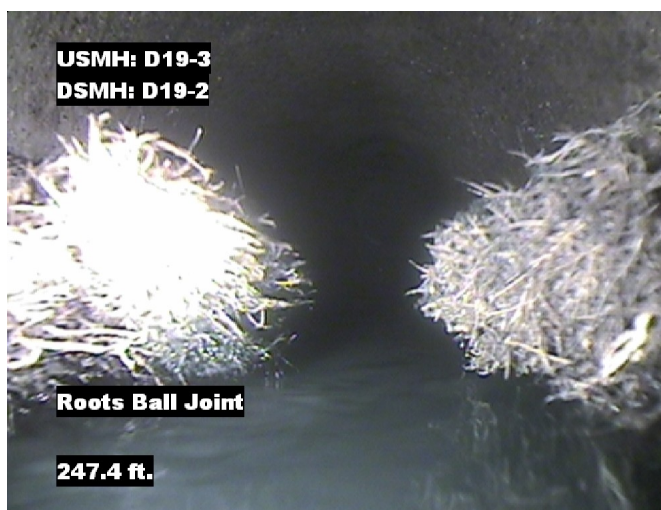
Distance: 247.4 ft. Grade: 4
Condition: Roots Ball Joint
Remarks: N/A

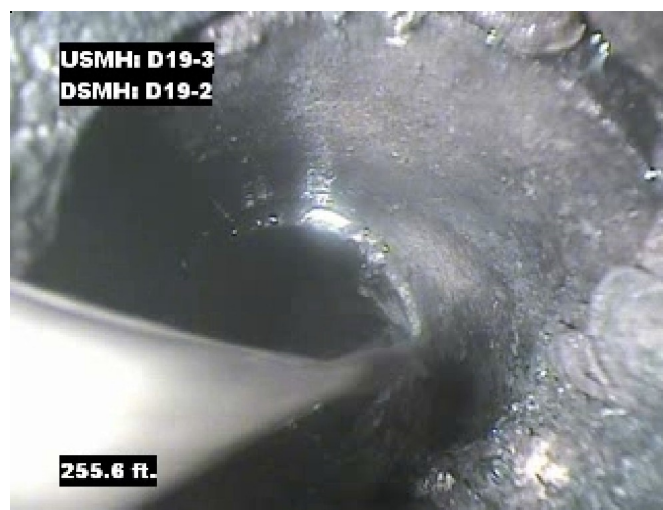
Distance: 255.5 ft. Grade: 0
Condition: Tap Factory Made
Remarks: drop line

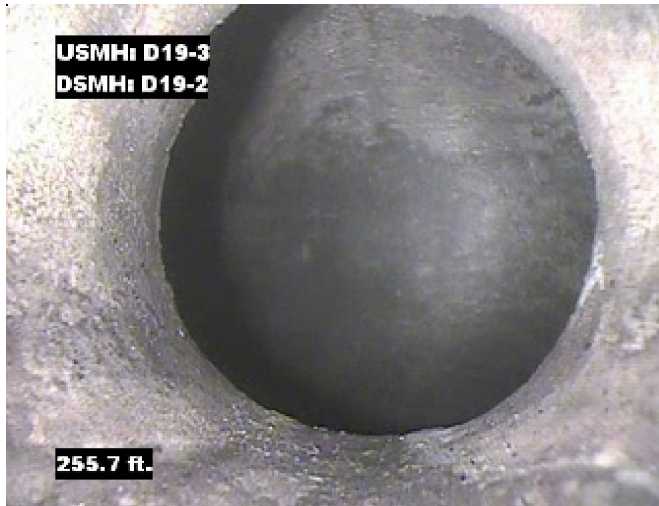
Distance: 255.7 ft. Grade: 0
Condition: Access Point Manhole
Remarks: D19-2
