Defect Listing

Pipe Segment Refere... D19-4_D19-3	City Oliver Springs	Street 716 Sycamore Ln	Material Concrete Pipe (non-...	Location C... Easement/R...	Sewer Use Sanitary
Upstream MH D19-4	Total Length 213.9	Year Laid	Shape Circular	Location Details Through Yards	
DS Manhole D19-3	Length surveyed 213.9	Year Renewed	Height 8	Width 8	Pipe Joint... 4

Image Report 4/Page

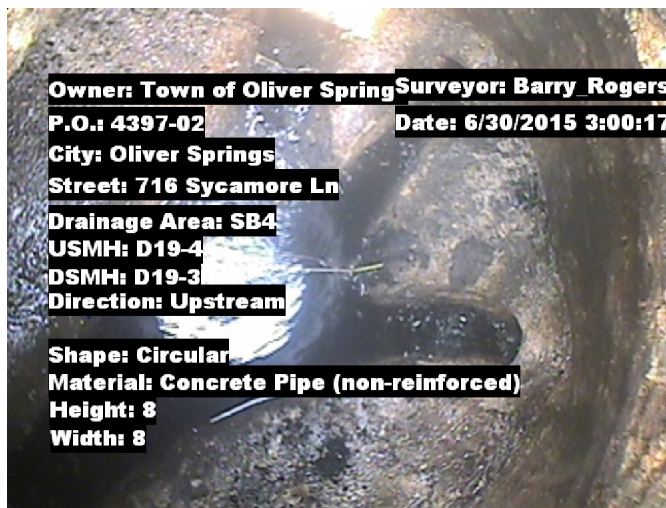
Distance: 0.0 ft. Grade: 0
Condition: Access Point Manhole
Remarks: D19-3

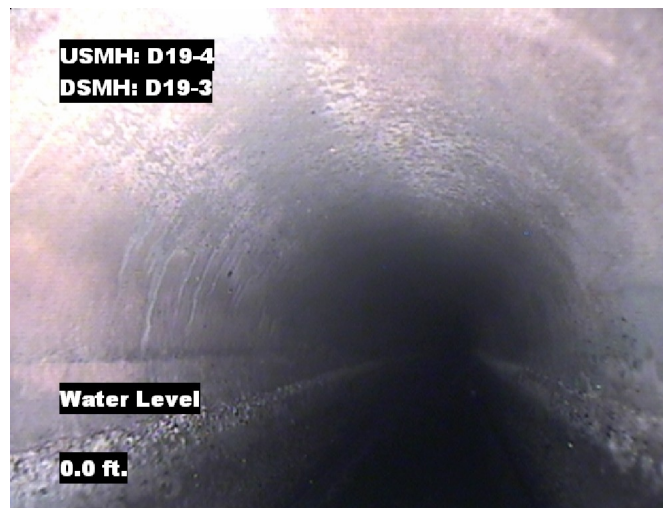
Distance: 0.0 ft. Grade: 0
Condition: Water Level
Remarks: N/A

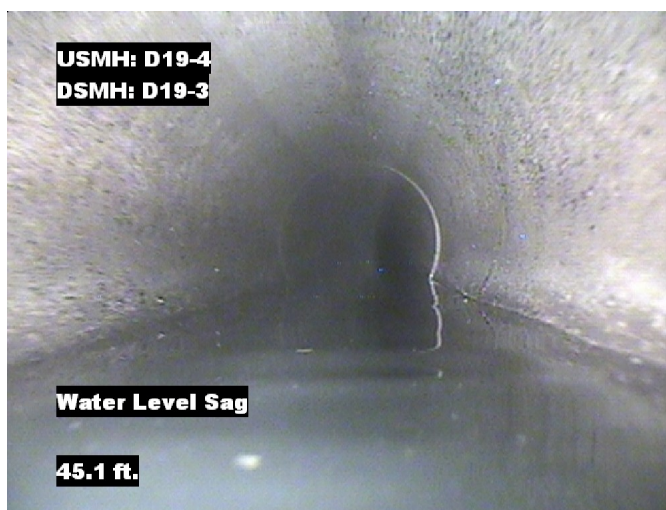
Distance: 45.1 ft. Grade: 2
Condition: Water Level Sag
Remarks: N/A

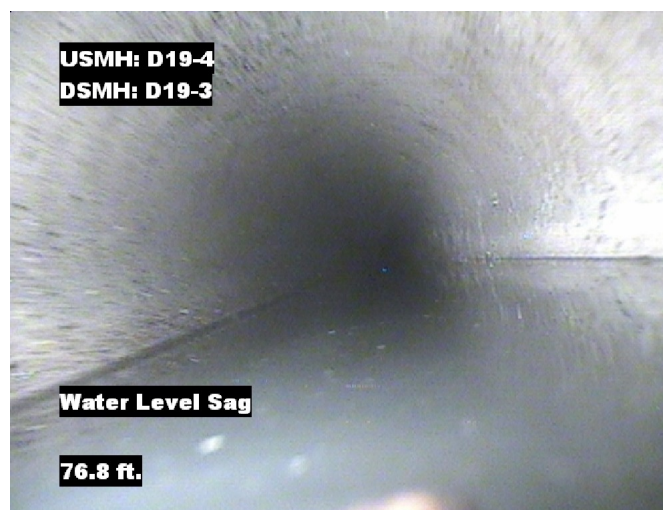
Distance: 76.8 ft. Grade: 2
Condition: Water Level Sag
Remarks: N/A

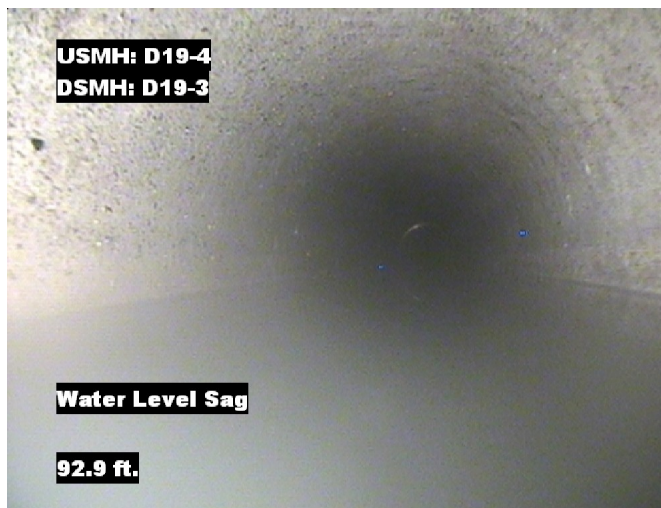
Distance: 92.9 ft. Grade: 2
Condition: Water Level Sag
Remarks: N/A

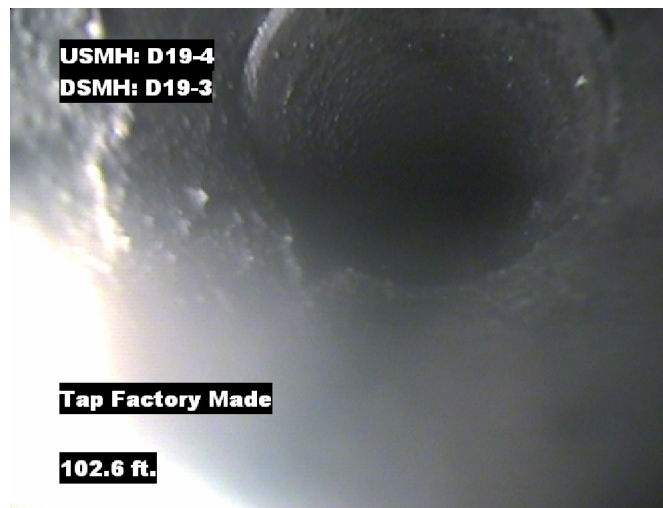
Distance: 102.6 ft. Grade: 0
Condition: Tap Factory Made
Remarks: N/A

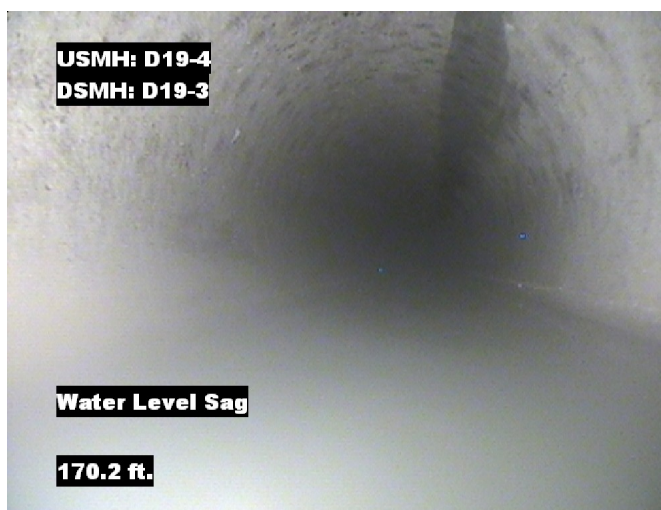
Distance: 170.2 ft. Grade: 2
Condition: Water Level Sag
Remarks: N/A

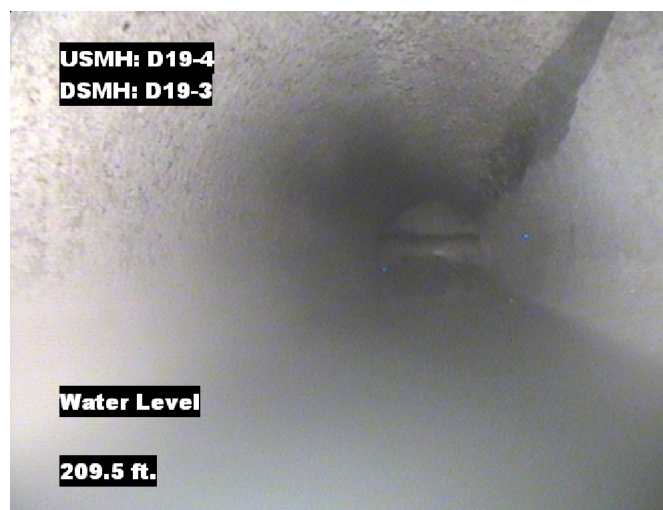
Distance: 209.5 ft. Grade: 0
Condition: Water Level
Remarks: N/A

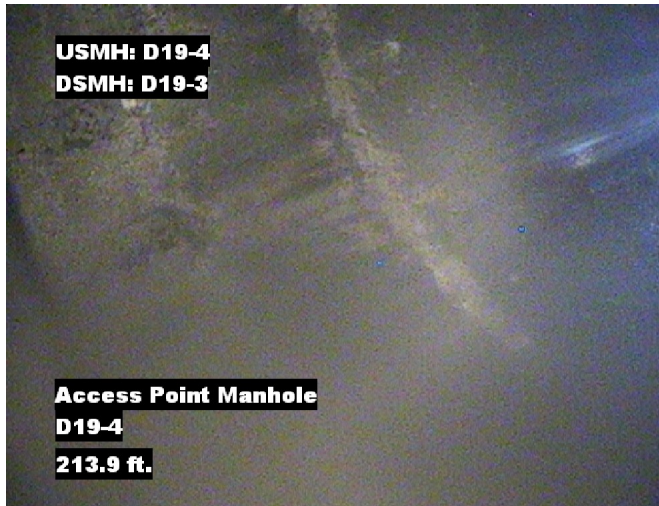
Distance: 213.9 ft. Grade: 0
Condition: Access Point Manhole
Remarks: D19-4
