## Defect Listing

Pipe Segment Refere... <b>D19-5_D19-4</b>	City <b>Oliver Springs</b>	Street <b>Sleepy Hollow</b>	Material <b>Concrete Pipe (non-...</b>	Location C... <b>Easement/R...</b>	Sewer Use <b>Sanitary</b>
Upstream MH <b>D19-5</b>	Total Length <b>273.5</b>	Year Laid	Shape <b>Circular</b>	Location Details	
DS Manhole <b>D19-4</b>	Length surveyed <b>273.5</b>	Year Renewed	Height <b>8</b>	Width <b>8</b>	Pipe Joint... <b>4</b>

SPR <b>N/A</b>	MPR <b>12</b>	PO Number <b>4397-03</b>	Customer <b>GRW</b>
SPRI <b>N/A</b>	MPRI <b>2.4</b>	Work Order <b>4397-02</b>	Purpose <b>Pre-Rehabilitation Survey</b>
QSR <b>N/A</b>	QMR <b>4124</b>		
OPR <b>12</b>	Surveyed By <b>Barry Rogers</b>	Direction <b>Downstream</b>	Date <b>20150630</b>
OPRI <b>2.4</b>	Certificate Number <b>U-1012-16405</b>	Pre-Cleaning <b>Jetting</b>	Time <b>14:01</b>
	Date Cleaned <b>20150630</b>	End Time <b>14:14</b>	Weather <b>Heavy Rain</b>
			Media label
			Additional Info

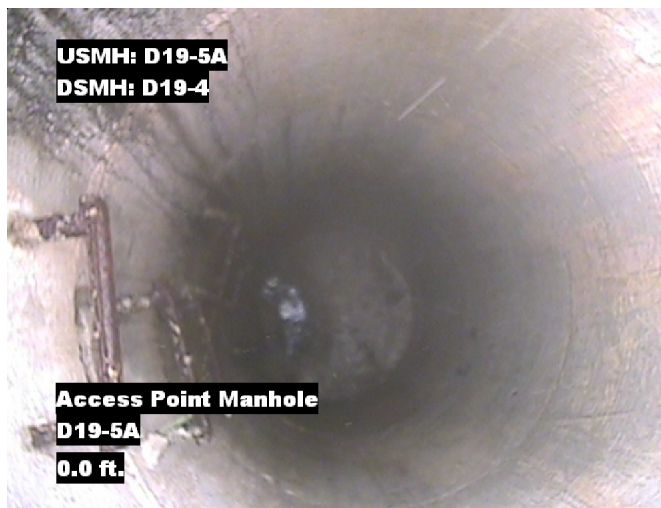
Distance: 0.0 ft. Grade: 0  
Condition: Access Point Manhole  
Remarks: D19-5A

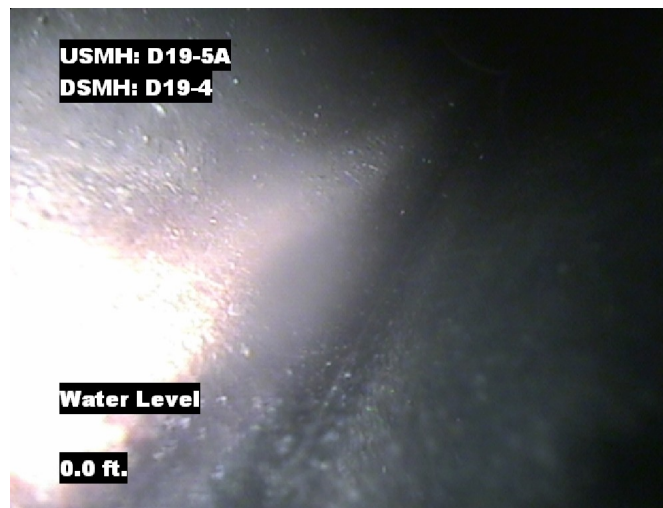
Distance: 0.0 ft. Grade: 0  
Condition: Water Level  
Remarks: N/A

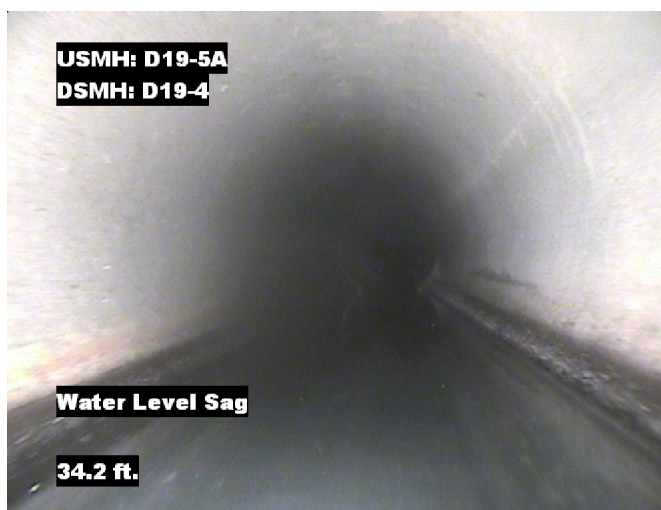
Distance: 34.2 ft. Grade: 2  
Condition: Water Level Sag  
Remarks: N/A

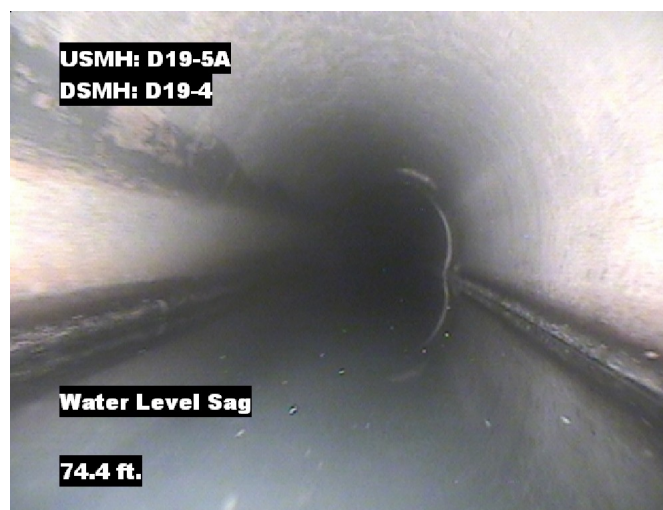
Distance: 74.2 ft. Grade: 2  
Condition: Water Level Sag  
Remarks: N/A

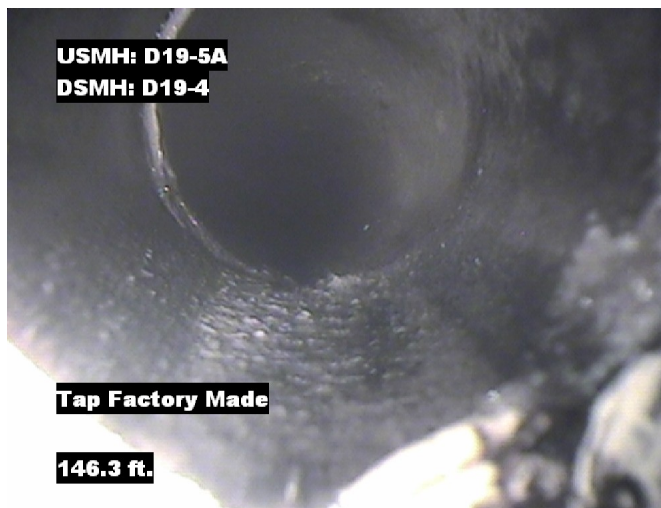
Distance: 146.3 ft. Grade: 0  
Condition: Tap Factory Made  
Remarks: N/A

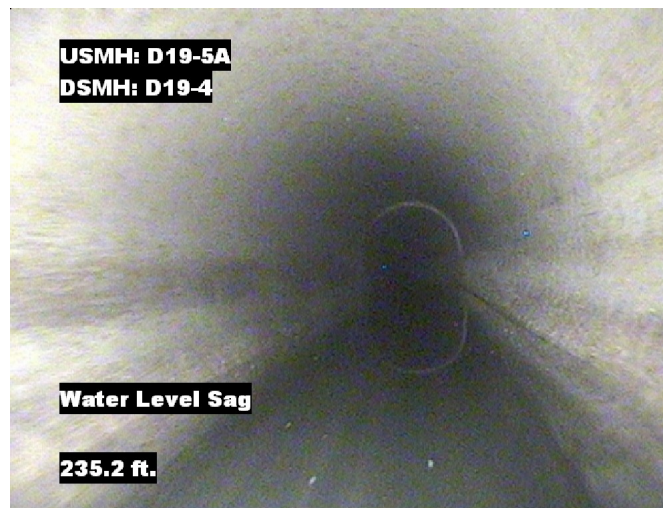
Distance: 235.2 ft. Grade: 2  
Condition: Water Level Sag  
Remarks: N/A

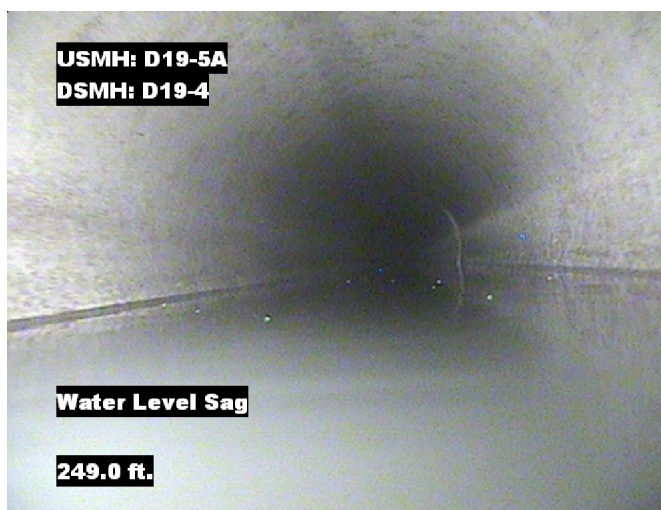
Distance: 249.0 ft. Grade: 2  
Condition: Water Level Sag  
Remarks: N/A

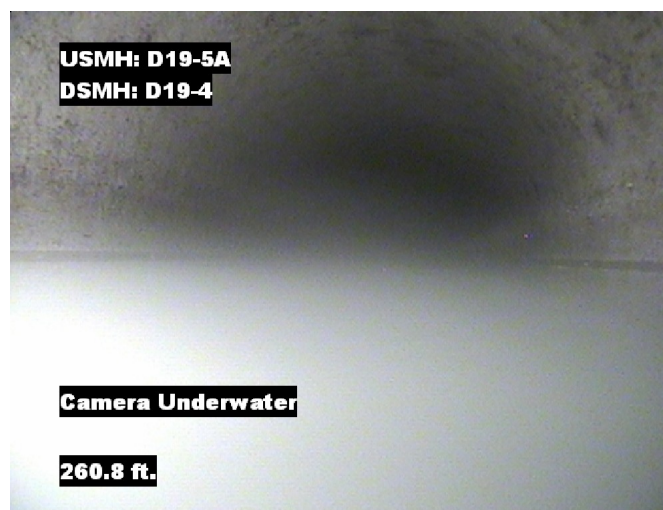
Distance: 260.8 ft. Grade: 4  
Condition: Camera Underwater  
Remarks: N/A

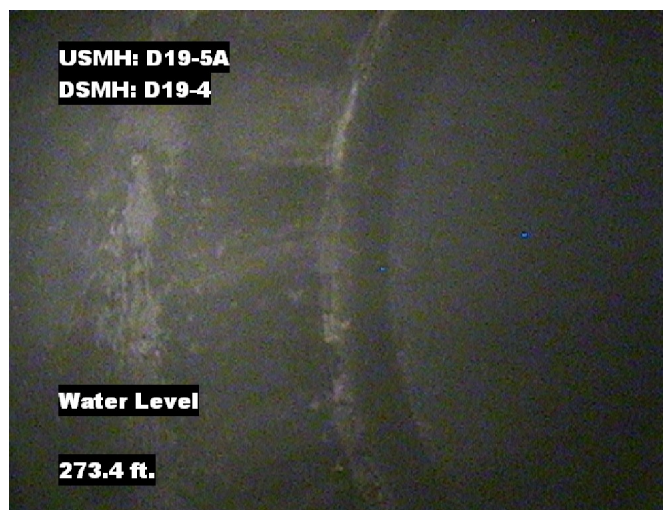
Distance: 273.4 ft. Grade: 0  
Condition: Water Level  
Remarks: N/A

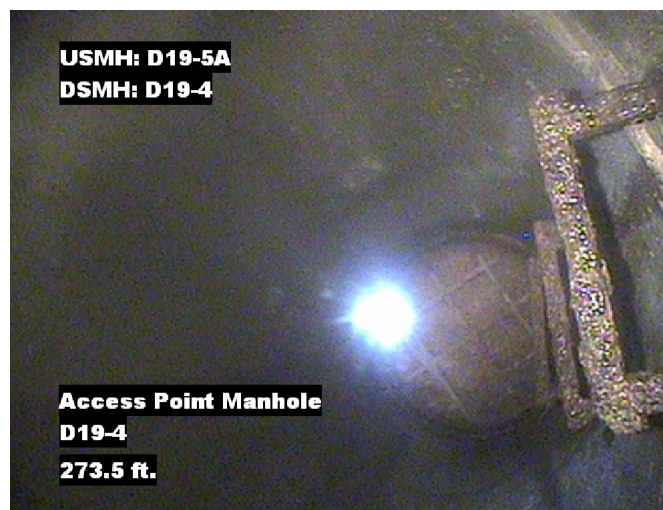
Distance: 273.5 ft. Grade: 0  
Condition: Access Point Manhole  
Remarks: D19-4
