Defect Listing

Pipe Segment Refere		City		Street	Mat	Material		Sewer Use	
D19-6_D19-5		Oliver Springs		Sleepy Hollow	Concrete F	Concrete Pipe (non		Sanitary	
Upstream MH		Total I	Length	Year Laid	Sha	ape	Location	n Details	
D1	D19-6		5.3		Circ	ular			
DS Ma	DS Manhole		surveyed	Year Renewed	Height	Width	Pipe Joint		
D1	D19-5		5.3		8	8	4		
SPR	N/A	MPR	15	PO Number		Pre-F			
0001	-	MADDI		4397-03					
SPRI	N/A	MPRI	2.1	Work Order					
QSR	N/A	QMR	3126	4397-02				urvey	
OF	PR	Surveyed By		Direction	Date		Media label		
1	5	Barry_Rogers		Downstream	2015	20150630			
OF	PRI	Certificate Number		Pre-Cleaning	Tir	Time			
2.1		U-1012-16405		Jetting	10:16		Damp		
	Date Cleaned					End Time		Additional Info	
	20150630					10:27

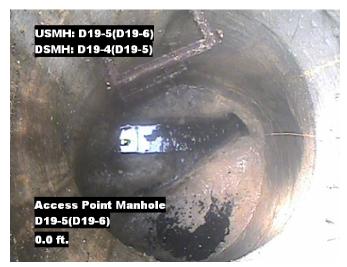
Distance: 0.0 ft. Grade: 0

Condition: Access Point Manhole

Remarks: D19-5(D19-6)

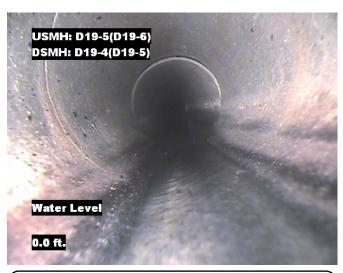
Distance: 0.0 ft. Grade: 0

Condition: Water Level

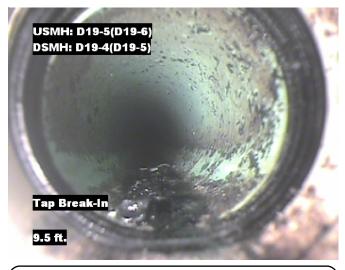
Distance: 9.5 ft. Grade: 0

Condition: Tap Break-In

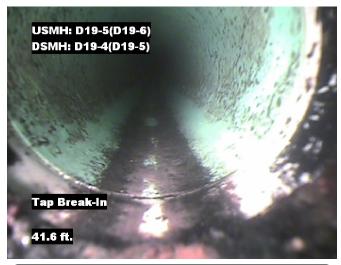
Distance: 41.6 ft. Grade: 0

Condition: Tap Break-In

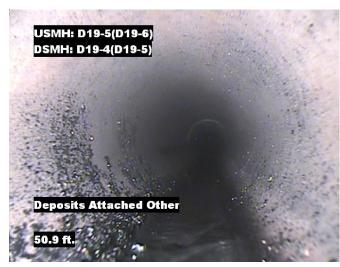
Distance: 50.9 ft. Grade: 3

Condition: Deposits Attached Other

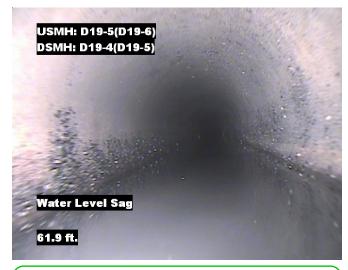
Distance: 61.9 ft. Grade: 2

Condition: Water Level Sag

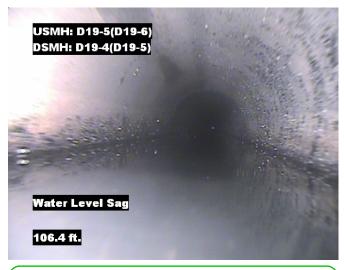
Distance: 106.2 ft. Grade: 2

Condition: Water Level Sag

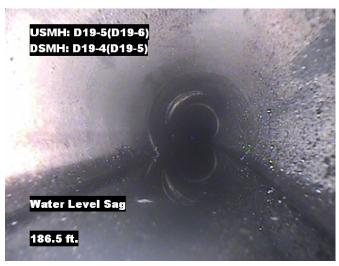
Distance: 186.5 ft. Grade: 2

Condition: Water Level Sag

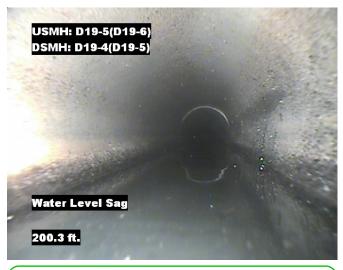
Distance: 200.3 ft. Grade: 2

Condition: Water Level Sag

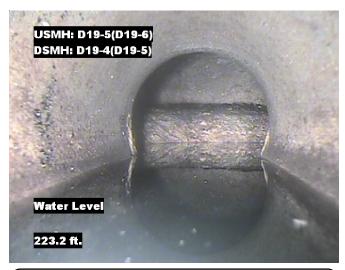
Distance: 223,2 ft. Grade: 0

Condition: Water Level

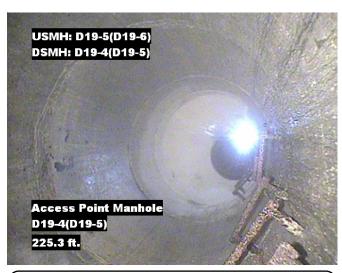
Distance: 225.3 ft. Grade:

Condition: Access Point Manhole

Remarks: D19-4(D19-5)
