Defect Listing

Pipe Segment Refere... D19-7_D19-6	City Oliver Springs	Street Sleepy Hollow	Material Concrete Pipe (non-...	Location C... Yard	Sewer Use Sanitary
Upstream MH D19-7	Total Length 182.4	Year Laid	Shape Circular	Location Details	
DS Manhole D19-6	Length surveyed 182.4	Year Renewed	Height 8	Width 8	Pipe Joint... 4

SPR N/A	MPR 8	PO Number 4397-03	Customer GRW
SPRI N/A	MPRI 2	Work Order 4397-02	Purpose Pre-Rehabilitation Survey
QSR N/A	QMR 2400		
OPR 8	Surveyed By Barry Rogers	Direction Downstream	Date 20150630
OPRI 2	Certificate Number U-1012-16405	Pre-Cleaning Jetting	Time 09:17
	Date Cleaned 20150630	End Time 09:40	Weather Damp
			Media label
			Additional Info

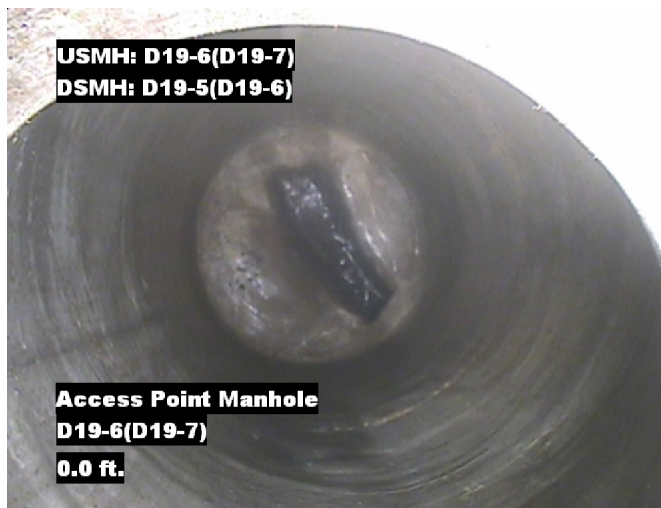
Distance: 0.0 ft. Grade: 0
Condition: Access Point Manhole
Remarks: D19-6(D19-7)

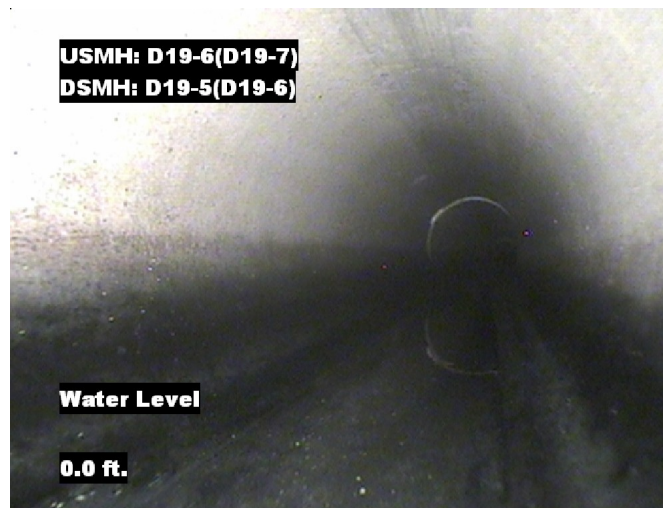
Distance: 0.0 ft. Grade: 0
Condition: Water Level
Remarks: N/A

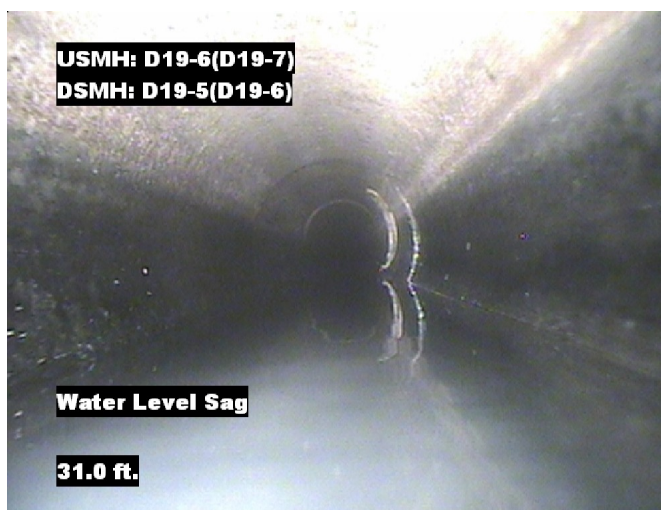
Distance: 30.9 ft. Grade: 2
Condition: Water Level Sag
Remarks: N/A

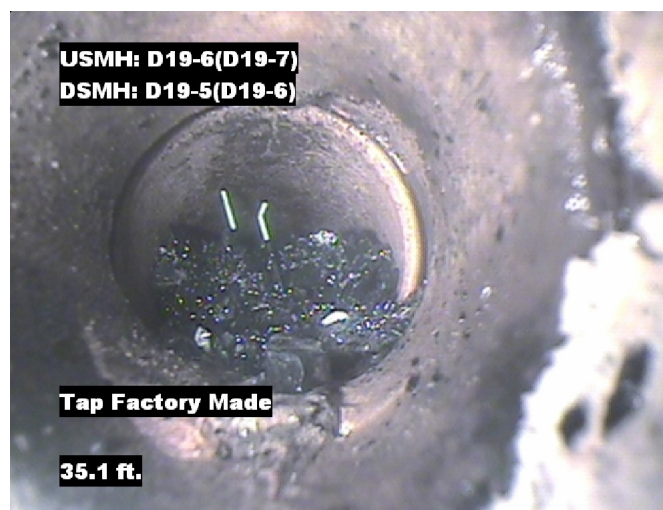
Distance: 35.1 ft. Grade: 0
Condition: Tap Factory Made
Remarks: N/A

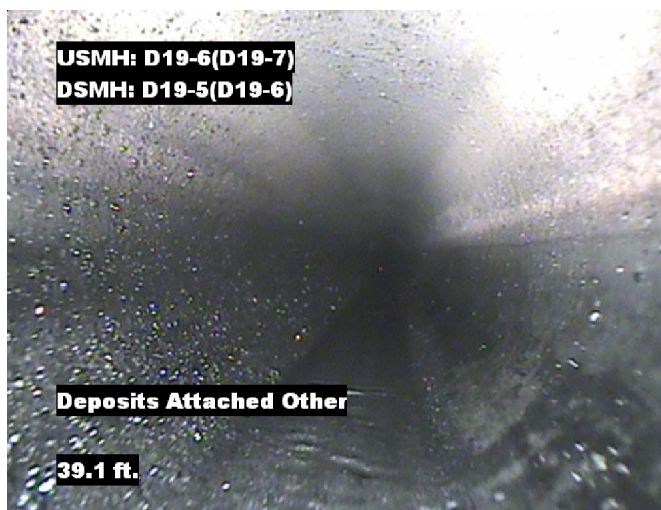
Distance: 39.1 ft. Grade: 2
Condition: Deposits Attached Other
Remarks: N/A

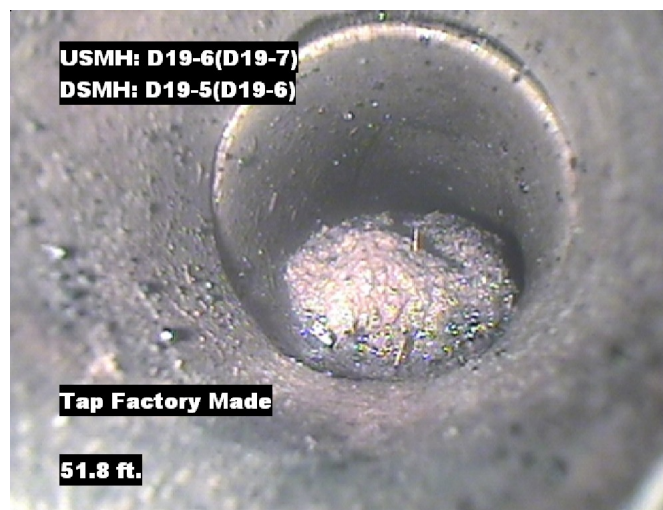
Distance: 51.8 ft. Grade: 0
Condition: Tap Factory Made
Remarks: N/A

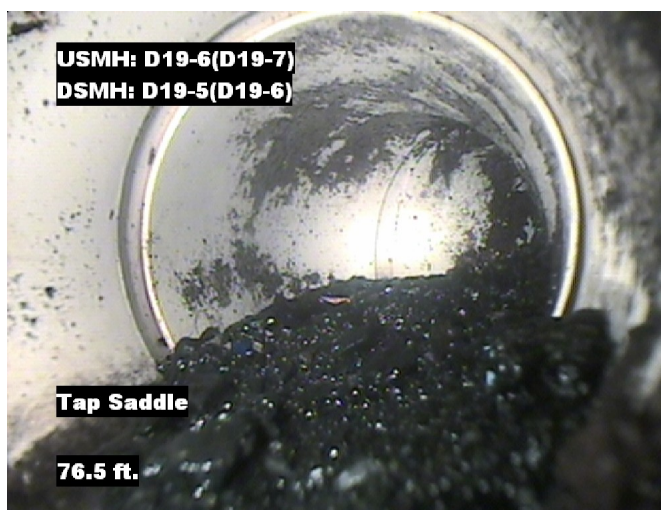
Distance: 76.5 ft. Grade: 0
Condition: Tap Saddle
Remarks: N/A

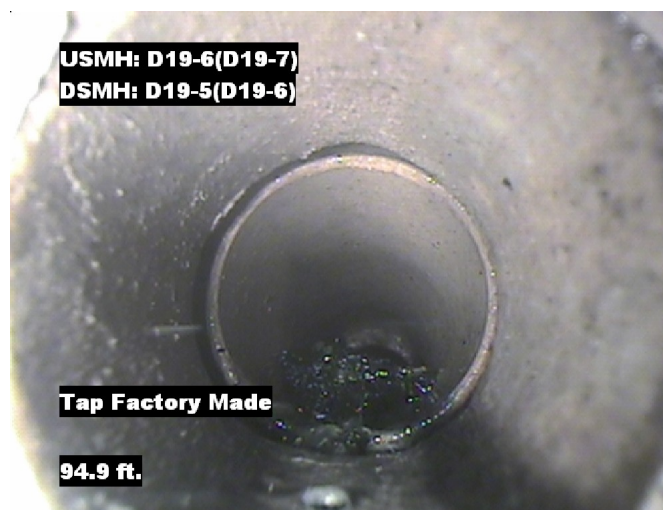
Distance: 94.9 ft. Grade: 0
Condition: Tap Factory Made
Remarks: N/A

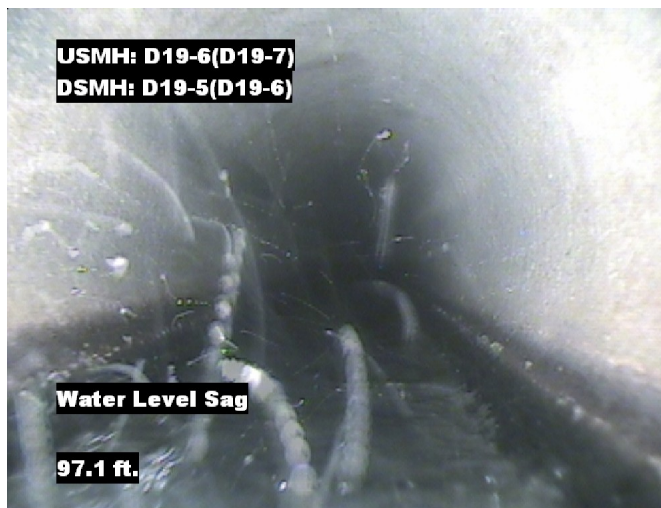
Distance: 97.1 ft. Grade: 2
Condition: Water Level Sag
Remarks: N/A

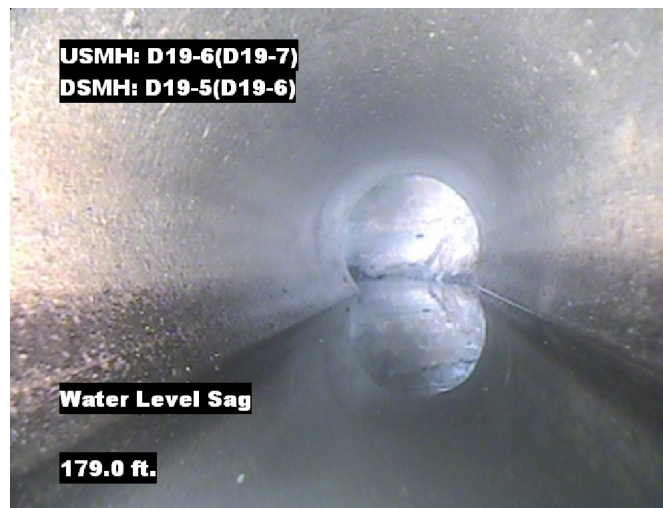
Distance: 179.0 ft. Grade: 2
Condition: Water Level Sag
Remarks: N/A

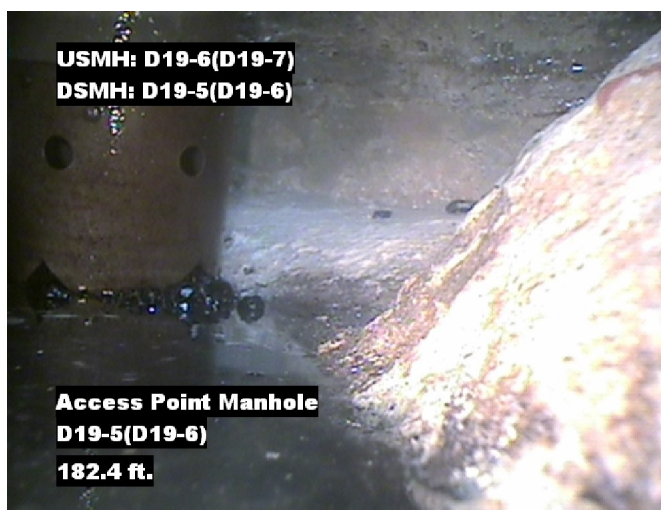
Distance: 182.4 ft. Grade: 0
Condition: Access Point Manhole
Remarks: D19-5(D19-6)
