Defect Listing

Pipe Segment Refere		City		Street	Material		Location C	Sewer Use
D19-8_D19-7		Oliver Springs		Sleepy Hollow	Concrete F	Pipe (non	Yard	Sanitary
Upstream MH		Total Length		Year Laid	Shape		Location Details	
D19-8		26	2.2		Circ	cular		
DS Manhole		Length surveyed		Year Renewed	Height	Width	Pipe Joint	
D19-7		262.2			8	8	4	
SPR	3	MPR	4	PO Number		Customer		
2001				4397-03		GRW		
SPRI	3	MPRI	4	Work Order			Purpose	
QSR	3100	QMR	4100	4397-02		Pre-Rehabilitation Surv		Survey
Ol	PR	Surve	/ed By	Direction	Date		Media label	
-	7	Barry_Rogers		Downstream	20150630			
OF	PRI	Certificate Number		Pre-Cleaning	Time		Weather	
3.5		U-1012-16405		Jetting	08:13		Damp	
		Date C	leaned	End Time		Additional Info		
		2015	0630		08:43

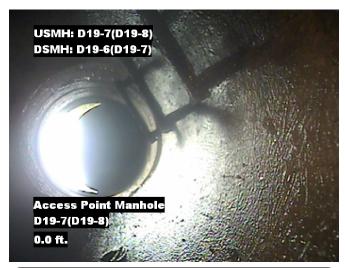
Distance: 0.0 ft. Grade: 0

Condition: Access Point Manhole

Remarks: D19-7(D19-8)

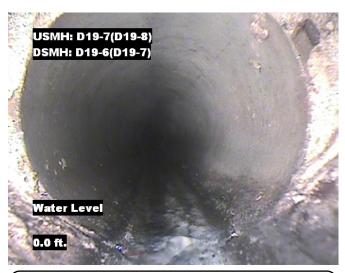
Distance: 0.0 ft. Grade: 0

Condition: Water Level

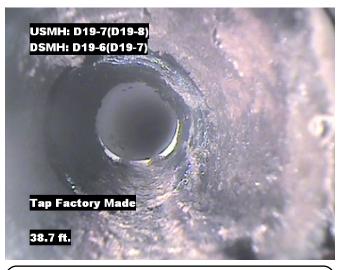
Distance: 38.7 ft. Grade: 0

Condition: Tap Factory Made

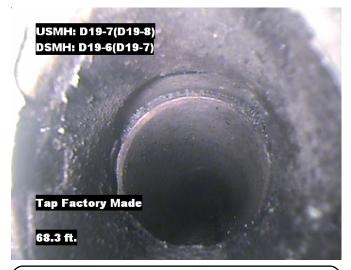
Distance: 68.3 ft. Grade: 0

Condition: Tap Factory Made

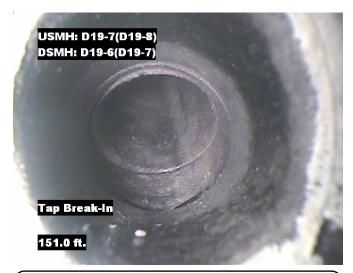
Distance: 151.0 ft. Grade:

Condition: Tap Break-In

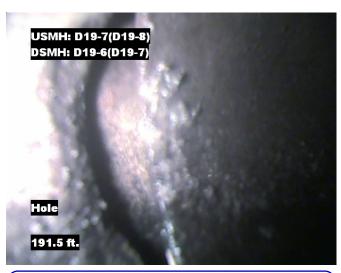
Distance: 191.5 ft. Grade: 3

Condition: Hole Remarks: N/A

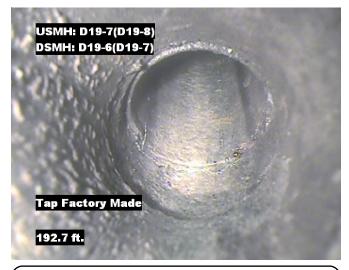
Distance: 192.7 ft. Grade: 0

Condition: Tap Factory Made

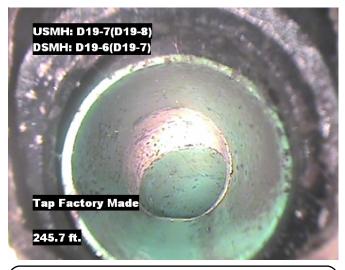
Distance: 245.7 ft. Grade: 0

Condition: Tap Factory Made

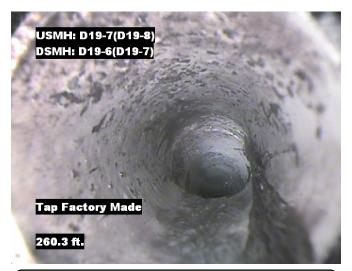
Distance: 260.3 ft. Grade: 0

Condition: Tap Factory Made

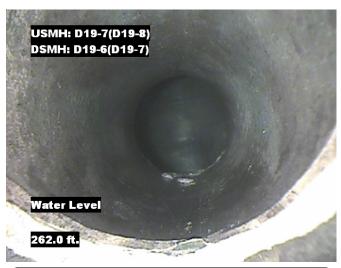
Distance: 262.0 ft. Grade: 0

Condition: Water Level

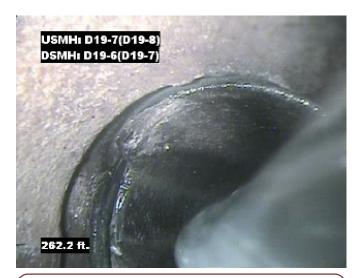
Distance: 262.2 ft. Grade: 4

Condition: Infiltration Runner

Remarks: drop line

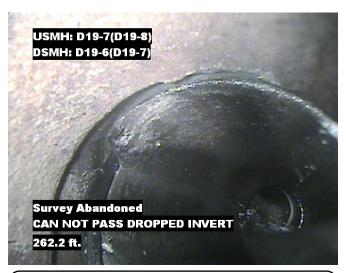
Distance: 262.3 ft. Grade: 0

Condition: Survey Abandoned

Remarks: CAN NOT PASS DROPPED INVERT
