Defect Listing

Pipe Segment Refere... D19-9_D19-8	City Oliver Springs	Street Sleepy Hollow	Material Other	Location C... Yard	Sewer Use Sanitary
Upstream MH D19-9	Total Length 174.7	Year Laid	Shape Circular	Location Details	
DS Manhole D19-8	Length surveyed 174.7	Year Renewed	Height 8	Width 8	Pipe Joint... N/A

SPR N/A	MPR 2	PO Number 4397-03	Customer GRW
SPRI N/A	MPRI 2	Work Order 4397-02	Purpose Pre-Rehabilitation Survey
QSR N/A	QMR 2100		
OPR 2	Surveyed By Barry Rogers	Direction Downstream	Date 20150630
OPRI 2	Certificate Number U-1012-16405	Pre-Cleaning Jetting	Time 07:46
	Date Cleaned 20150630	End Time 08:01	Weather Damp
			Media label
			Additional Info

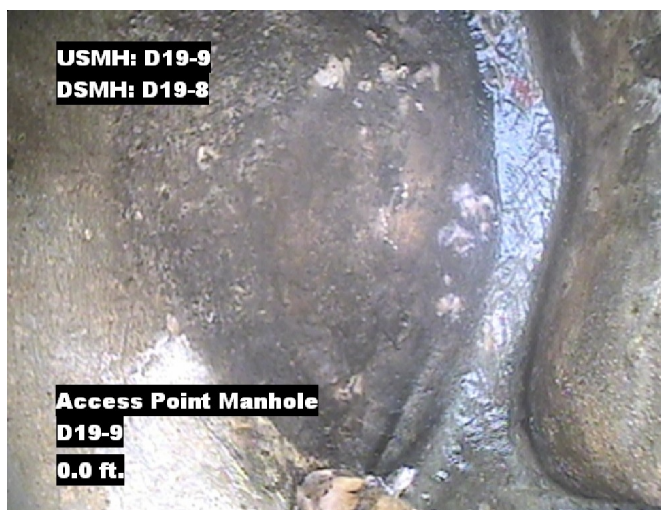
Distance: 0.0 ft. Grade: 0
Condition: Access Point Manhole
Remarks: D19-9

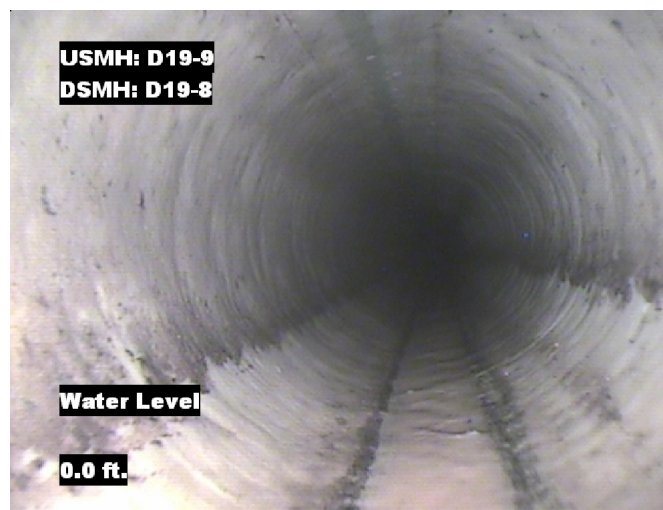
Distance: 0.0 ft. Grade: 0
Condition: Water Level
Remarks: N/A

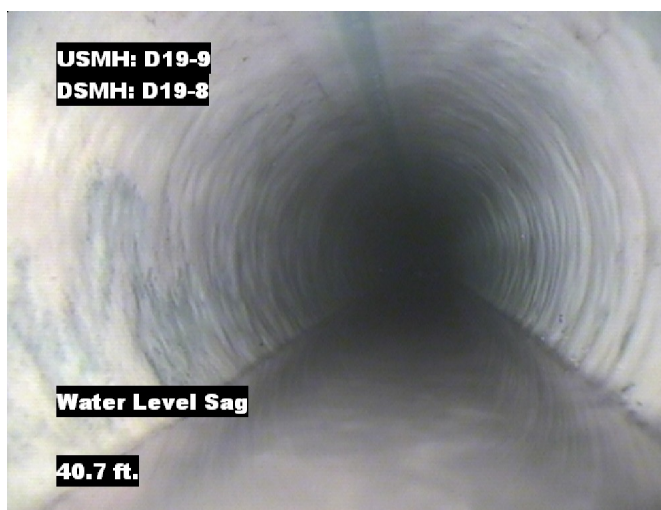
Distance: 40.7 ft. Grade: 2
Condition: Water Level Sag
Remarks: N/A

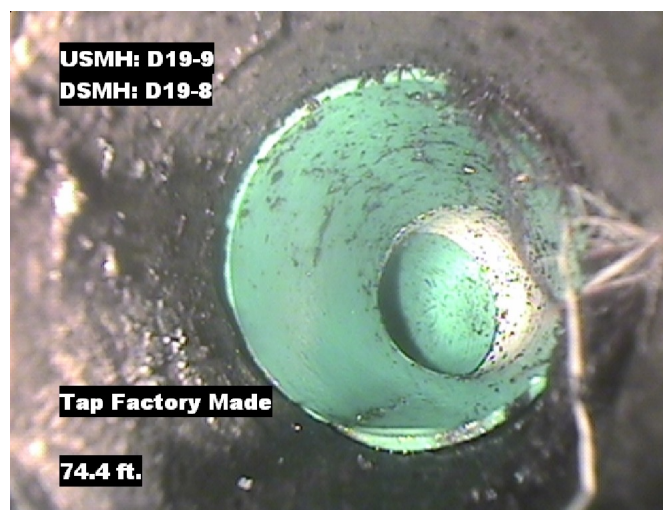
Distance: 74.4 ft. Grade: 0
Condition: Tap Factory Made
Remarks: N/A

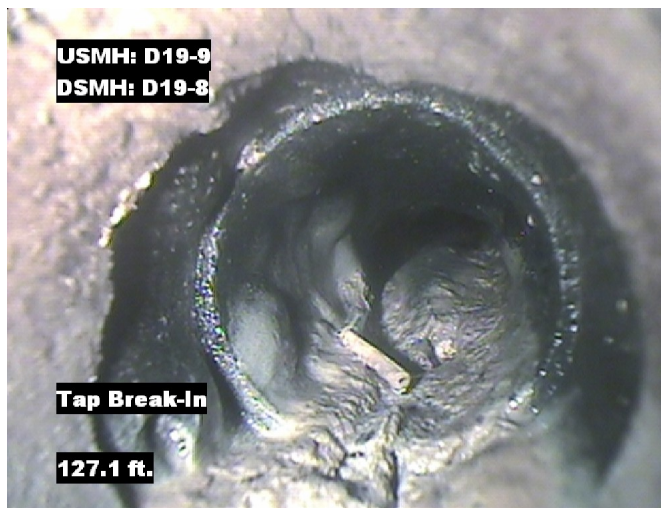
Distance: 127.1 ft. Grade: 0
Condition: Tap Break-In
Remarks: N/A

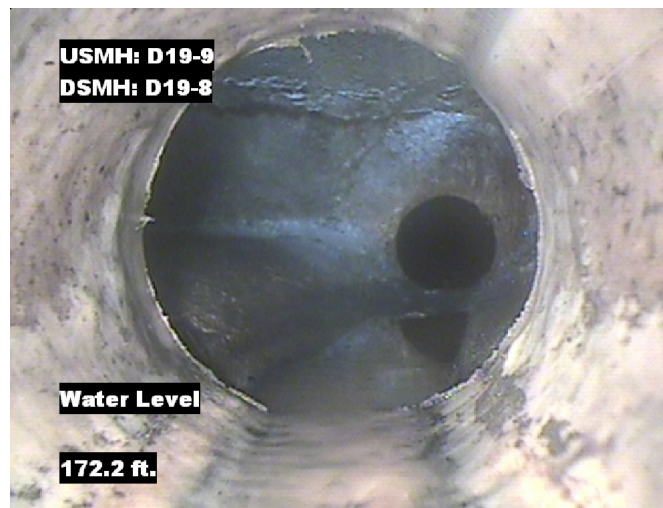
Distance: 172.2 ft. Grade: 0
Condition: Water Level
Remarks: N/A

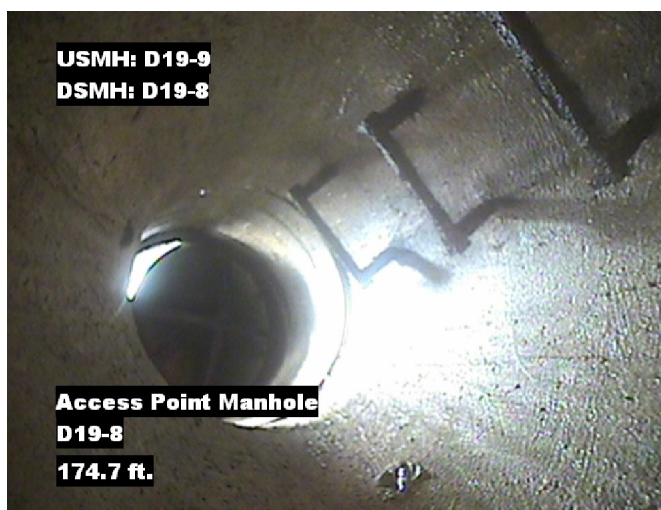
Distance: 174.7 ft. Grade: 0
Condition: Access Point Manhole
Remarks: D19-8
