Defect Listing

Pipe Segment Refere...	City	Street	Material	Location C...	Sewer Use
D2-1_D1-6	Oliver Springs	Henley Cir	Concrete Pipe (non-...	Light High...	Sanitary
Upstream MH	Total Length	Year Laid	Shape	Location Details	
D2-1	266.5		Circular		
DS Manhole	Length surveyed	Year Renewed	Height	Width	Pipe Joint...
D1-6	266.5		8	8	4

SPR	N/A	MPR	5	PO Number	Customer
SPRI	N/A	MPRI	2.5	4397-03	GRW
QSR	N/A	QMR	3121	Work Order	Purpose
				4397-02	Pre-Rehabilitation Survey
OPR	Surveyed By	Direction	Date	Media label	
5	Barry Rogers	Downstream	20150707		
OPRI	Certificate Number	Pre-Cleaning	Time	Weather	
2.5	U-1012-16405	Jetting	15:02	Dry	
Date Cleaned			End Time	Additional Info	
20150707			15:30

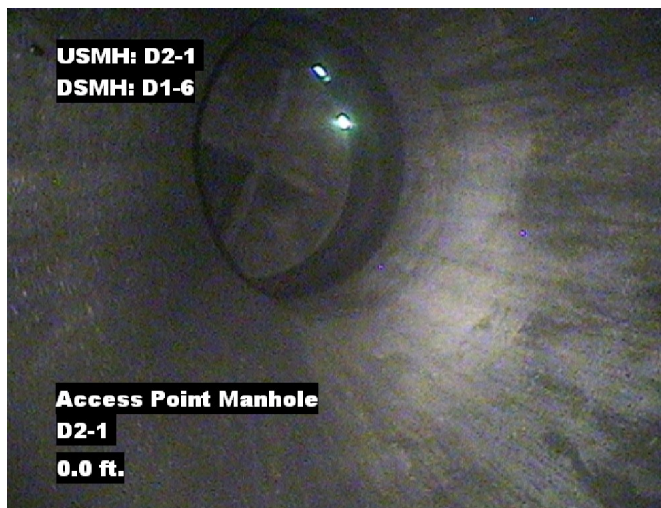
Distance: 0.0 ft. Grade: 0
Condition: Access Point Manhole
Remarks: D2-1

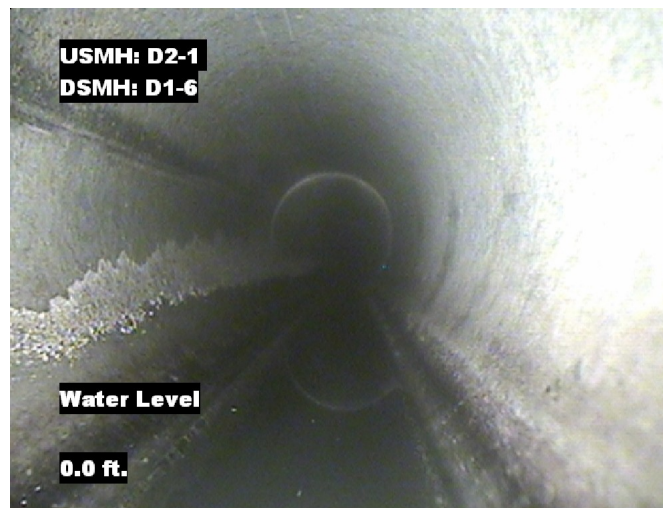
Distance: 0.0 ft. Grade: 0
Condition: Water Level
Remarks: N/A

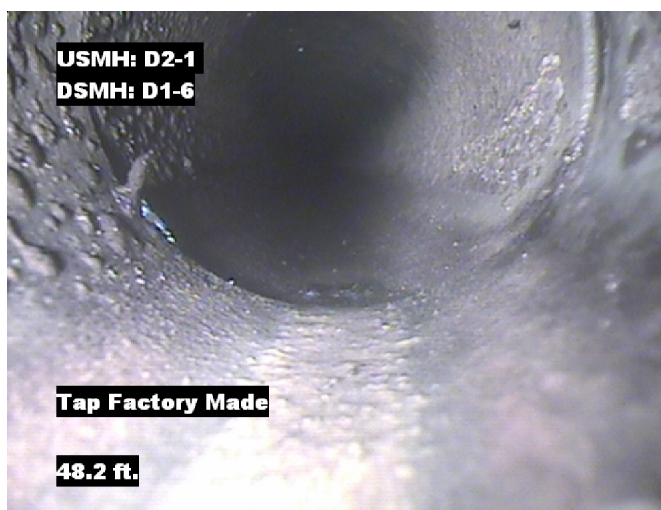
Distance: 48.2 ft. Grade: 0
Condition: Tap Factory Made
Remarks: N/A

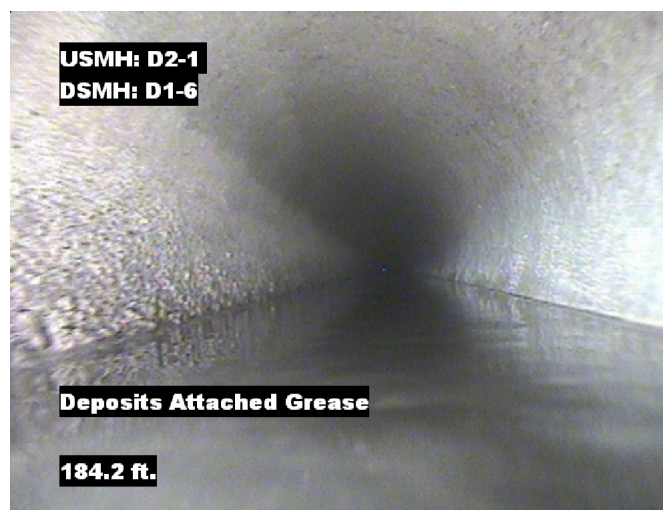
Distance: 184.1 ft. Grade: 3
Condition: Deposits Attached Grease
Remarks: N/A

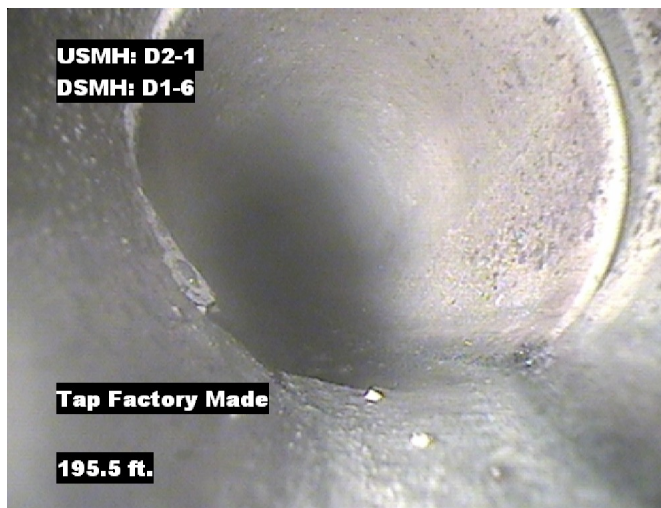
Distance: 195.5 ft. Grade: 0
Condition: Tap Factory Made
Remarks: N/A

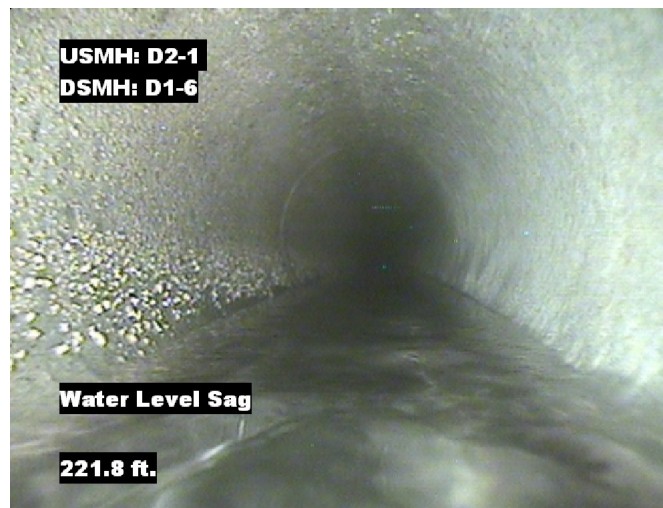
Distance: 221.8 ft. Grade: 2
Condition: Water Level Sag
Remarks: N/A

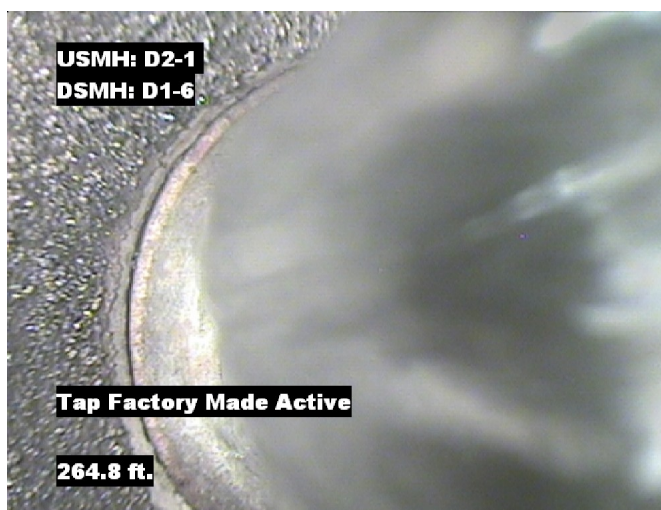
Distance: 264.8 ft. Grade: 0
Condition: Tap Factory Made Active
Remarks: N/A

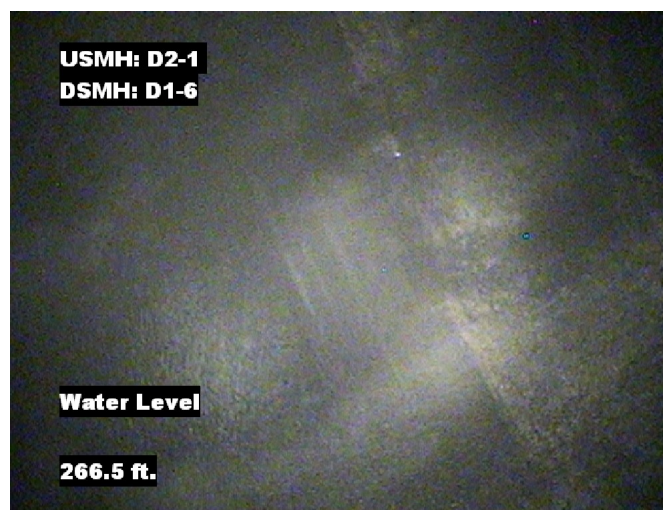
Distance: 266.5 ft. Grade: 0
Condition: Water Level
Remarks: N/A

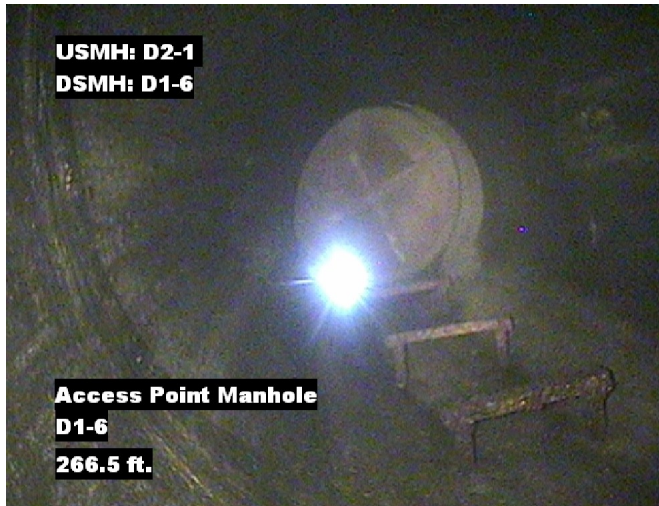
Distance: 266.5 ft. Grade: 0
Condition: Access Point Manhole
Remarks: D1-6
