Defect Listing

Pipe Segment Refere... D2-2_D2-1	City Oliver Springs	Street Henley Cir	Material Concrete Pipe (non-...	Location C... Light High...	Sewer Use Sanitary
Upstream MH D2-2	Total Length 258.1	Year Laid	Shape Circular	Location Details	
DS Manhole D2-1	Length surveyed 258.1	Year Renewed	Height 8	Width 8	Pipe Joint... 4

SPR N/A	MPR 2	PO Number 4397-03	Customer GRW
SPRI N/A	MPRI 2	Work Order 4397-02	Purpose Pre-Rehabilitation Survey
QSR N/A	QMR 2100		
OPR 2	Surveyed By Barry Rogers	Direction Downstream	Date 20150707
OPRI 2	Certificate Number U-1012-16405	Pre-Cleaning Jetting	Time 14:33
	Date Cleaned 20150707	End Time 14:57	Weather Dry
			Additional Info

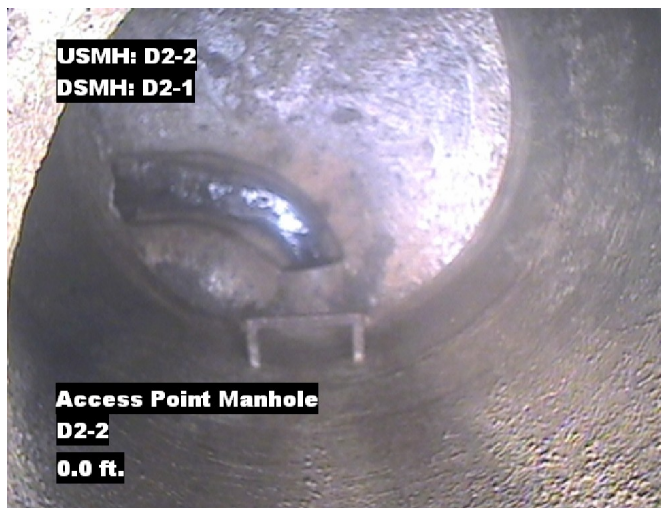
Distance: 0.0 ft. Grade: 0
Condition: Access Point Manhole
Remarks: D2-2

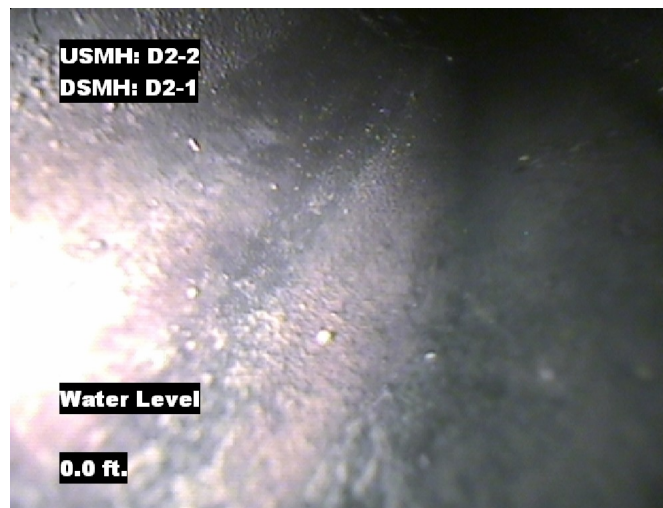
Distance: 0.0 ft. Grade: 0
Condition: Water Level
Remarks: N/A

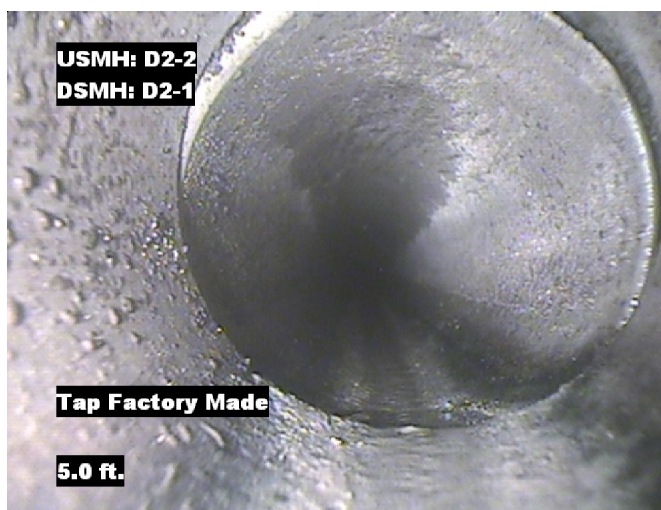
Distance: 5.0 ft. Grade: 0
Condition: Tap Factory Made
Remarks: N/A

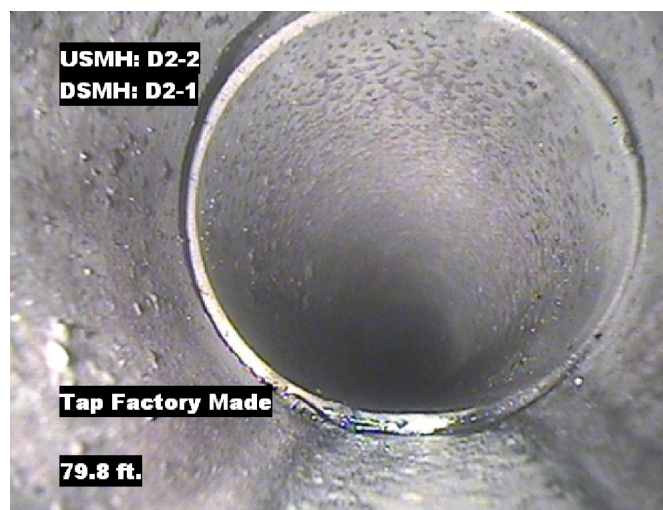
Distance: 79.8 ft. Grade: 0
Condition: Tap Factory Made
Remarks: N/A

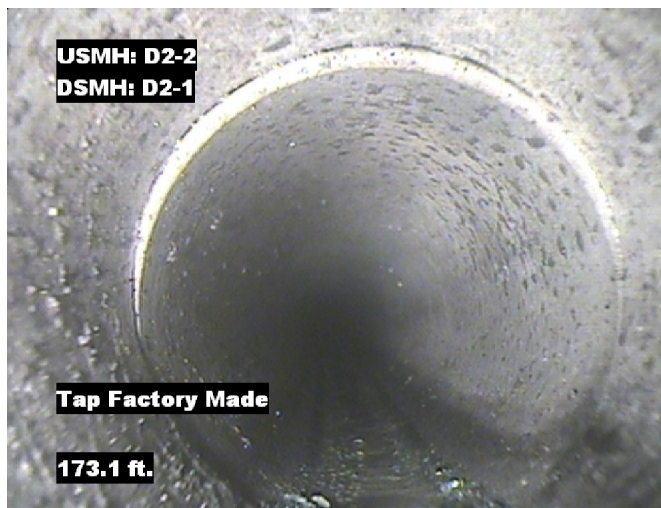
Distance: 173.1 ft. Grade: 0
Condition: Tap Factory Made
Remarks: N/A

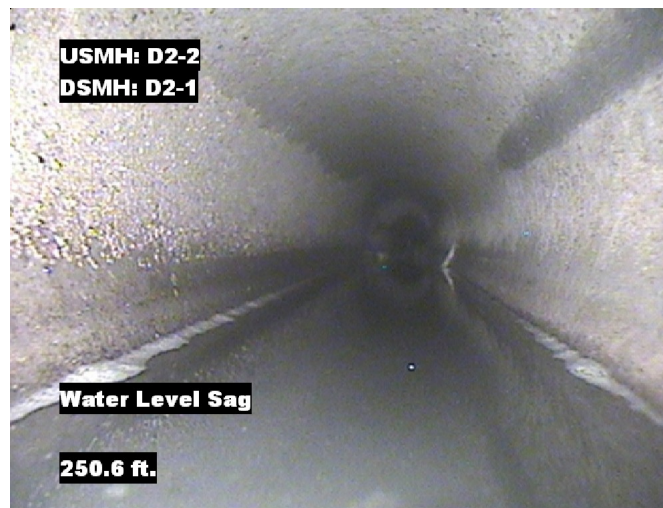
Distance: 250.6 ft. Grade: 2
Condition: Water Level Sag
Remarks: N/A

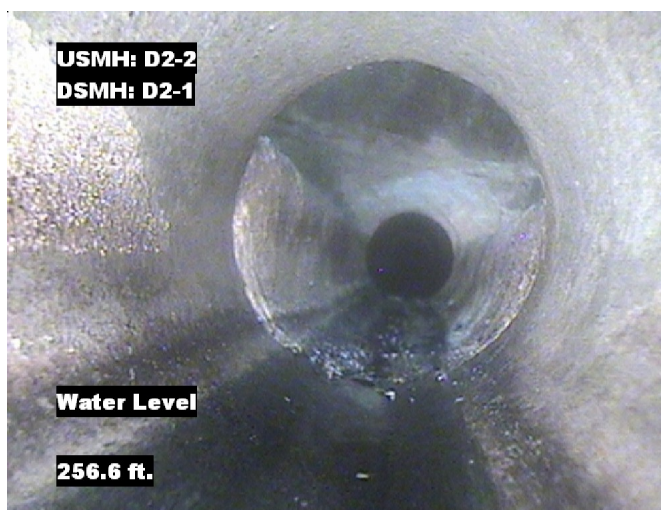
Distance: 256.6 ft. Grade: 0
Condition: Water Level
Remarks: N/A

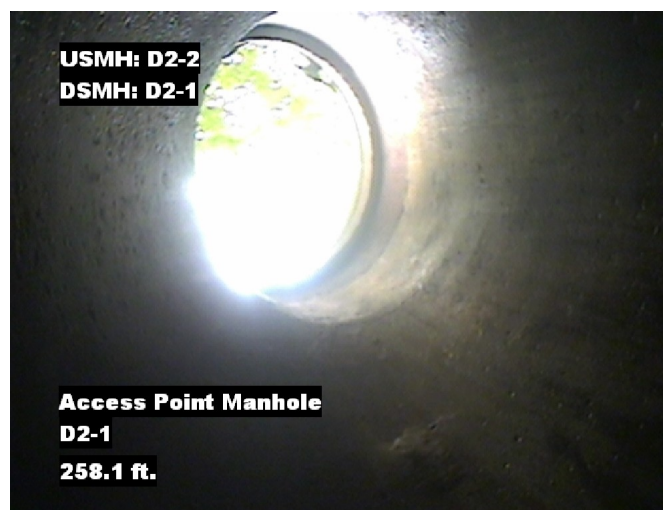
Distance: 258.1 ft. Grade: 0
Condition: Access Point Manhole
Remarks: D2-1
