## Defect Listing

Pipe Segment Refere... <b>D2-3_D2-2</b>	City <b>Oliver Springs</b>	Street <b>Henley Cir</b>	Material <b>Concrete Pipe (non-...</b>	Location C... <b>Light High...</b>	Sewer Use <b>Sanitary</b>
Upstream MH <b>D2-3</b>	Total Length <b>272.3</b>	Year Laid	Shape <b>Circular</b>	Location Details	
DS Manhole <b>D2-2</b>	Length surveyed <b>272.3</b>	Year Renewed	Height <b>8</b>	Width <b>8</b>	Pipe Joint... <b>4</b>

SPR <b>1</b>	MPR <b>8</b>	PO Number <b>4397-03</b>	Customer <b>GRW</b>
SPRI <b>1</b>	MPRI <b>2.7</b>	Work Order <b>4397-02</b>	Purpose <b>Pre-Rehabilitation Survey</b>
QSR <b>1100</b>	QMR <b>3221</b>		
OPR <b>9</b>	Surveyed By <b>Barry Rogers</b>	Direction <b>Downstream</b>	Date <b>20150707</b>
OPRI <b>2.3</b>	Certificate Number <b>U-1012-16405</b>	Pre-Cleaning <b>Jetting</b>	Time <b>14:02</b>
	Date Cleaned <b>20150707</b>	End Time <b>14:22</b>	Weather <b>Dry</b>
		Additional Info

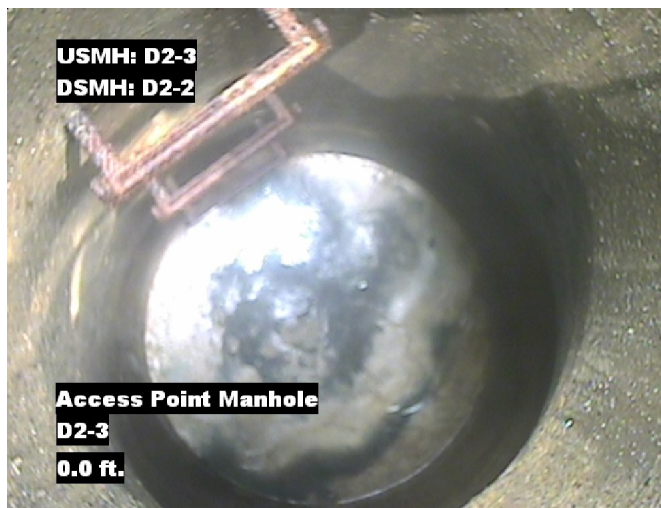
Distance: 0.0 ft. Grade: 0  
Condition: Access Point Manhole  
Remarks: D2-3

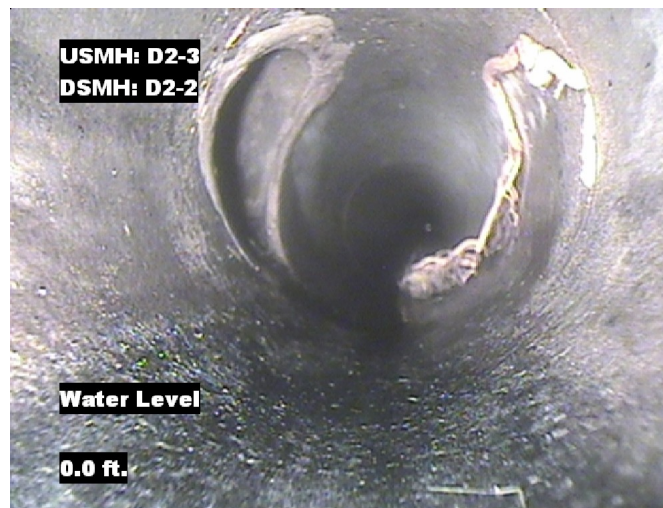
Distance: 0.0 ft. Grade: 0  
Condition: Water Level  
Remarks: N/A

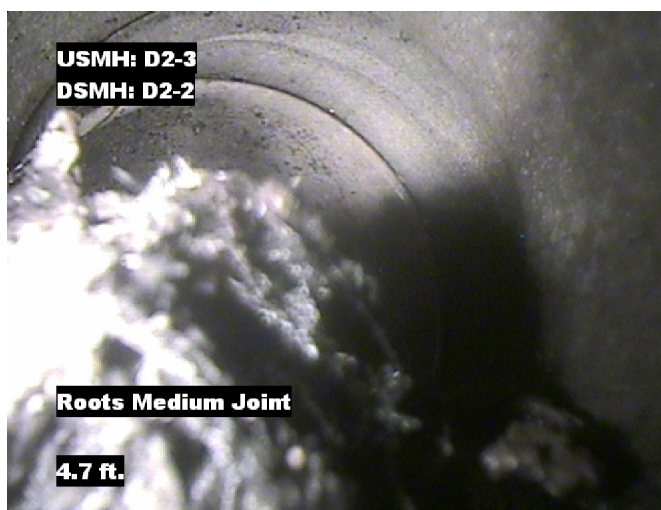
Distance: 4.7 ft. Grade: 3  
Condition: Roots Medium Joint  
Remarks: N/A

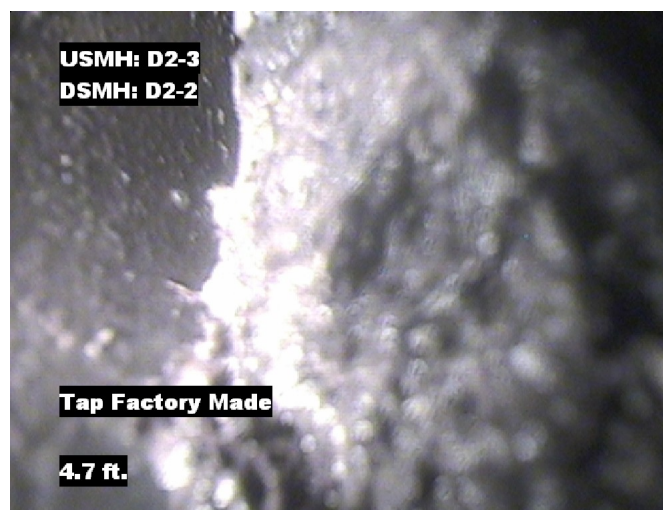
Distance: 4.7 ft. Grade: 0  
Condition: Tap Factory Made  
Remarks: N/A

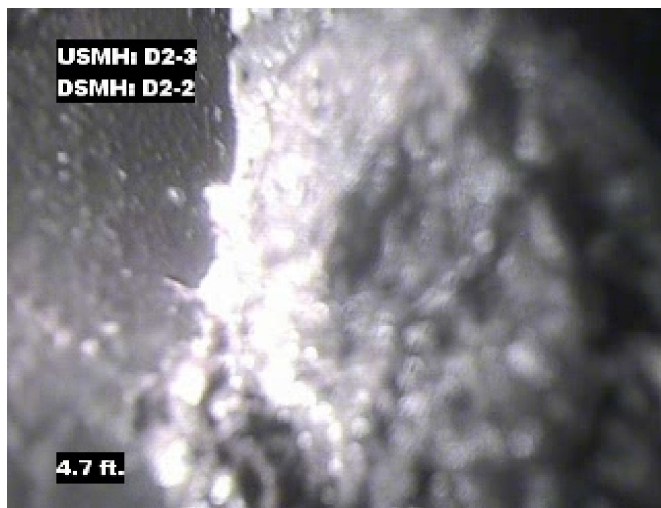
Distance: 4.9 ft. Grade: 3  
Condition: Roots Tap Barrel  
Remarks: N/A

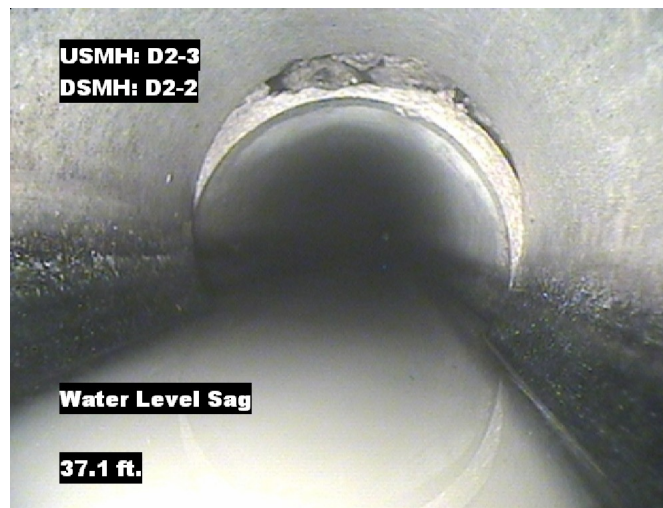
Distance: 37.1 ft. Grade: 2  
Condition: Water Level Sag  
Remarks: N/A

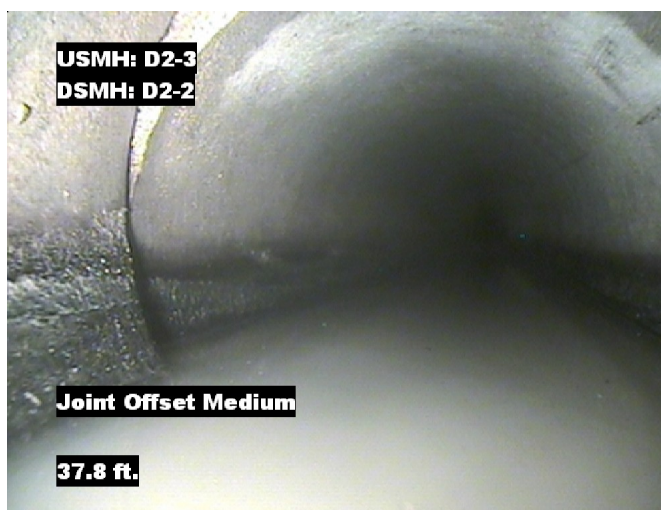
Distance: 37.8 ft. Grade: 1  
Condition: Joint Offset Medium  
Remarks: N/A

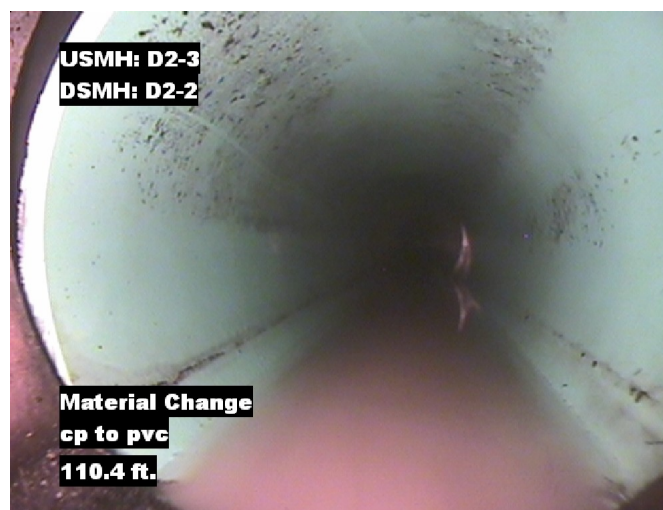
Distance: 110.4 ft. Grade: 0  
Condition: Material Change  
Remarks: cp to pvc

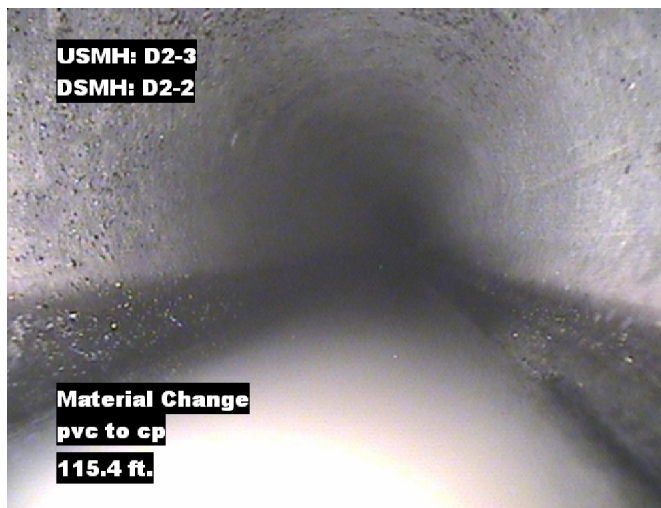
Distance: 115.4 ft. Grade: 0  
Condition: Material Change  
Remarks: pvc to cp

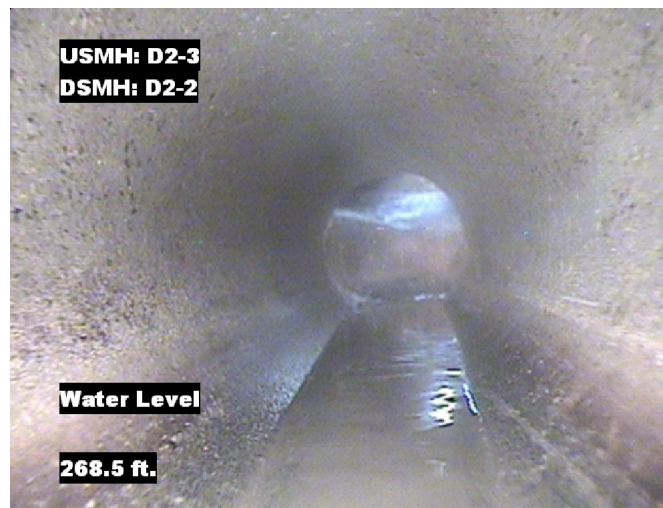
Distance: 268.5 ft. Grade: 0  
Condition: Water Level  
Remarks: N/A

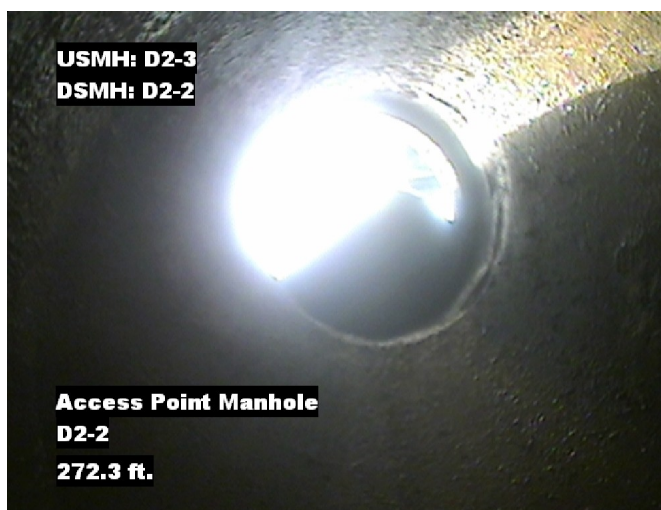
Distance: 272.3 ft. Grade: 0  
Condition: Access Point Manhole  
Remarks: D2-2
