Defect Listing

Pipe Segment Refere... D20-1_PS-4	City Oliver Springs	Street Airport rd	Material PolyVinyl Chloride	Location C... Easement/R...	Sewer Use Sanitary
Upstream MH D20-1	Total Length 16	Year Laid	Shape Circular	Location Details Side of rd in Field	
DS Manhole PS-4	Length surveyed 16	Year Renewed	Height 8	Width 8	Pipe Joint... 13

Image Report 4/Page

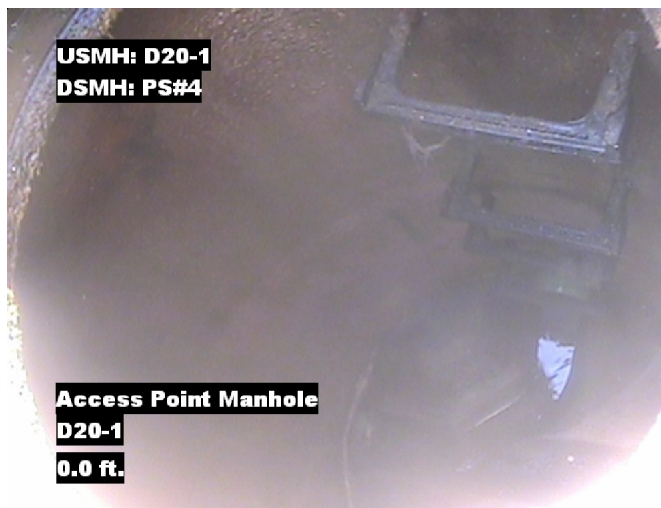
Distance: 0.0 ft. Grade: 0
Condition: Access Point Manhole
Remarks: D20-1

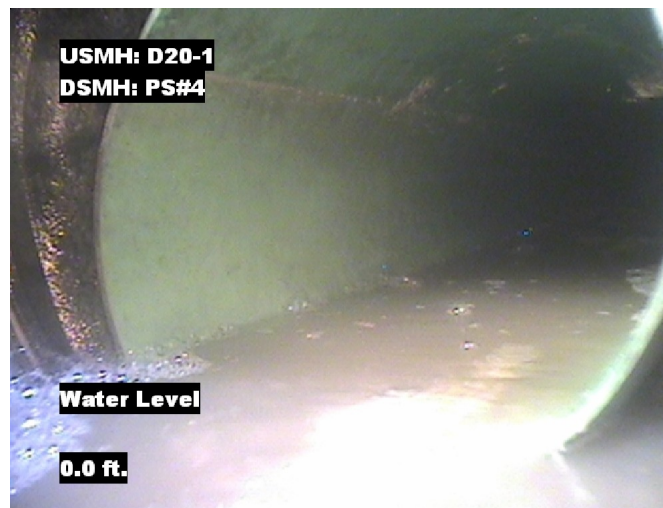
Distance: 0.0 ft. Grade: 0
Condition: Water Level
Remarks: N/A

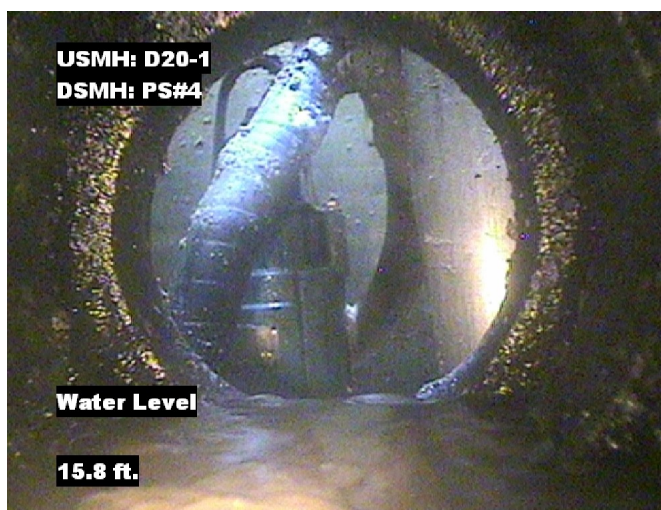
Distance: 15.8 ft. Grade: 0
Condition: Water Level
Remarks: N/A

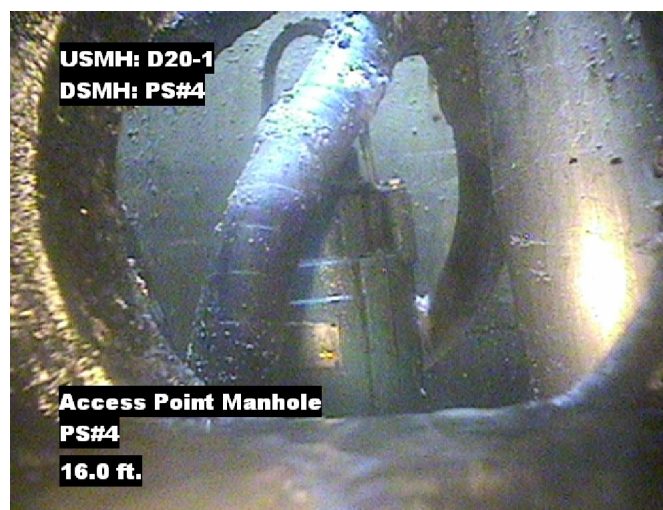
Distance: 16.0 ft. Grade: 0
Condition: Access Point Manhole
Remarks: PS#4
