Defect Listing

Pipe Segment Refere... D20-10_D20-9	City Oliver Springs	Street AIRPORT RD	Material PolyVinyl Chloride	Location C... Easement/R...	Sewer Use Sanitary
Upstream MH D20-10	Total Length 296.4	Year Laid	Shape Circular	Location Details Side of rd	
DS Manhole D20-9	Length surveyed 296.4	Year Renewed	Height 8	Width 8	Pipe Joint... 13

Image Report 4/Page

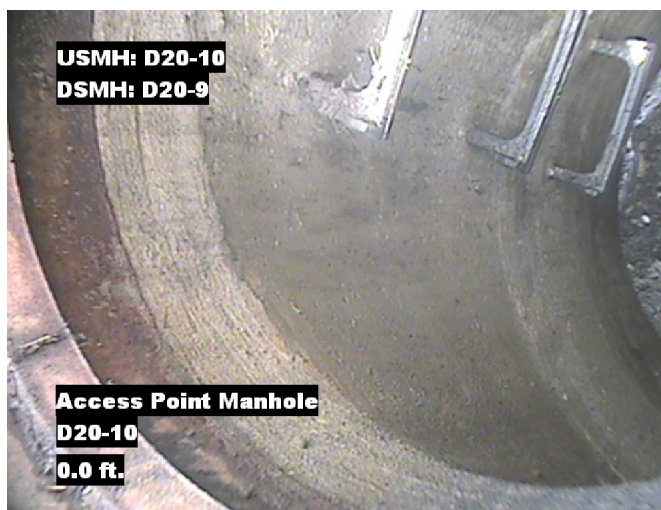
Distance: 0.0 ft. Grade: 0
Condition: Access Point Manhole
Remarks: D20-10

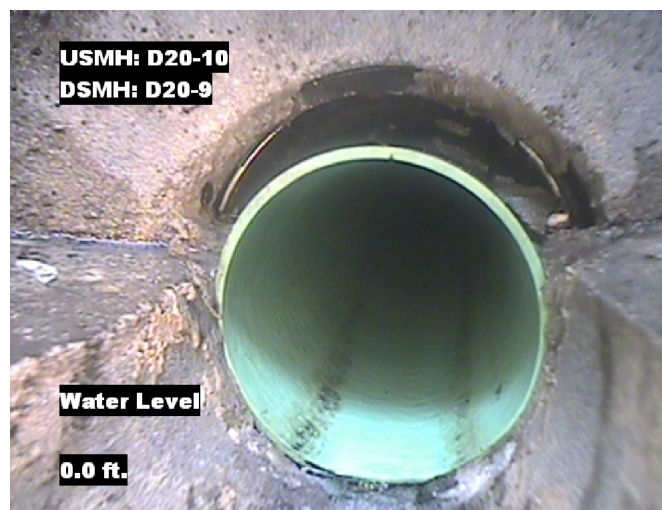
Distance: 0.0 ft. Grade: 0
Condition: Water Level
Remarks: N/A

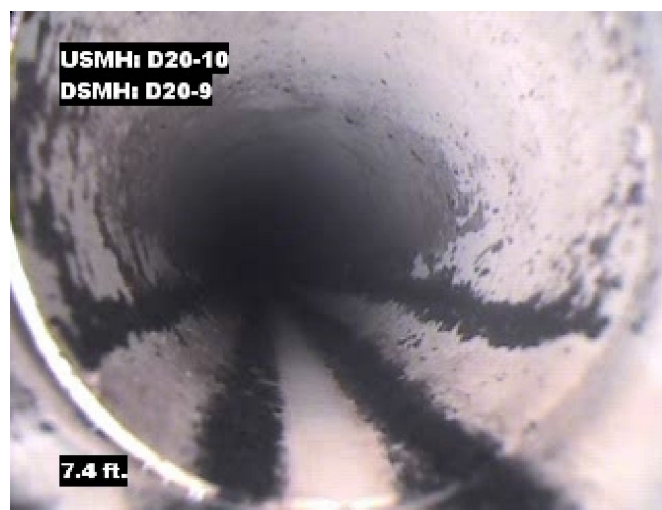
Distance: 7.4 ft. Grade: 0
Condition: Tap Saddle Active
Remarks: N/A

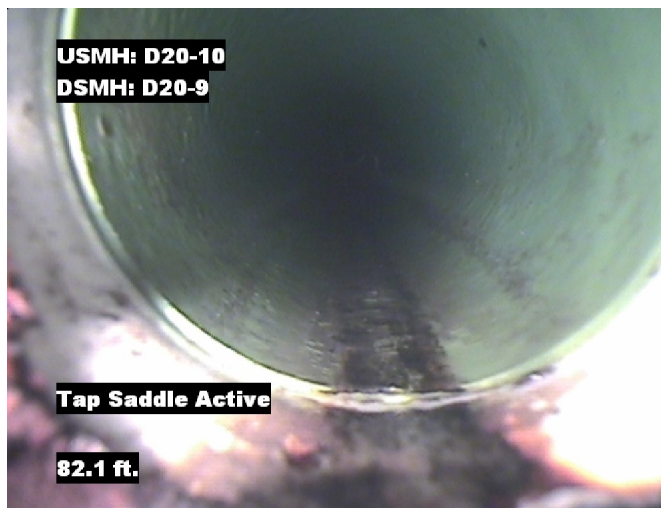
Distance: 82.1 ft. Grade: 0
Condition: Tap Saddle Active
Remarks: N/A

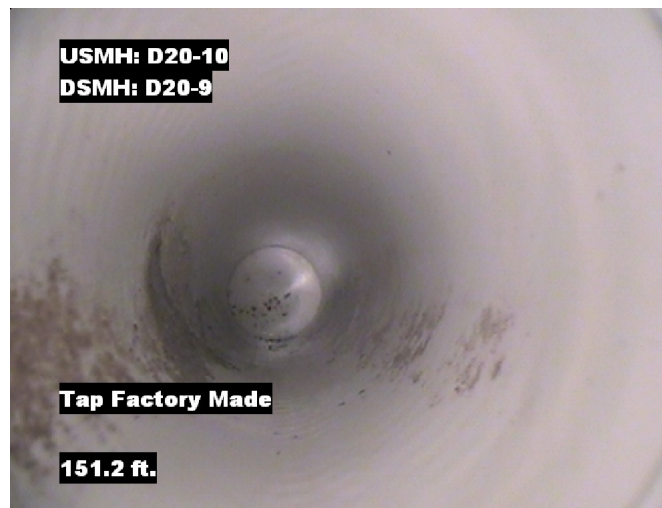
Distance: 151.2 ft. Grade: 0
Condition: Tap Factory Made
Remarks: N/A

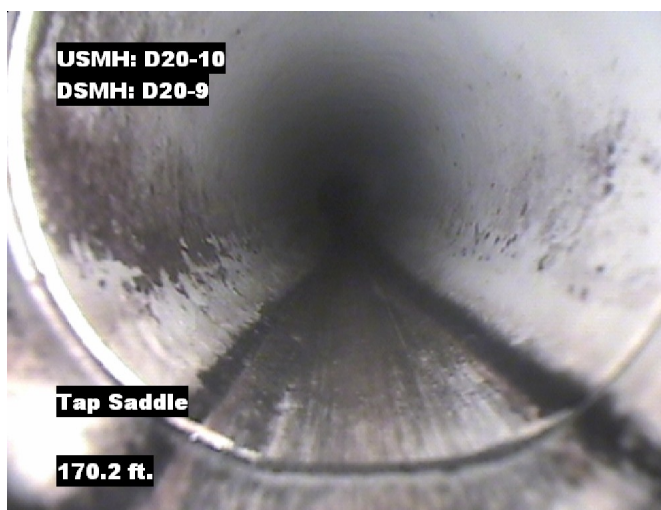
Distance: 170.2 ft. Grade: 0
Condition: Tap Saddle
Remarks: N/A

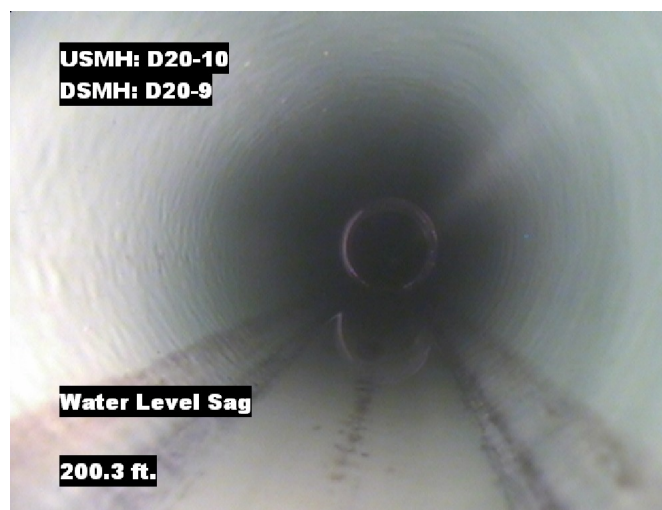
Distance: 200.3 ft. Grade: 2
Condition: Water Level Sag
Remarks: N/A

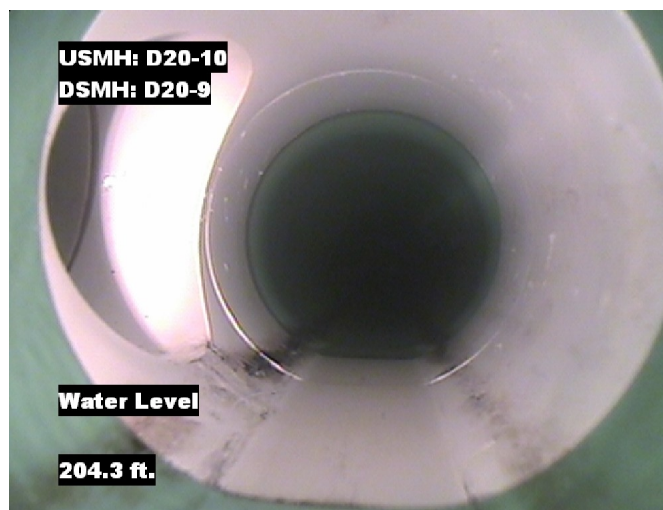
Distance: 204.3 ft. Grade: 0
Condition: Water Level
Remarks: N/A

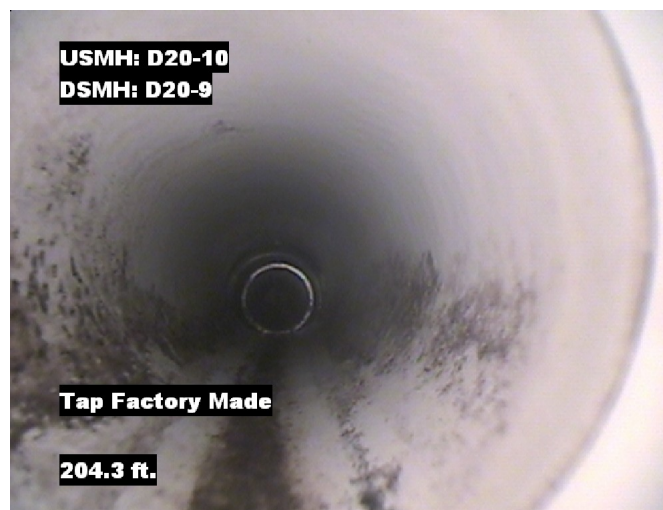
Distance: 204.3 ft. Grade: 0
Condition: Tap Factory Made
Remarks: N/A

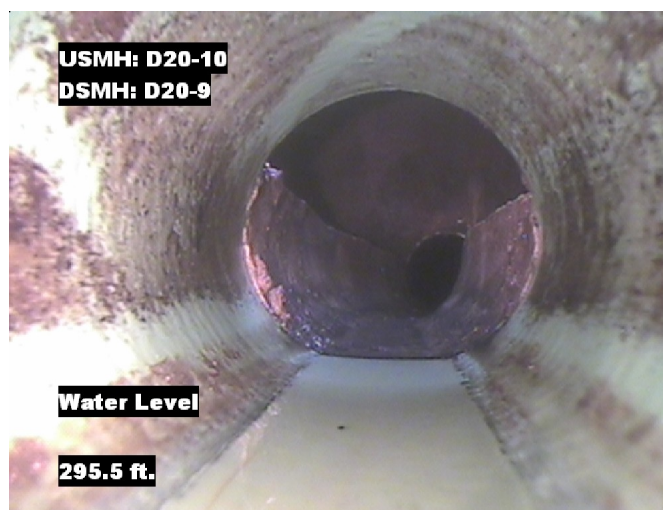
Distance: 295.5 ft. Grade: 0
Condition: Water Level
Remarks: N/A

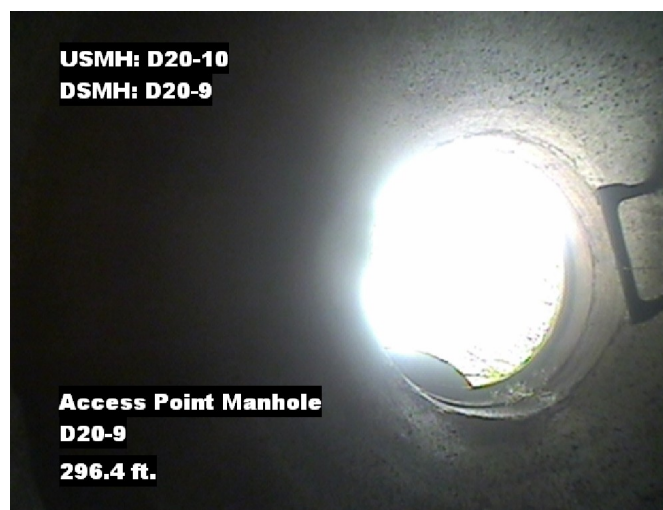
Distance: 296.4 ft. Grade: 0
Condition: Access Point Manhole
Remarks: D20-9
