## Defect Listing

Pipe Segment Refere... <b>D20-11_D20-10</b>	City <b>Oliver Springs</b>	Street <b>Airport rd</b>	Material <b>PolyVinyl Chloride</b>	Location C... <b>Easement/R...</b>	Sewer Use <b>Sanitary</b>
Upstream MH <b>D20-11</b>	Total Length <b>34.6</b>	Year Laid	Shape <b>Circular</b>	Location Details <b>Side of rd</b>	
DS Manhole <b>D20-10</b>	Length surveyed <b>34.6</b>	Year Renewed	Height <b>8</b>	Width <b>8</b>	Pipe Joint... <b>13</b>

SPR <b>N/A</b>	MPR <b>N/A</b>	PO Number <b>4397-03</b>	Customer <b>GRW</b>
SPRI <b>N/A</b>	MPRI <b>N/A</b>	Work Order <b>4397-02</b>	Purpose <b>Pre-Rehabilitation Survey</b>
QSR <b>N/A</b>	QMR <b>N/A</b>		
OPR <b>N/A</b>	Surveyed By <b>Barry Rogers</b>	Direction <b>Downstream</b>	Date <b>20150601</b>
OPRI <b>N/A</b>	Certificate Number <b>U-1012-16405</b>	Pre-Cleaning <b>Jetting</b>	Time <b>12:06</b>
	Date Cleaned <b>20150601</b>	End Time <b>12:15</b>	Weather <b>Damp</b>
		Additional Info <b>TFA @ 30.6' Runnin...</b>

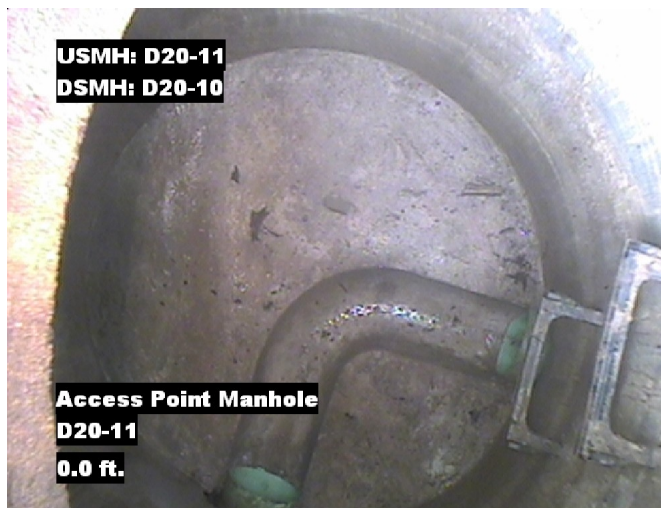
Distance: 0.0 ft. Grade: 0  
Condition: Access Point Manhole  
Remarks: D20-11

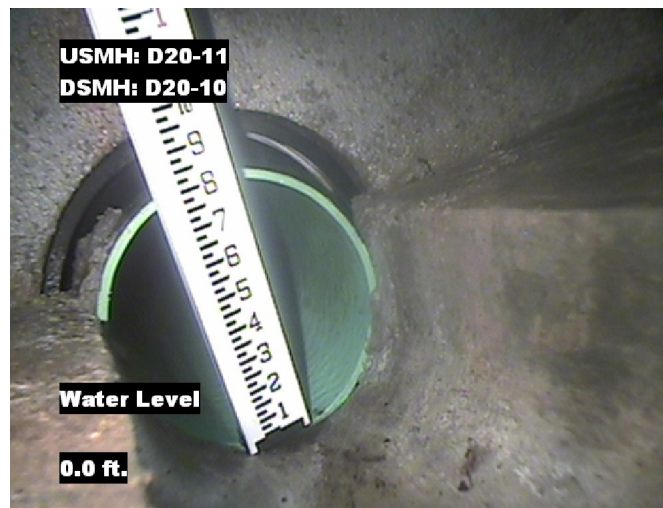
Distance: 0.0 ft. Grade: 0  
Condition: Water Level  
Remarks: N/A

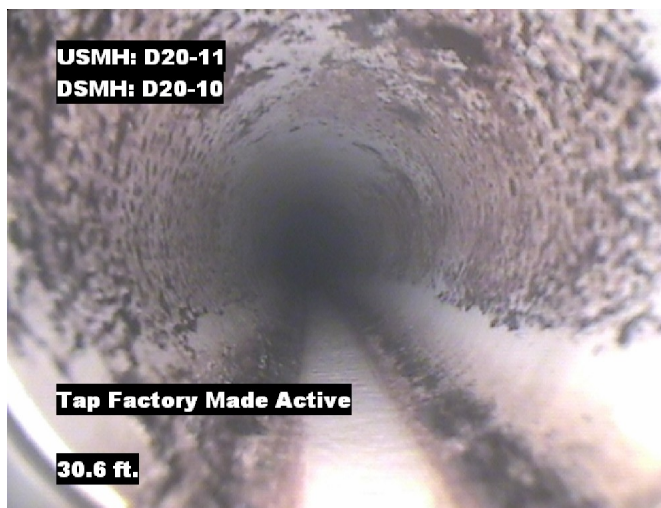
Distance: 30.6 ft. Grade: 0  
Condition: Tap Factory Made Active  
Remarks: N/A

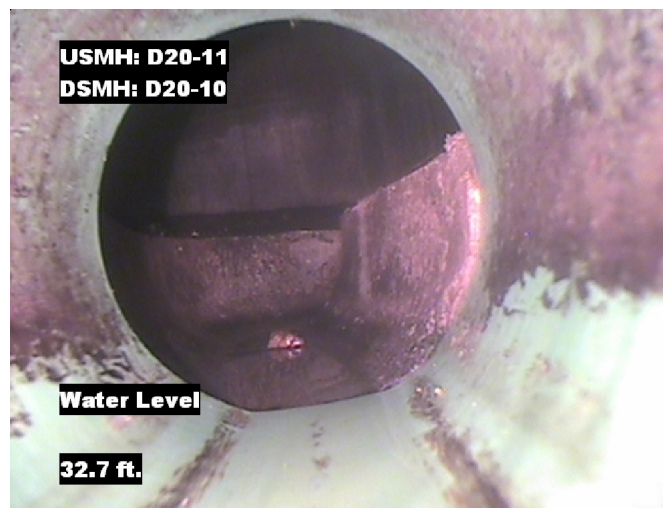
Distance: 32.7 ft. Grade: 0  
Condition: Water Level  
Remarks: N/A

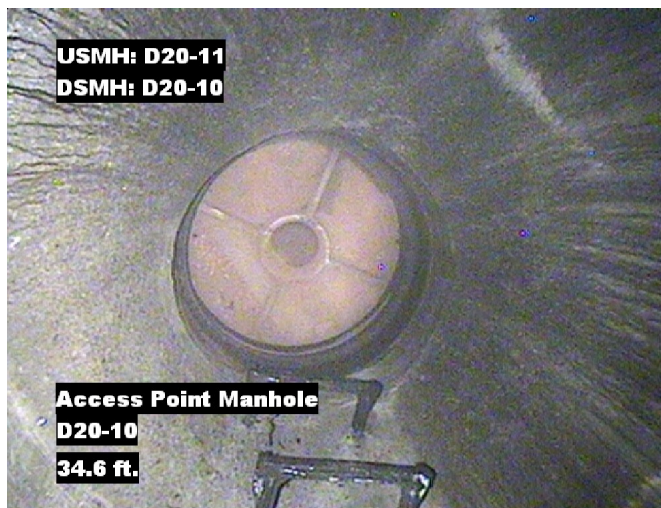
Distance: 34.6 ft.      Grade: 0  
Condition: Access Point Manhole  
Remarks: D20-10
