Defect Listing

Pipe Segment Refere... D20-12_D20-11	City Oliver Springs	Street Airport rd	Material PolyVinyl Chloride	Location C... Yard	Sewer Use Sanitary
Upstream MH D20-12	Total Length 201.7	Year Laid	Shape Circular	Location Details Off Side of RD	
DS Manhole D20-11	Length surveyed 201.7	Year Renewed	Height 8	Width 8	Pipe Joint... 13

Image Report 4/Page

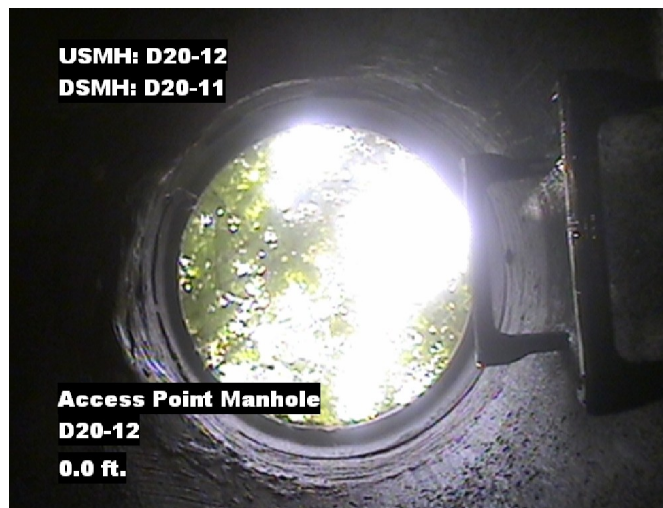
Distance: 0.0 ft. Grade: 0
Condition: Access Point Manhole
Remarks: D20-12

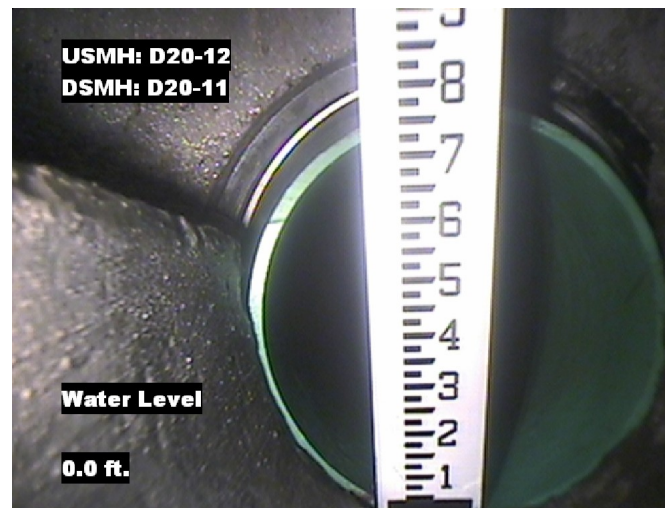
Distance: 0.0 ft. Grade: 0
Condition: Water Level
Remarks: N/A

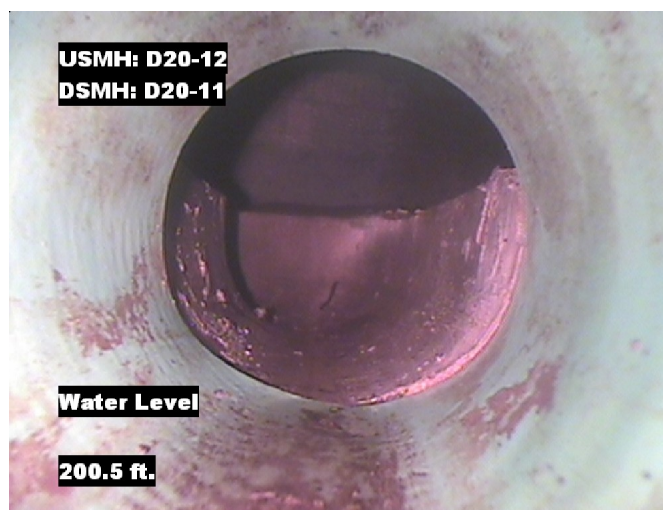
Distance: 200.5 ft. Grade: 0
Condition: Water Level
Remarks: N/A

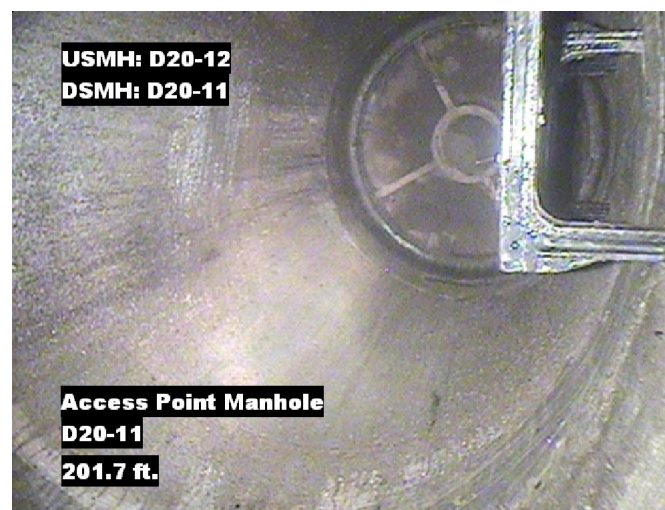
Distance: 201.7 ft. Grade: 0
Condition: Access Point Manhole
Remarks: D20-11
