Defect Listing

Pipe Segment Refere... D20-13_D20-12	City Oliver Springs	Street Airport Road	Material PolyVinyl Chloride	Location C... Yard	Sewer Use Sanitary
Upstream MH D20-13	Total Length 127.3	Year Laid	Shape Circular	Location Details Side of Road	
DS Manhole D20-12	Length surveyed 127.3	Year Renewed	Height 8	Width 8	Pipe Joint... 13

SPR N/A	MPR 2	PO Number 4397-03		Customer GRW	
SPRI N/A	MPRI 2	Work Order 4397-02		Purpose Pre-Rehabilitation Survey	
QSR N/A	QMR 2100				
OPR 2	Surveyed By Barry Rogers	Direction Downstream	Date 20150601	Media label	
OPRI 2	Certificate Number U-1012-16405	Pre-Cleaning Jetting	Time 10:23	Weather Damp	
Date Cleaned 20150601			End Time 10:34	Additional Info

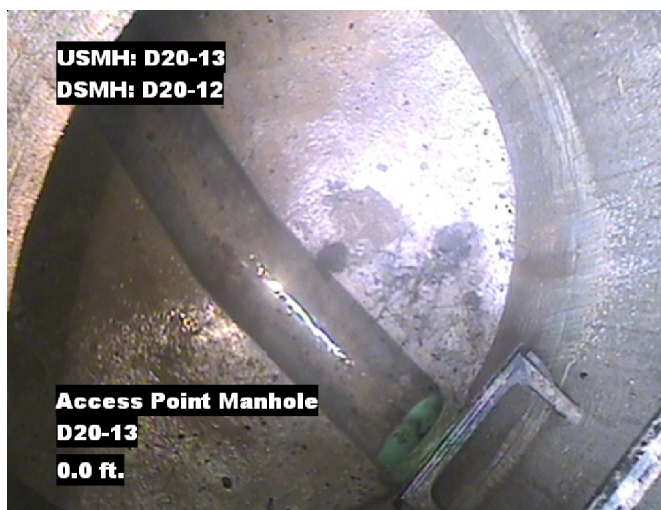
Distance: 0.0 ft. Grade: 0
Condition: Access Point Manhole
Remarks: D20-13

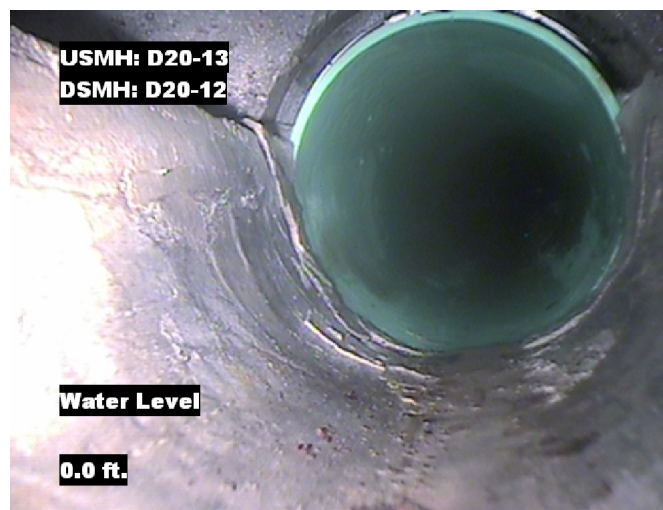
Distance: 0.0 ft. Grade: 0
Condition: Water Level
Remarks: N/A

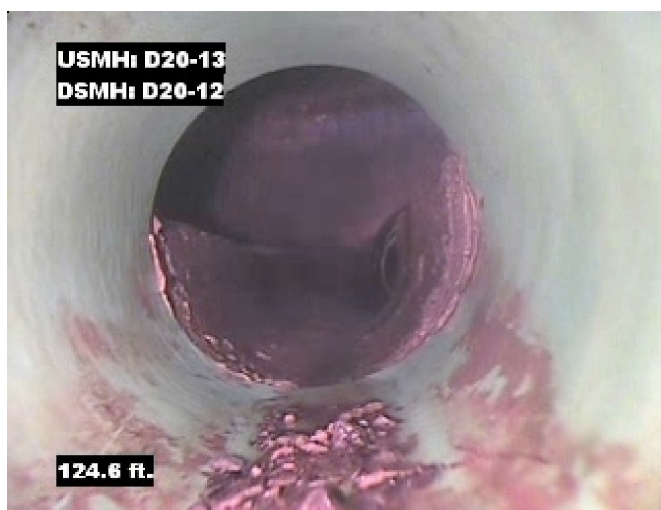
Distance: 124.6 ft. Grade: 2
Condition: Deposits Settled Fine
Remarks: N/A

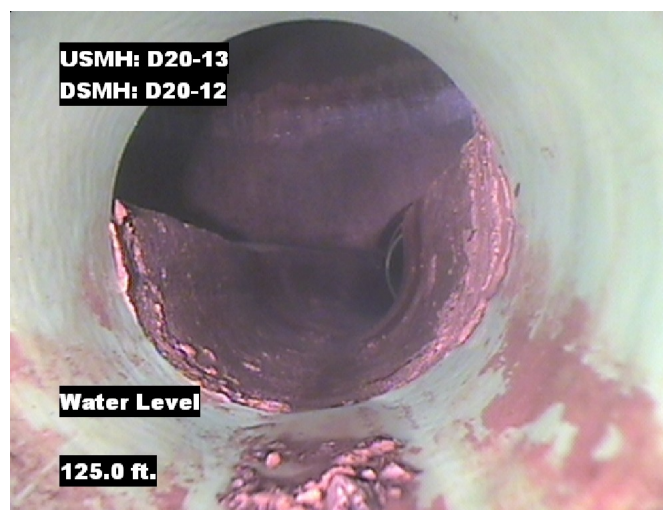
Distance: 125.0 ft. Grade: 0
Condition: Water Level
Remarks: N/A

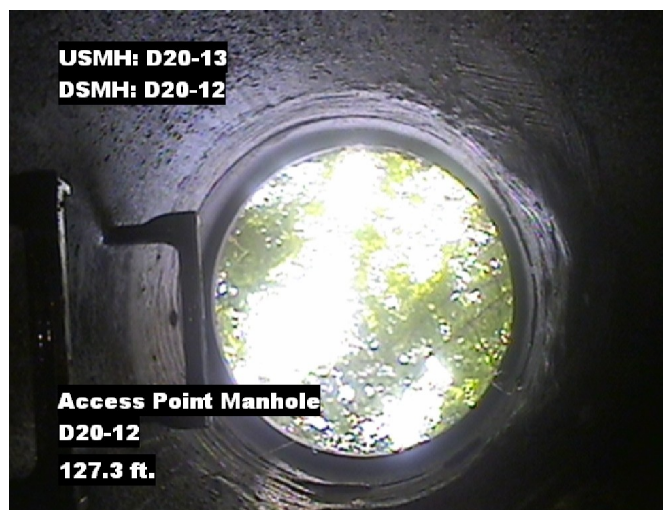
Distance: 127.3 ft. Grade: 0
Condition: Access Point Manhole
Remarks: D20-12
