## Defect Listing

Pipe Segment Refere... <b>D20-14_D20-13</b>	City <b>Oliver Springs</b>	Street <b>Airport Rd</b>	Material <b>PolyVinyl Chloride</b>	Location C... <b>Easement/R...</b>	Sewer Use <b>Sanitary</b>
Upstream MH <b>D20-14</b>	Total Length <b>225</b>	Year Laid	Shape <b>Circular</b>	Location Details <b>Side of Road</b>	
DS Manhole <b>D20-13</b>	Length surveyed <b>225</b>	Year Renewed	Height <b>8</b>	Width <b>8</b>	Pipe Joint... <b>13</b>

SPR <b>N/A</b>	MPR <b>N/A</b>	PO Number <b>4397-03</b>		Customer <b>GRW</b>	
SPRI <b>N/A</b>	MPRI <b>N/A</b>	Work Order <b>4397-02</b>		Purpose <b>Pre-Rehabilitation Survey</b>	
QSR <b>N/A</b>	QMR <b>N/A</b>				
OPR <b>N/A</b>	Surveyed By <b>Barry Rogers</b>	Direction <b>Downstream</b>	Date <b>20150601</b>	Media label	
OPRI <b>N/A</b>	Certificate Number <b>U-1012-16405</b>	Pre-Cleaning <b>Jetting</b>	Time <b>09:34</b>	Weather <b>Saturated</b>	
Date Cleaned <b>20150601</b>			End Time <b>09:57</b>	Additional Info

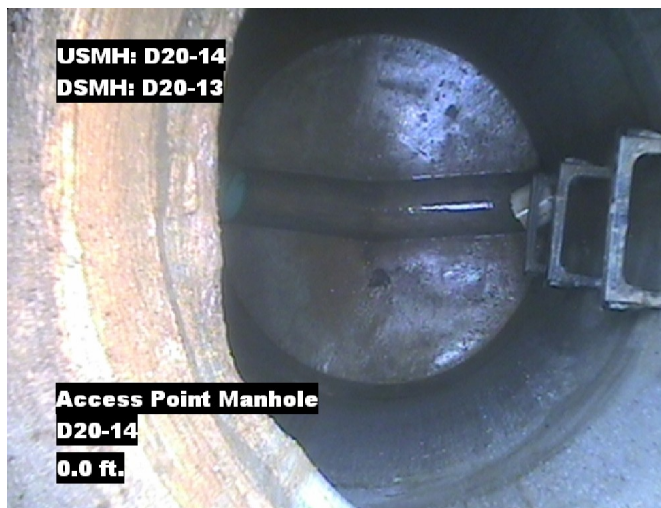
Distance: 0.0 ft. Grade: 0  
Condition: Access Point Manhole  
Remarks: D20-14

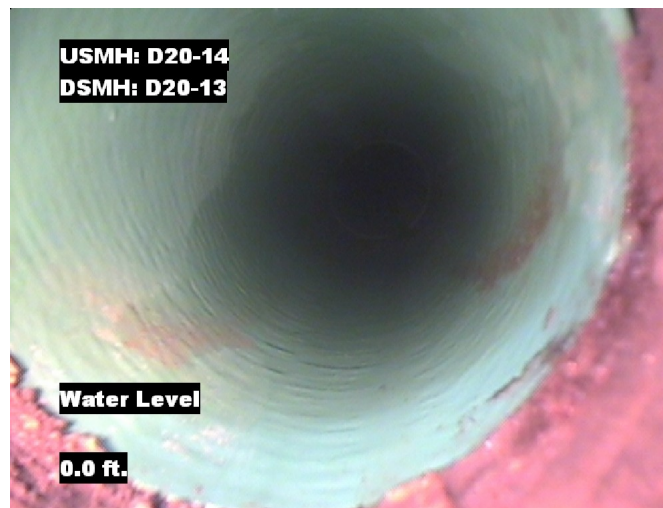
Distance: 0.0 ft. Grade: 0  
Condition: Water Level  
Remarks: N/A

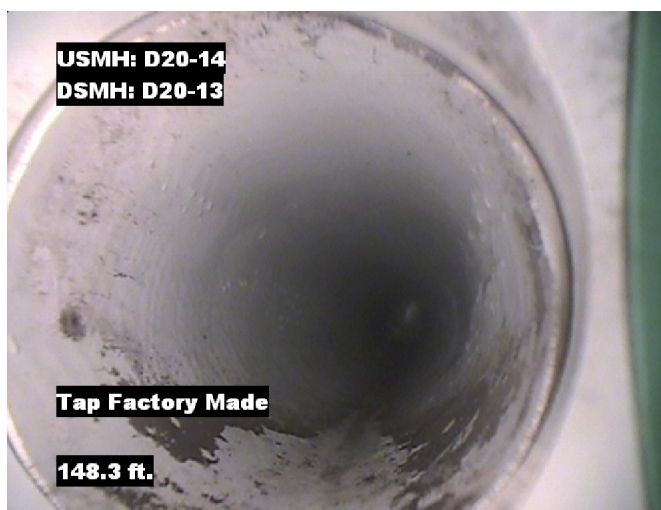
Distance: 148.3 ft. Grade: 0  
Condition: Tap Factory Made  
Remarks: N/A

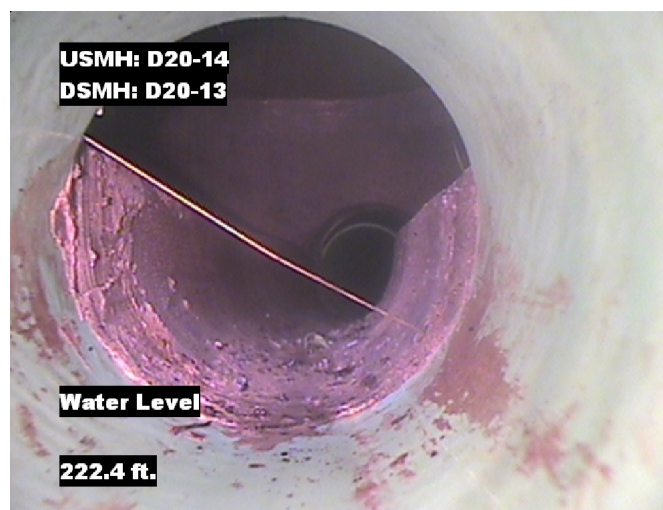
Distance: 222.4 ft. Grade: 0  
Condition: Water Level  
Remarks: N/A

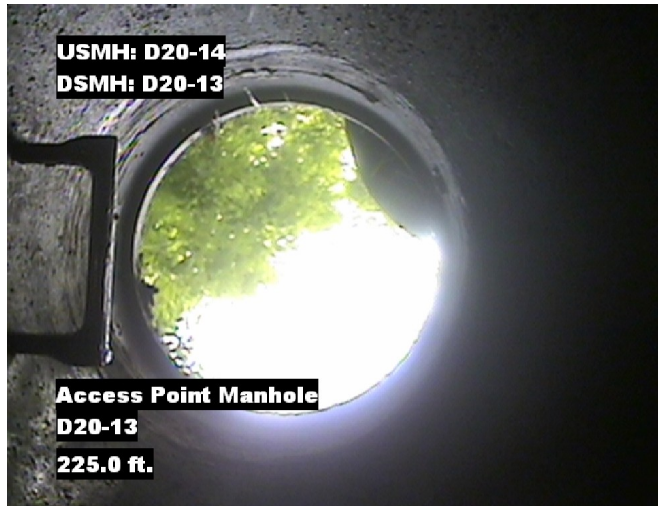
Distance: 225.0 ft. Grade: 0  
Condition: Access Point Manhole  
Remarks: D20-13
