Defect Listing

Pipe Segment Refere... D20-15_D20-6	City Oliver Springs	Street Aspen Ln	Material PolyVinyl Chloride	Location C... Yard	Sewer Use Sanitary
Upstream MH D20-15	Total Length 87.4	Year Laid	Shape Circular	Location Details Side of Yard	
DS Manhole D20-6	Length surveyed 87.4	Year Renewed	Height 8	Width 8	Pipe Joint... 13

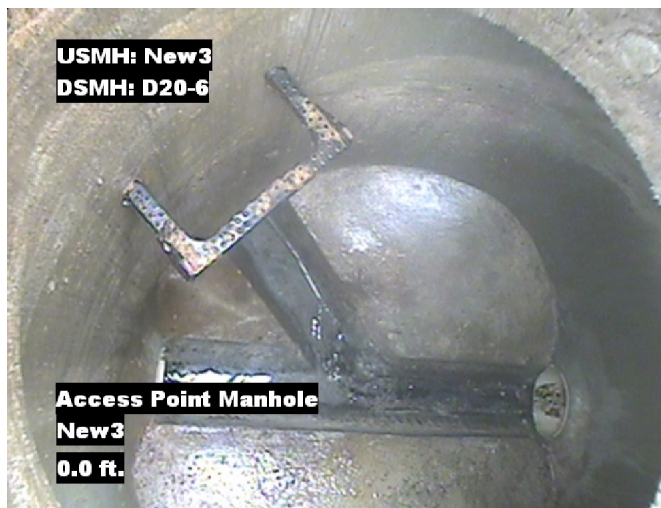
Distance: 0.0 ft. Grade: 0
Condition: Access Point Manhole
Remarks: D20-15

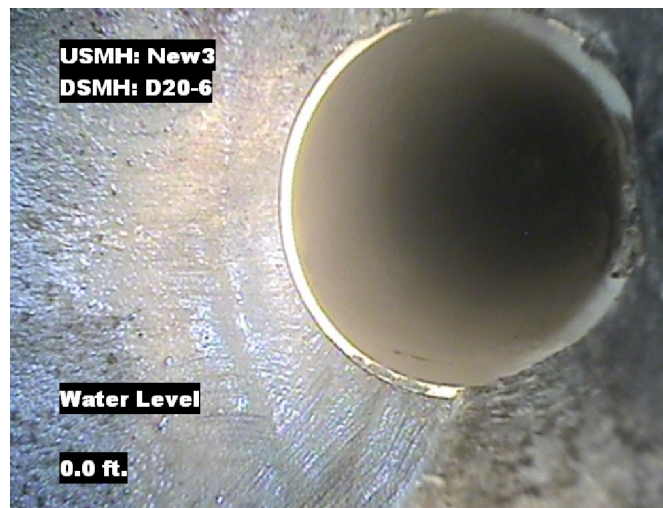
Distance: 0.0 ft. Grade: 0
Condition: Water Level
Remarks: N/A

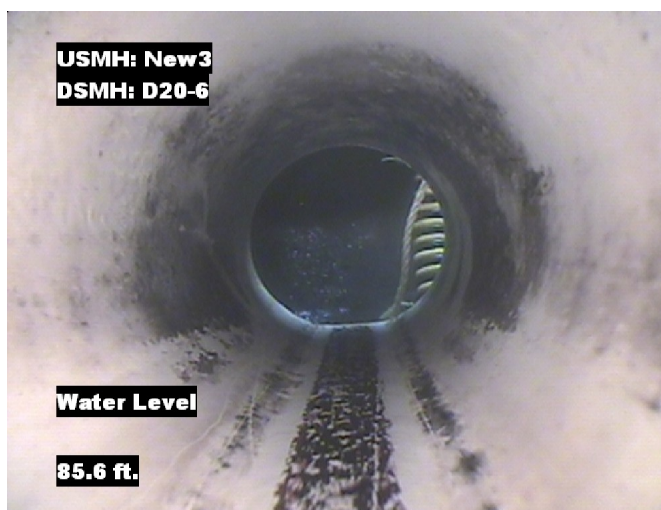
Distance: 85.6 ft. Grade: 0
Condition: Water Level
Remarks: N/A

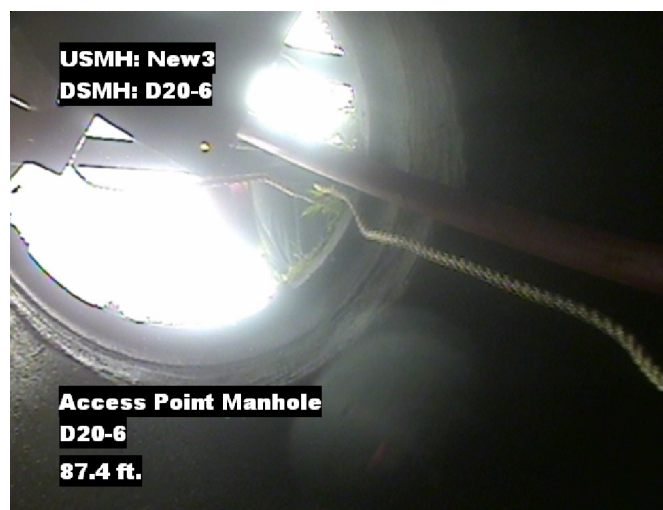
Distance: 87.4 ft. Grade: 0
Condition: Access Point Manhole
Remarks: D20-6
