## Defect Listing

Pipe Segment Refere... <b>D20-2_D20-1</b>	City <b>Oliver Springs</b>	Street <b>Airport Rd</b>	Material <b>PolyVinyl Chloride</b>	Location C... <b>Easement/R...</b>	Sewer Use <b>Sanitary</b>
Upstream MH <b>D20-2</b>	Total Length <b>297.8</b>	Year Laid	Shape <b>Circular</b>	Location Details <b>Side of rd in Field</b>	
DS Manhole <b>D20-1</b>	Length surveyed <b>297.8</b>	Year Renewed	Height <b>8</b>	Width <b>8</b>	Pipe Joint... <b>13</b>

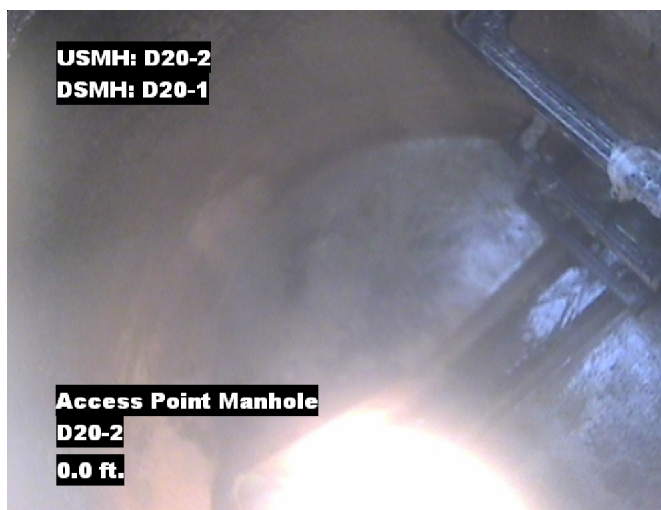
Distance: 0.0 ft. Grade: 0  
Condition: Access Point Manhole  
Remarks: D20-2

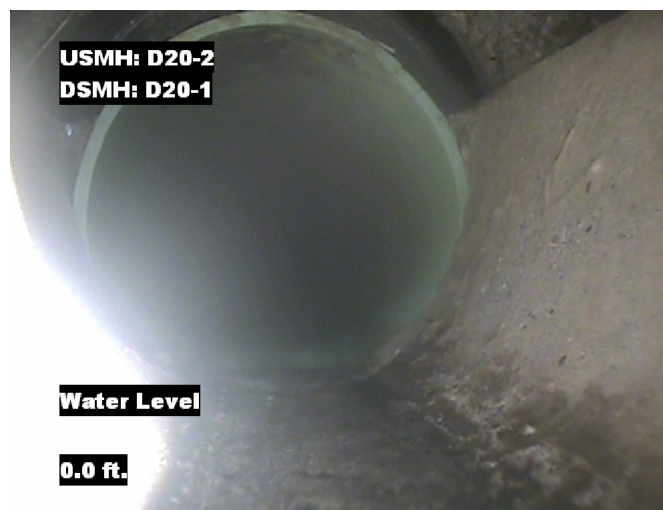
Distance: 0.0 ft. Grade: 0  
Condition: Water Level  
Remarks: N/A

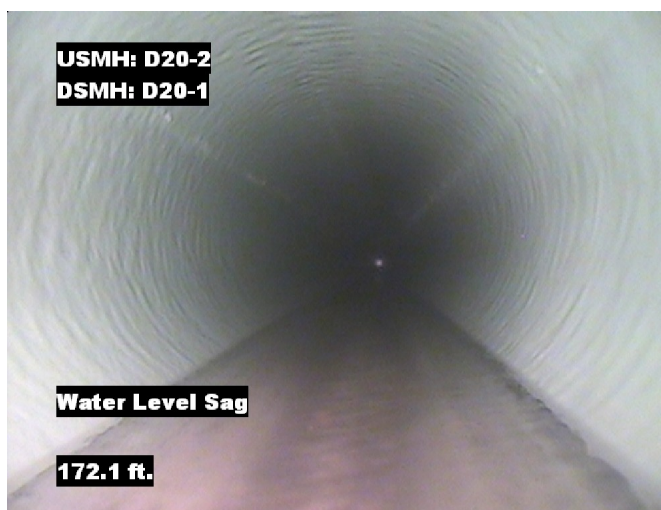
Distance: 172.1 ft. Grade: 2  
Condition: Water Level Sag  
Remarks: N/A

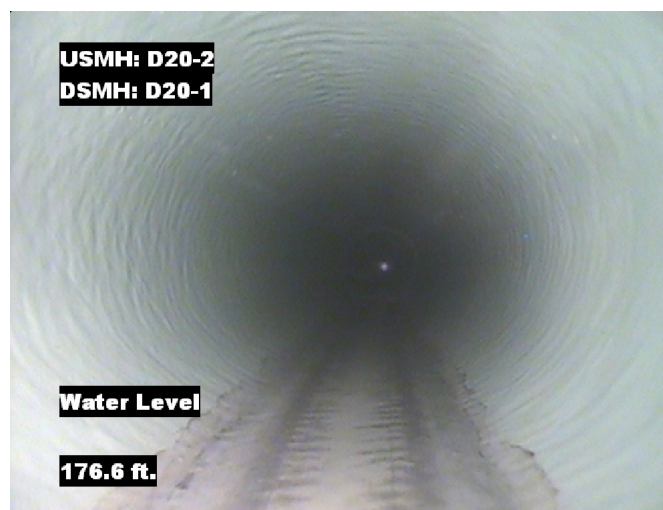
Distance: 176.6 ft. Grade: 0  
Condition: Water Level  
Remarks: N/A

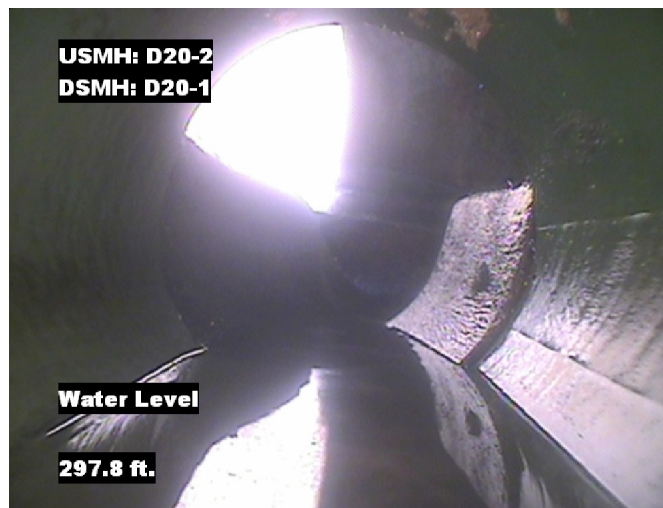
Distance: 297.8 ft.      Grade: 0  
Condition: Water Level  
Remarks: N/A

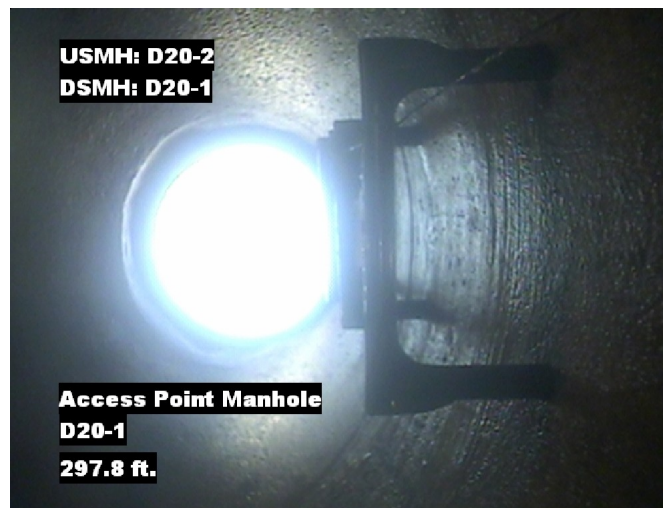
Distance: 297.8 ft.      Grade: 0  
Condition: Access Point Manhole  
Remarks: D20-1
