## Defect Listing

| Pipe Segment Refere...<br><b>D20-3_D20-2</b> | City<br><b>Oliver Springs</b> | Street<br><b>Airport Rd</b> | Material<br><b>PolyVinyl Chloride</b> | | Location C...<br><b>Yard</b> | Sewer Use<br><b>Sanitary</b> |

| SPRI<br><b>N/A</b> | MPRI<br><b>N/A</b> | Work Order<br><b>4397-02</b> | | Purpose<br><b>Pre-Rehabilitation Survey</b> | |

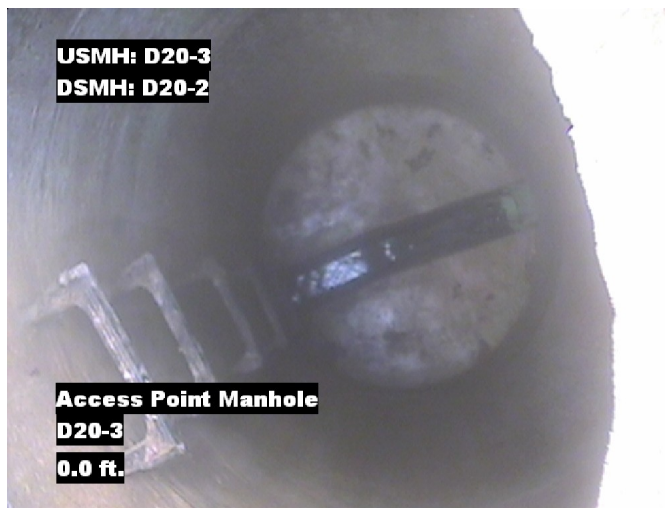
Distance: 0.0 ft. Grade: 0  
Condition: Access Point Manhole  
Remarks: D20-3

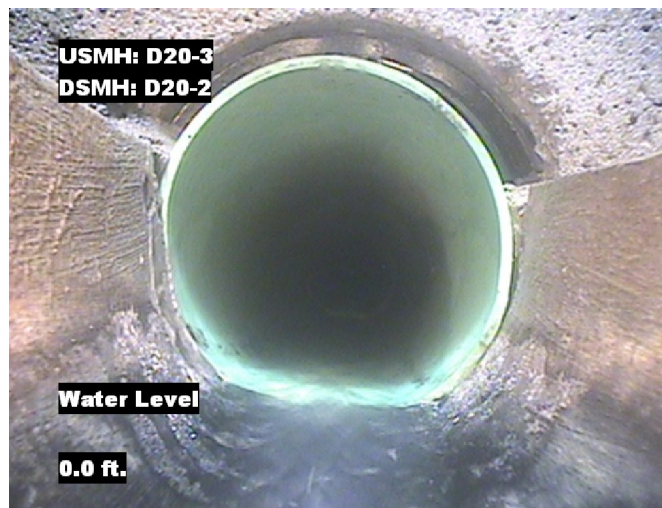
Distance: 0.0 ft. Grade: 0  
Condition: Water Level  
Remarks: N/A

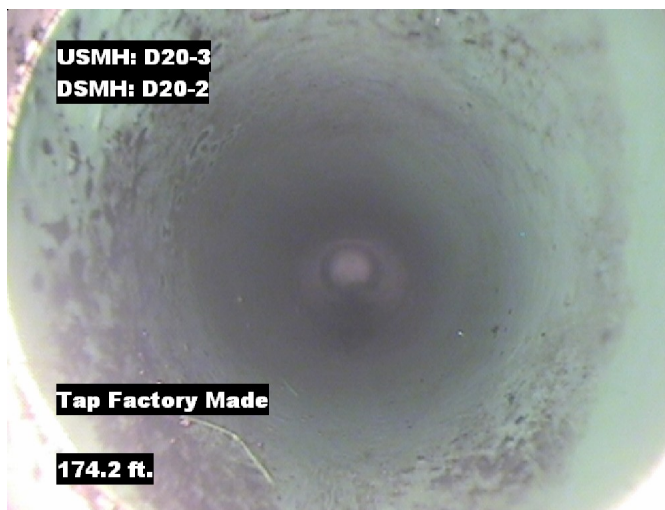
Distance: 174.2 ft. Grade: 0  
Condition: Tap Factory Made  
Remarks: N/A

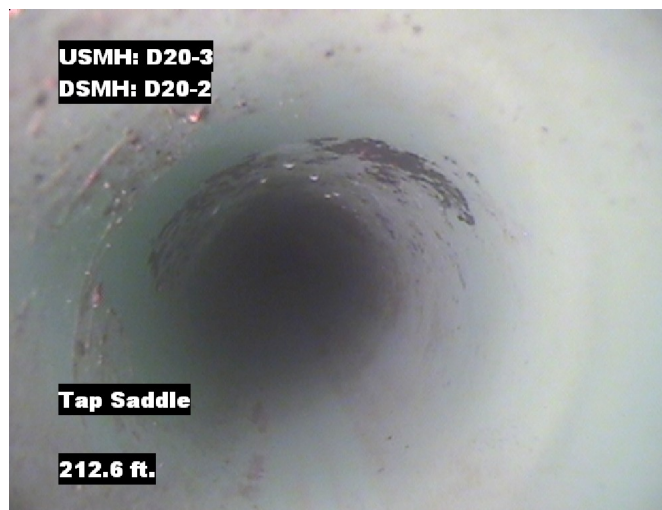
Distance: 212.6 ft. Grade: 0  
Condition: Tap Saddle  
Remarks: N/A

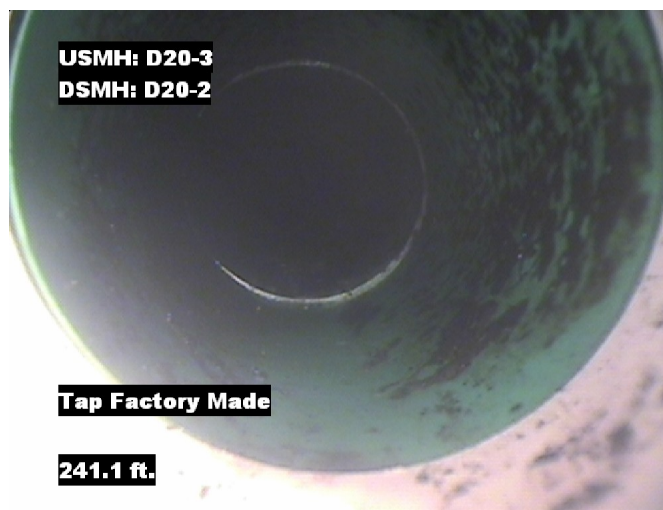
Distance: 241.1 ft. Grade: 0  
Condition: Tap Factory Made  
Remarks: N/A

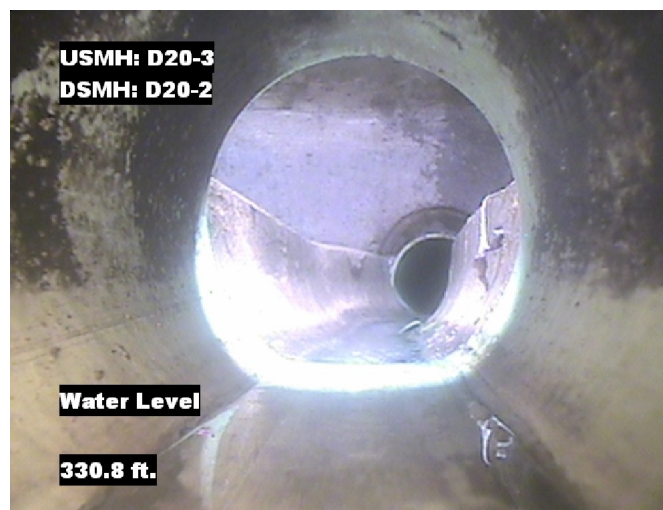
Distance: 330.8 ft. Grade: 0  
Condition: Water Level  
Remarks: N/A

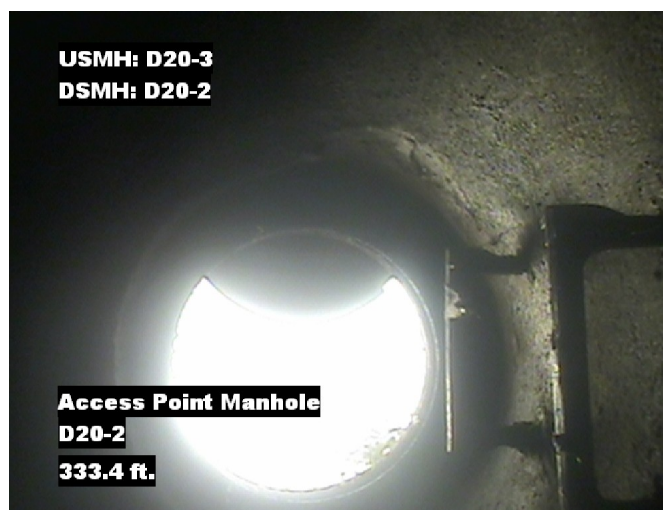
Distance: 333.4 ft. Grade: 0  
Condition: Access Point Manhole  
Remarks: D20-2
