## Defect Listing

Pipe Segment Refere... <b>D20-4_D20-3</b>	City <b>Oliver Springs</b>	Street <b>Airport RD</b>	Material <b>PolyVinyl Chloride</b>	Location C... <b>Yard</b>	Sewer Use <b>Sanitary</b>
Upstream MH <b>D20-4</b>	Total Length <b>280.7</b>	Year Laid	Shape <b>Circular</b>	Location Details <b>Side of Yard</b>	
DS Manhole <b>D20-3</b>	Length surveyed <b>280.7</b>	Year Renewed	Height <b>8</b>	Width <b>8</b>	Pipe Joint... <b>13</b>

SPR <b>N/A</b>	MPR <b>4</b>	PO Number <b>4397-03</b>		Customer <b>GRW</b>	
SPRI <b>N/A</b>	MPRI <b>2</b>	Work Order <b>4397-02</b>		Purpose <b>Pre-Rehabilitation Survey</b>	
QSR <b>N/A</b>	QMR <b>2200</b>				
OPR <b>4</b>	Surveyed By <b>Barry Rogers</b>	Direction <b>Downstream</b>	Date <b>20150603</b>	Media label	
OPRI <b>2</b>	Certificate Number <b>U-1012-16405</b>	Pre-Cleaning <b>Jetting</b>	Time <b>08:45</b>	Weather <b>Dry</b>	
Date Cleaned <b>20150603</b>			End Time <b>09:04</b>	Additional Info

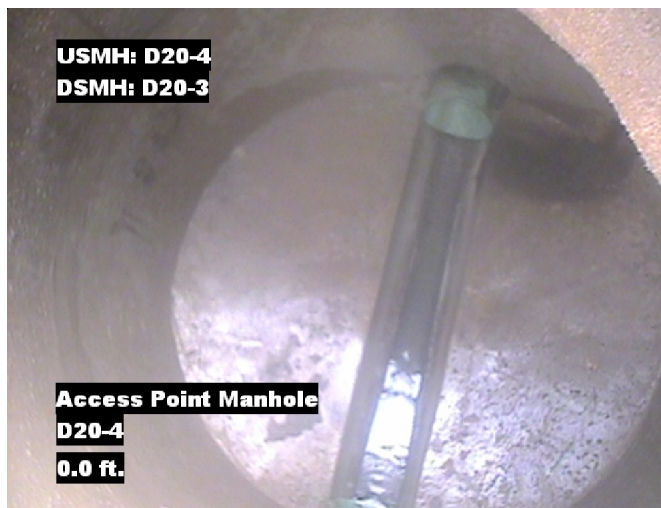
Distance: 0.0 ft. Grade: 0  
Condition: Access Point Manhole  
Remarks: D20-4

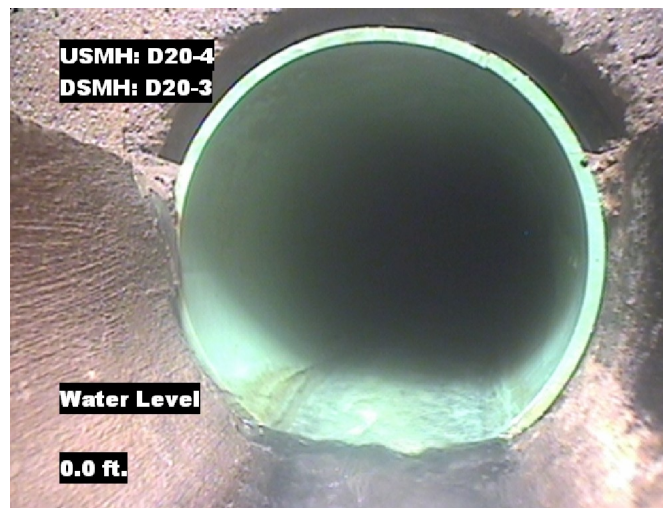
Distance: 0.0 ft. Grade: 0  
Condition: Water Level  
Remarks: N/A

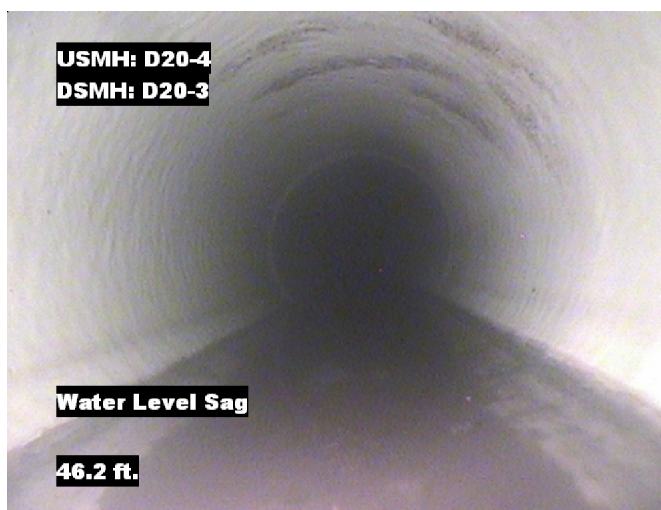
Distance: 46.2 ft. Grade: 2  
Condition: Water Level Sag  
Remarks: N/A

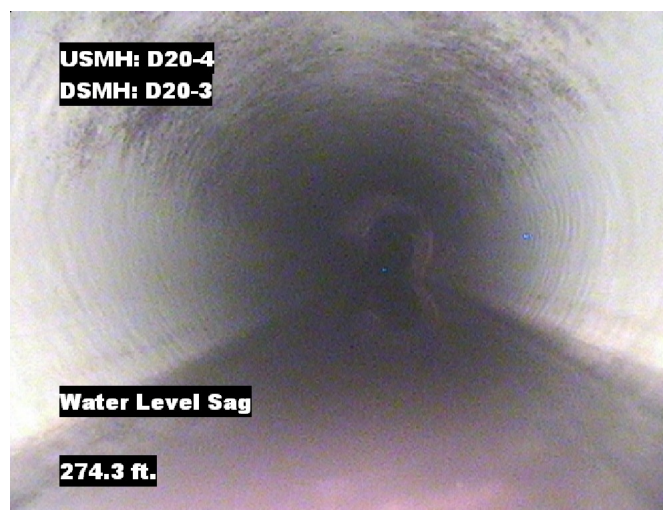
Distance: 274.3 ft. Grade: 2  
Condition: Water Level Sag  
Remarks: N/A

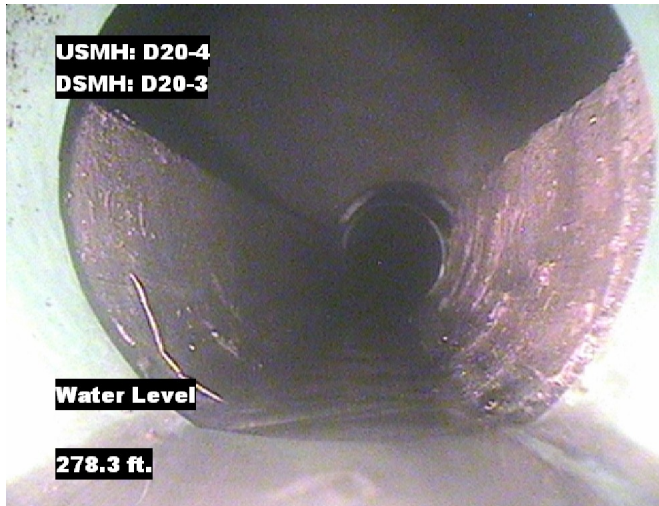
Distance: 278.3 ft.      Grade: 0  
Condition: Water Level  
Remarks: N/A
