## Defect Listing

Pipe Segment Refere... <b>D20-5_D20-4</b>	City <b>Oliver Springs</b>	Street <b>Airport rd</b>	Material <b>PolyVinyl Chloride</b>		Location C... <b>Yard</b>	Sewer Use <b>Sanitary</b>
Upstream MH <b>D20-5</b>	Total Length <b>312</b>	Year Laid	Shape <b>Circular</b>		Location Details <b>Side of RD</b>	
DS Manhole <b>D20-4</b>	Length surveyed <b>312</b>	Year Renewed	Height <b>8</b>	Width <b>8</b>	Pipe Joint... <b>13</b>

SPR <b>N/A</b>	MPR <b>2</b>	PO Number <b>4397-03</b>		Customer <b>GRW</b>	
SPRI <b>N/A</b>	MPRI <b>2</b>	Work Order <b>4397-02</b>		Purpose <b>Pre-Rehabilitation Survey</b>	
QSR <b>N/A</b>	QMR <b>2100</b>				
OPR <b>2</b>	Surveyed By <b>Barry Rogers</b>	Direction <b>Downstream</b>	Date <b>20150603</b>	Media label	
OPRI <b>2</b>	Certificate Number <b>U-1012-16405</b>	Pre-Cleaning <b>Jetting</b>	Time <b>07:59</b>	Weather <b>Dry</b>	
Date Cleaned <b>20150603</b>			End Time <b>08:22</b>	Additional Info

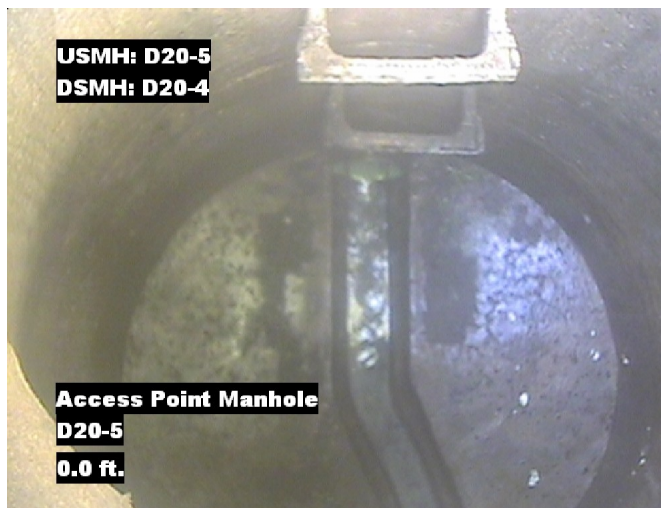
Distance: 0.0 ft. Grade: 0  
Condition: Access Point Manhole  
Remarks: D20-5

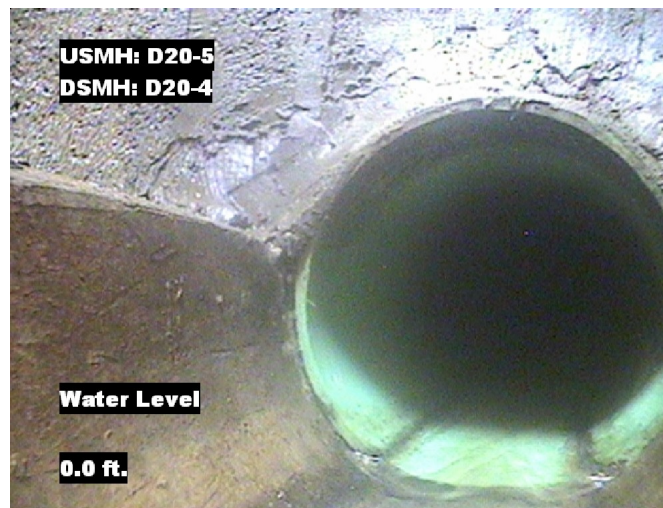
Distance: 0.0 ft. Grade: 0  
Condition: Water Level  
Remarks: N/A

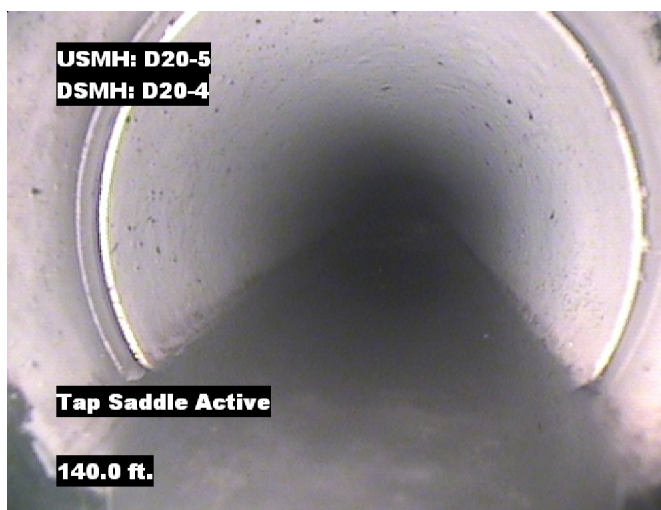
Distance: 140.0 ft. Grade: 0  
Condition: Tap Saddle Active  
Remarks: N/A

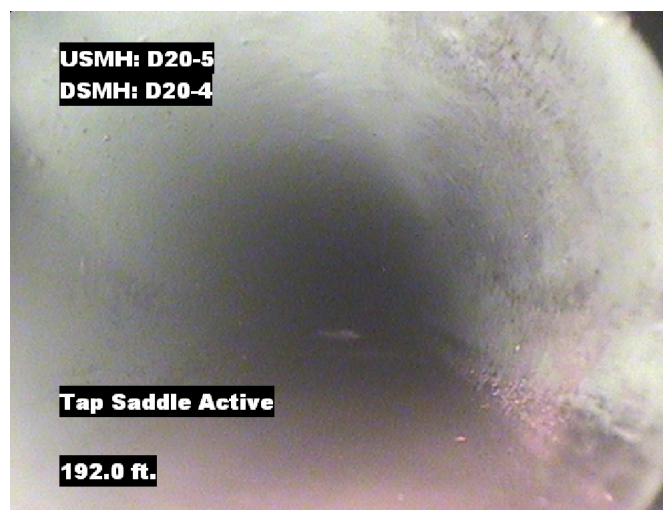
Distance: 192.0 ft. Grade: 0  
Condition: Tap Saddle Active  
Remarks: N/A

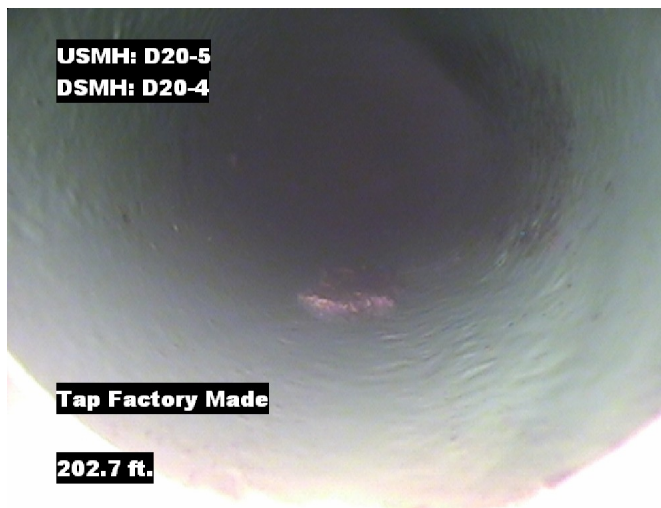
Distance: 202.7 ft. Grade: 0  
Condition: Tap Factory Made  
Remarks: N/A

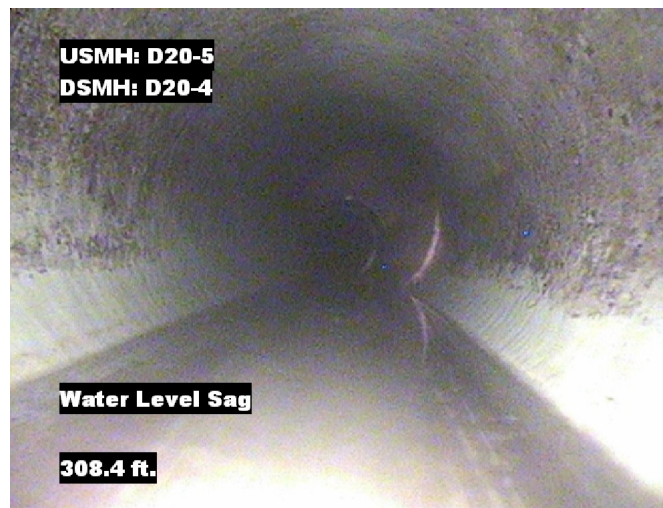
Distance: 308.4 ft. Grade: 2  
Condition: Water Level Sag  
Remarks: N/A

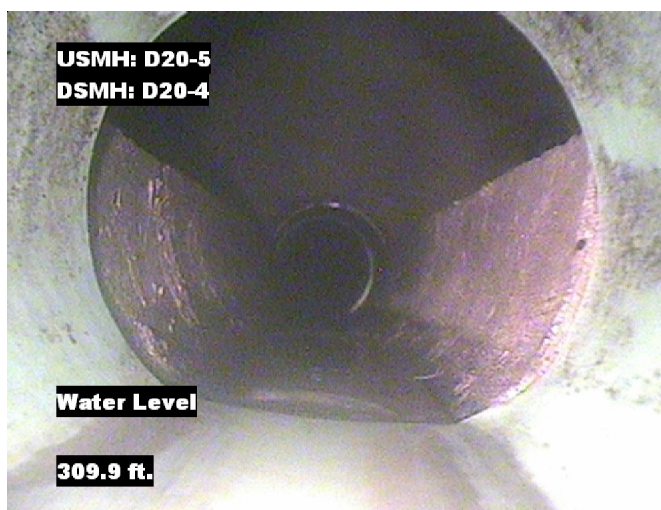
Distance: 309.9 ft. Grade: 0  
Condition: Water Level  
Remarks: N/A
