Defect Listing

Pipe Segment Refere... D20-6_D20-5	City Oliver Springs	Street Airport Rd	Material PolyVinyl Chloride		Location C... Yard	Sewer Use Sanitary
Upstream MH D20-6	Total Length 106.1	Year Laid	Shape Circular		Location Details Side of Rd	
DS Manhole D20-5	Length surveyed 106.1	Year Renewed	Height 8	Width 8	Pipe Joint... 13

SPR N/A	MPR N/A	PO Number 4397-03		Customer GRW	
SPRI N/A	MPRI N/A	Work Order 4397-02		Purpose Pre-Rehabilitation Survey	
QSR N/A	QMR N/A				
OPR N/A	Surveyed By Barry Rogers	Direction Downstream	Date 20150602	Media label	
OPRI N/A	Certificate Number U-1012-16405	Pre-Cleaning Jetting	Time 12:20	Weather Damp	
Date Cleaned 20150602			End Time 12:31	Additional Info

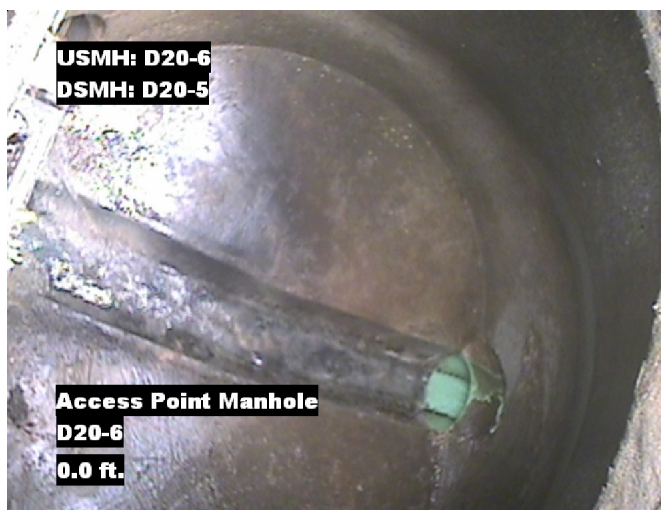
Distance: 0.0 ft. Grade: 0
Condition: Access Point Manhole
Remarks: D20-6

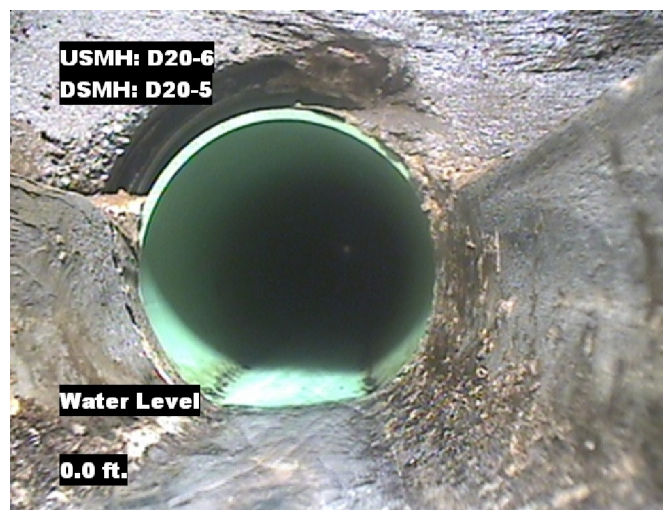
Distance: 0.0 ft. Grade: 0
Condition: Water Level
Remarks: N/A

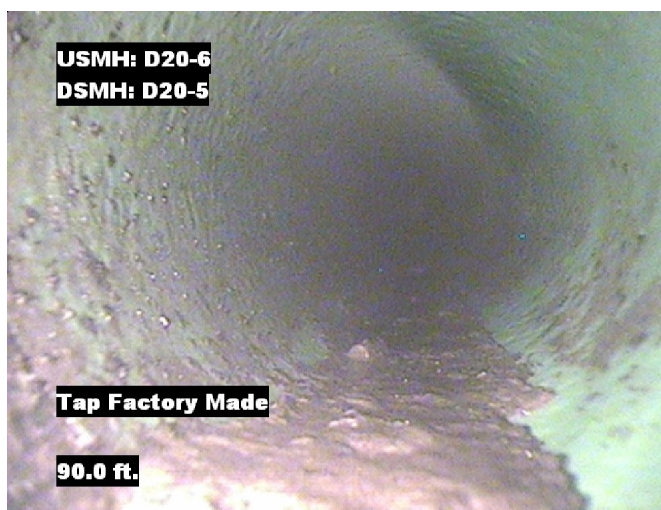
Distance: 90.0 ft. Grade: 0
Condition: Tap Factory Made
Remarks: N/A

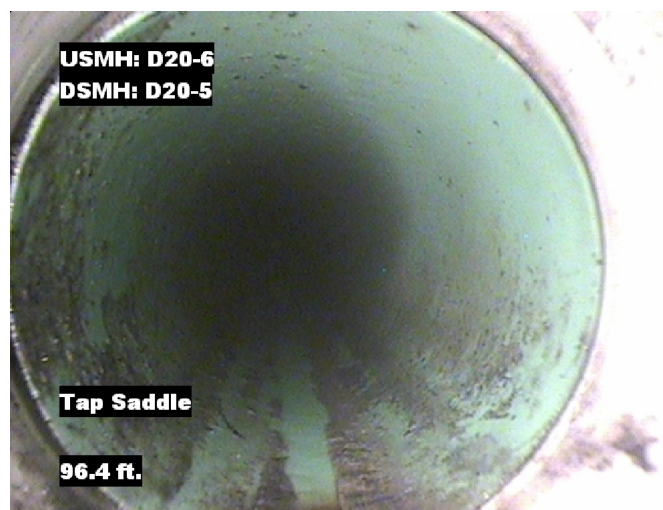
Distance: 96.4 ft. Grade: 0
Condition: Tap Saddle
Remarks: N/A

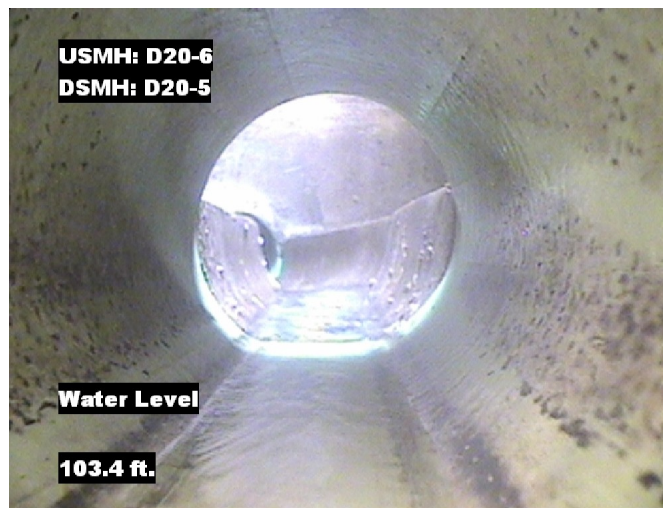
Distance: 103.4 ft. Grade: 0
Condition: Water Level
Remarks: N/A

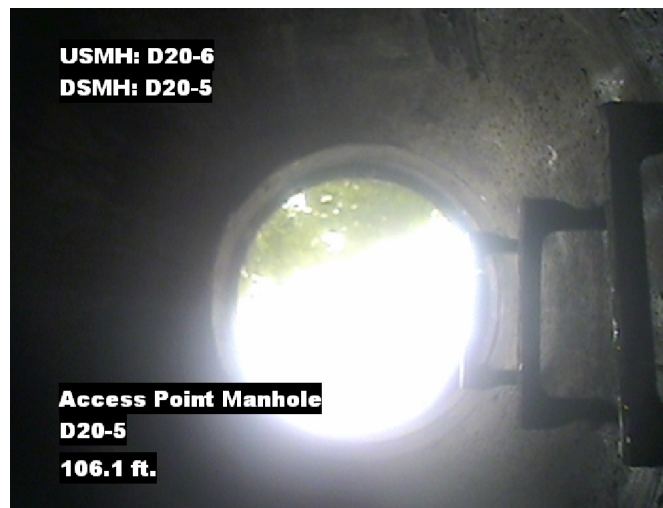
Distance: 106.1 ft. Grade: 0
Condition: Access Point Manhole
Remarks: D20-5
