Defect Listing

Pipe Segment Refere... D20-7_D20-6	City Oliver Springs	Street Airport rd	Material PolyVinyl Chloride		Location C... Yard	Sewer Use Sanitary
Upstream MH D20-7	Total Length 354.1	Year Laid	Shape Circular		Location Details Side of Rd	
DS Manhole D20-6	Length surveyed 354.1	Year Renewed	Height 8	Width 8	Pipe Joint... 13

SPR N/A	MPR N/A	PO Number 4397-03		Customer GRW	
SPRI N/A	MPRI N/A	Work Order 4397-02		Purpose Pre-Rehabilitation Survey	
QSR N/A	QMR N/A				
OPR N/A	Surveyed By Barry Rogers	Direction Downstream	Date 20150602	Media label	
OPRI N/A	Certificate Number U-1012-16405	Pre-Cleaning Jetting	Time 09:39	Weather Damp	
Date Cleaned 20150602			End Time 10:01	Additional Info

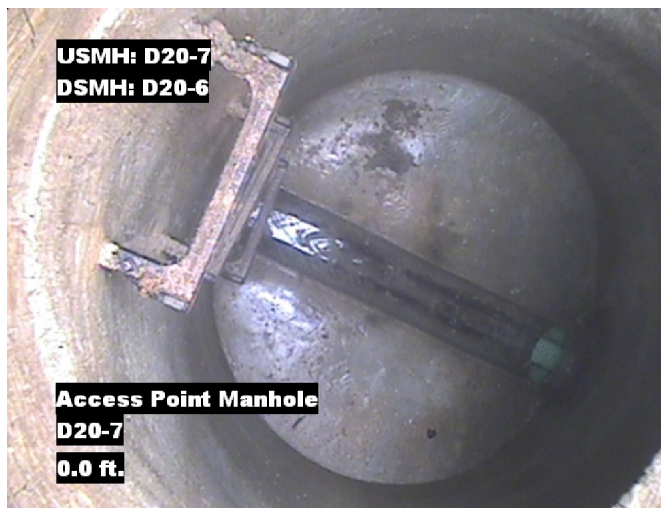
Distance: 0.0 ft. Grade: 0
Condition: Access Point Manhole
Remarks: D20-7

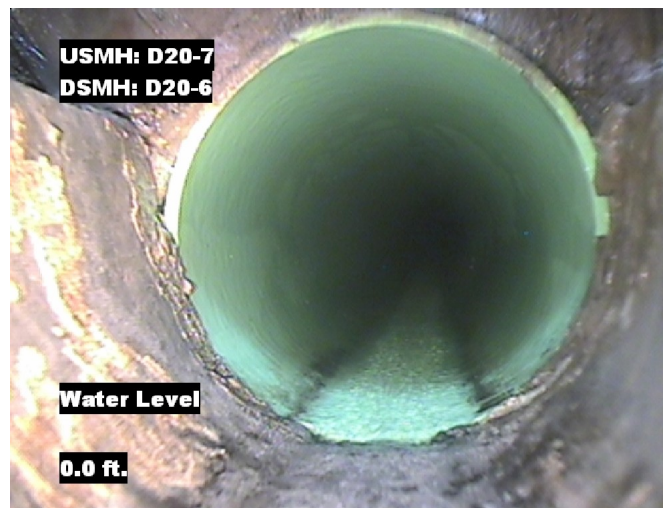
Distance: 0.0 ft. Grade: 0
Condition: Water Level
Remarks: N/A

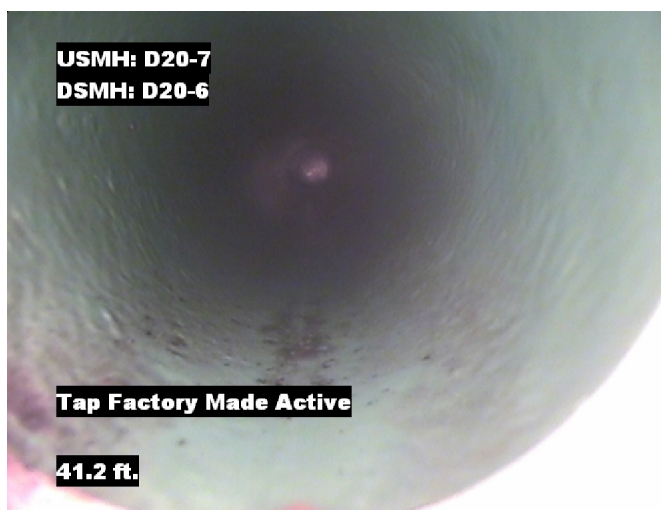
Distance: 41.2 ft. Grade: 0
Condition: Tap Factory Made Active
Remarks: N/A

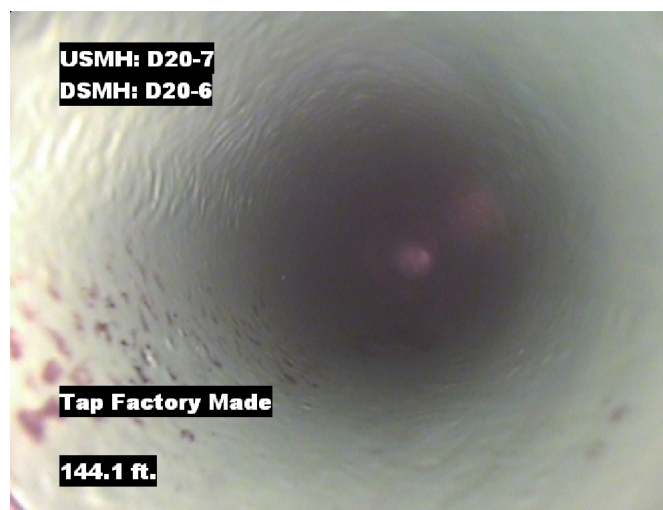
Distance: 144.1 ft. Grade: 0
Condition: Tap Factory Made
Remarks: N/A

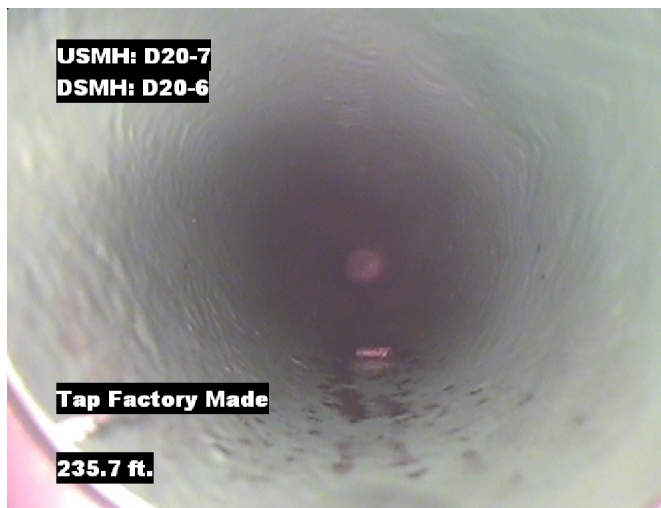
Distance: 235.7 ft. Grade: 0
Condition: Tap Factory Made
Remarks: N/A

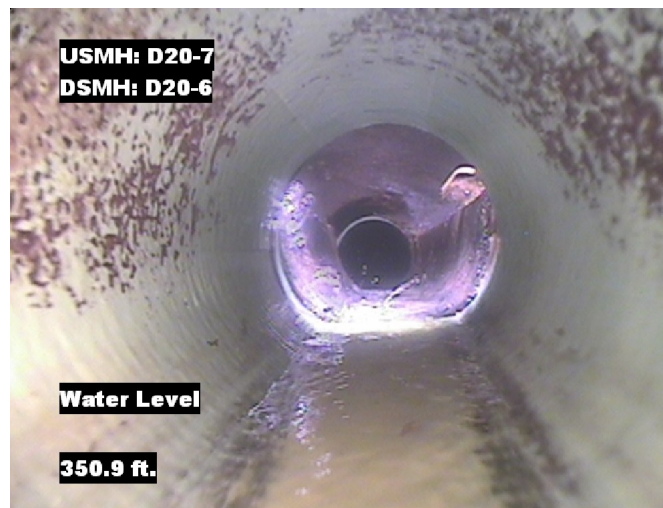
Distance: 350.9 ft. Grade: 0
Condition: Water Level
Remarks: N/A

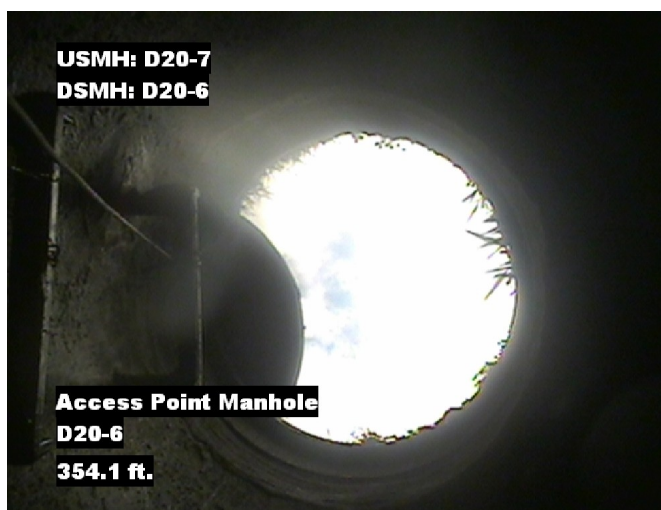
Distance: 354.1 ft. Grade: 0
Condition: Access Point Manhole
Remarks: D20-6
