## Defect Listing

Pipe Segment Refere... <b>D20-8_D20-7</b>	City <b>Oliver Springs</b>	Street <b>Airport Rd</b>	Material <b>PolyVinyl Chloride</b>	Location C... <b>Easement/R...</b>	Sewer Use <b>Sanitary</b>
Upstream MH <b>D20-8</b>	Total Length <b>136</b>	Year Laid	Shape <b>Circular</b>	Location Details <b>Side of Rd</b>	
DS Manhole <b>D20-7</b>	Length surveyed <b>136</b>	Year Renewed	Height <b>6</b>	Width <b>6</b>	Pipe Joint... <b>13</b>

SPR <b>N/A</b>	MPR <b>3</b>	PO Number <b>4397-03</b>		Customer <b>GRW</b>	
SPRI <b>N/A</b>	MPRI <b>3</b>	Work Order <b>4397-02</b>		Purpose <b>Pre-Rehabilitation Survey</b>	
QSR <b>N/A</b>	QMR <b>3100</b>				
OPR <b>3</b>	Surveyed By <b>Barry Rogers</b>	Direction <b>Downstream</b>	Date <b>20150602</b>	Media label	
OPRI <b>3</b>	Certificate Number <b>U-1012-16405</b>	Pre-Cleaning <b>Jetting</b>	Time <b>07:28</b>	Weather <b>Damp</b>	
Date Cleaned <b>20150601</b>			End Time <b>07:47</b>	Additional Info

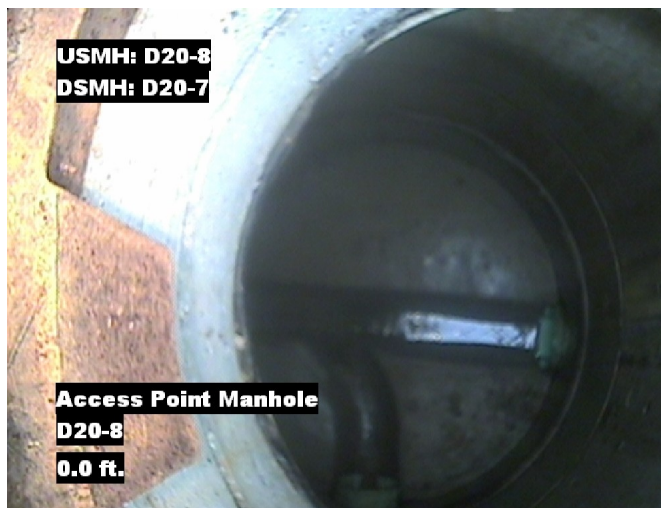
Distance: 0.0 ft. Grade: 0  
Condition: Access Point Manhole  
Remarks: D20-8

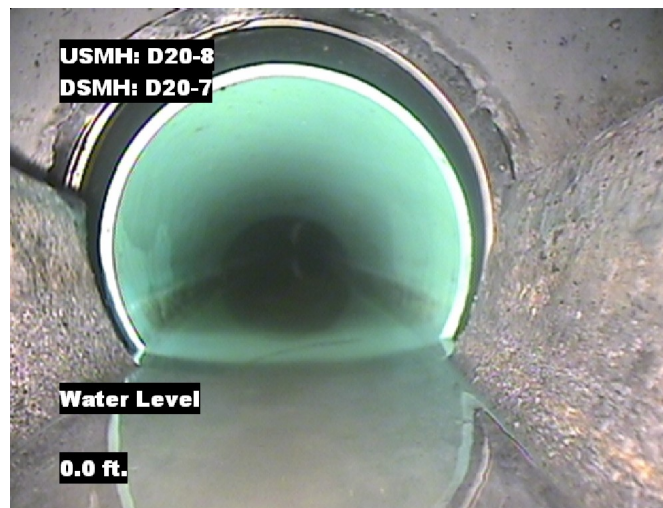
Distance: 0.0 ft. Grade: 0  
Condition: Water Level  
Remarks: N/A

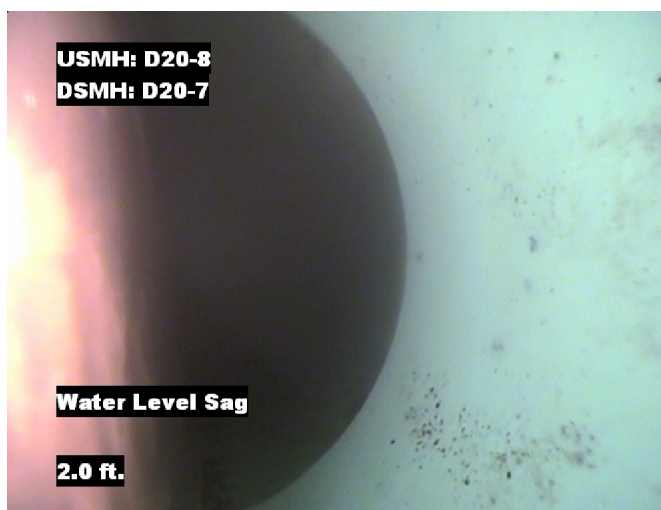
Distance: 2.0 ft. Grade: 3  
Condition: Water Level Sag  
Remarks: N/A

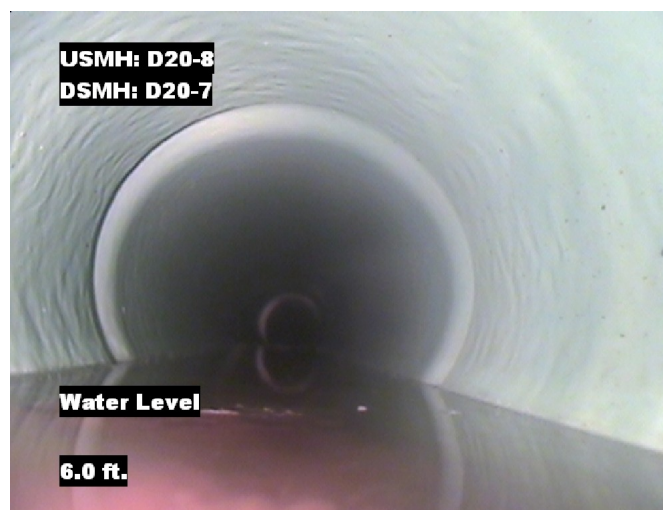
Distance: 6.0 ft. Grade: 0  
Condition: Water Level  
Remarks: N/A

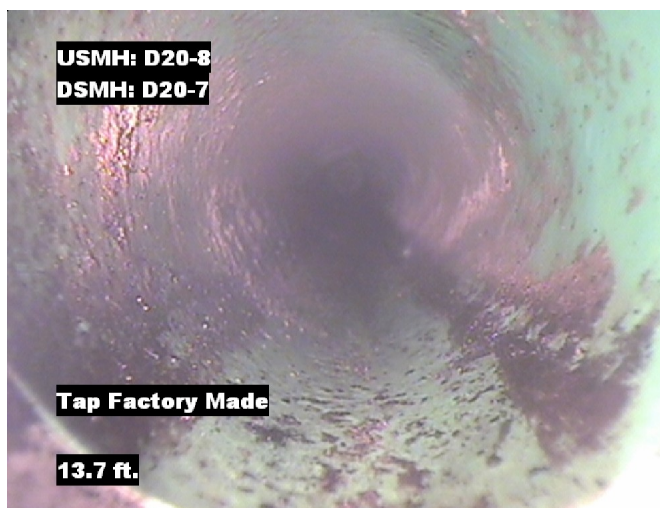
Distance: 13.7 ft. Grade: 0  
Condition: Tap Factory Made  
Remarks: N/A

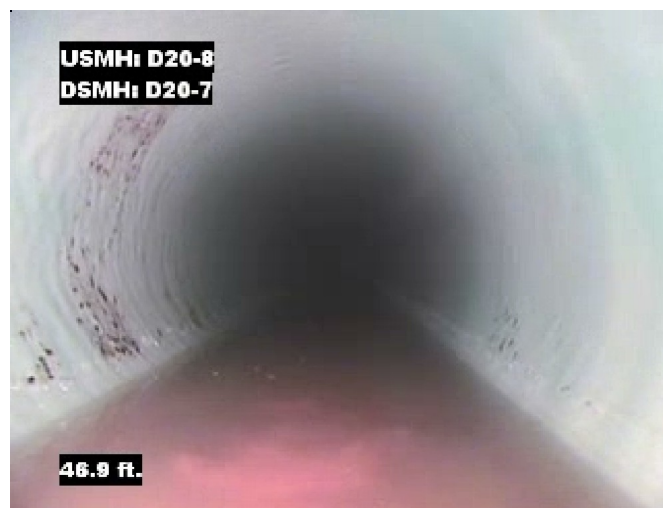
Distance: 46.9 ft. Grade: 0  
Condition: Water Level  
Remarks: N/A

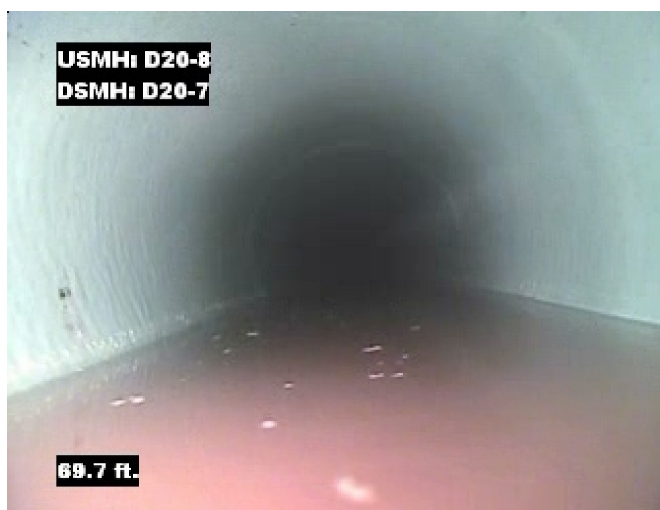
Distance: 69.7 ft. Grade: 0  
Condition: Water Level  
Remarks: N/A

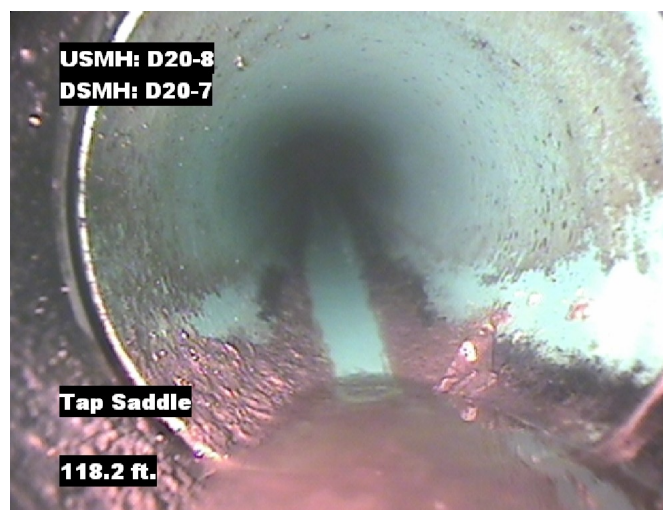
Distance: 118.2 ft. Grade: 0  
Condition: Tap Saddle  
Remarks: N/A

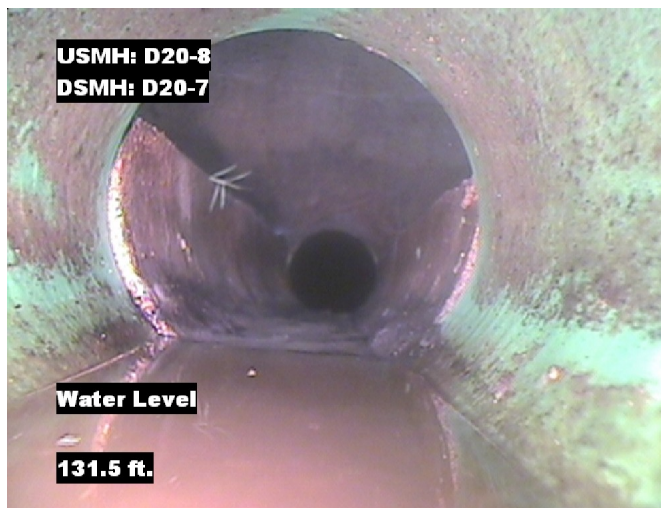
Distance: 131.5 ft.      Grade: 0  
Condition: Water Level  
Remarks: N/A

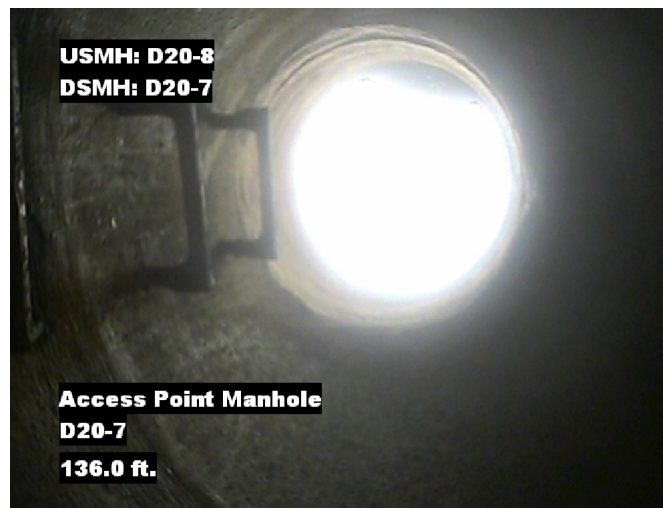
Distance: 136.0 ft.      Grade: 0  
Condition: Access Point Manhole  
Remarks: D20-7
