Defect Listing

Pipe Segment Refere... D20-9_D20-8	City Oliver Springs	Street Airport rd	Material PolyVinyl Chloride	Location C... Easement/R...	Sewer Use Sanitary
Upstream MH D20-9	Total Length 182	Year Laid	Shape Circular	Location Details Side of Rd	
DS Manhole D20-8	Length surveyed 182	Year Renewed	Height 8	Width 8	Pipe Joint... 13

SPR 1	MPR 6	PO Number 4397-03	Customer GRW
SPRI 1	MPRI 2	Work Order 4397-02	Purpose Pre-Rehabilitation Survey
QSR 1100	QMR 2300		
OPR 7	Surveyed By Barry Rogers	Direction Downstream	Date 20150601
OPRI 1.8	Certificate Number U-1012-16405	Pre-Cleaning Jetting	Time 14:03
	Date Cleaned 20150601	End Time 14:25	Weather Dry
			Additional Info

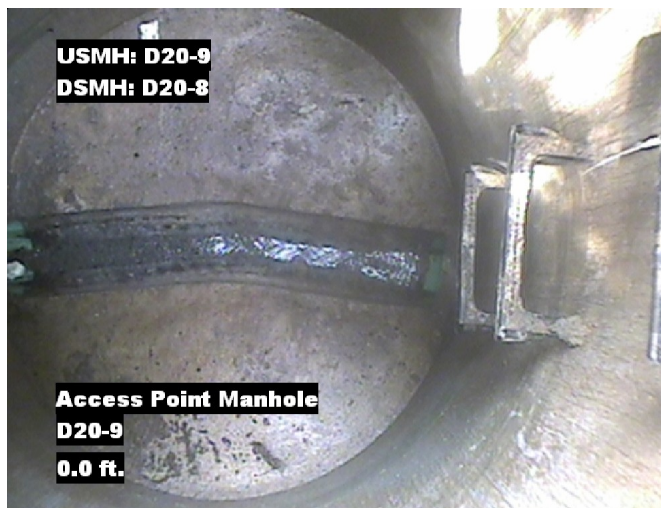
Distance: 0.0 ft. Grade: 0
Condition: Access Point Manhole
Remarks: D20-9

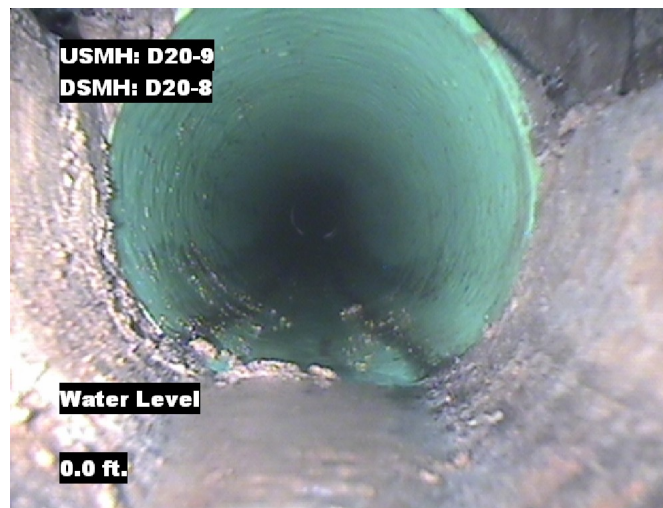
Distance: 0.0 ft. Grade: 0
Condition: Water Level
Remarks: N/A

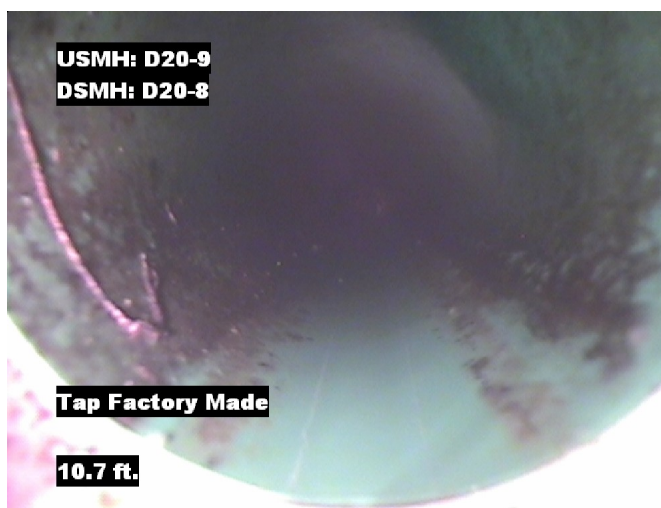
Distance: 10.7 ft. Grade: 0
Condition: Tap Factory Made
Remarks: N/A

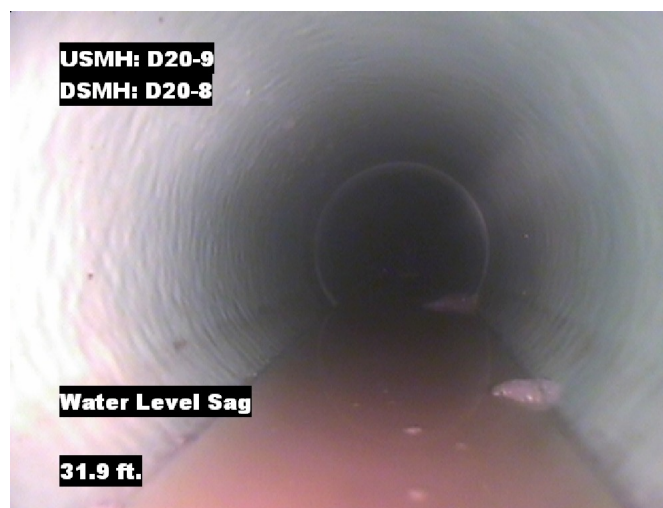
Distance: 31.9 ft. Grade: 2
Condition: Water Level Sag
Remarks: N/A

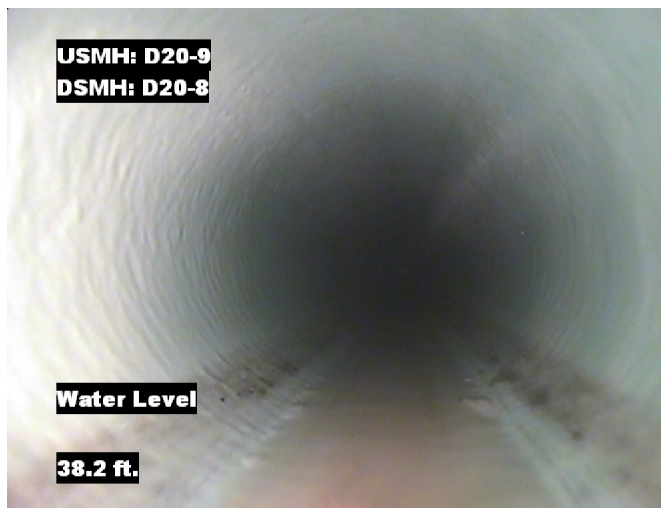
Distance: 38.2 ft. Grade: 0
Condition: Water Level
Remarks: N/A

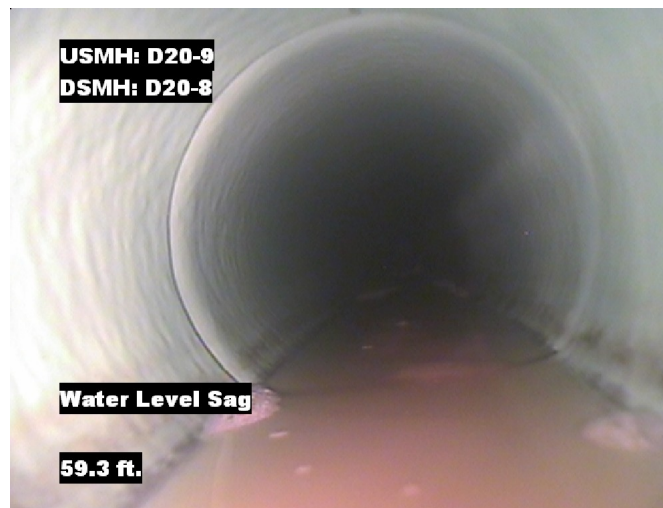
Distance: 59.3 ft. Grade: 2
Condition: Water Level Sag
Remarks: N/A

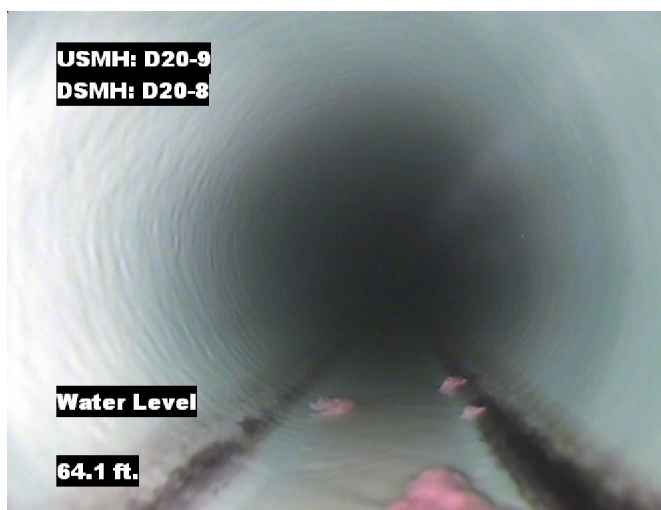
Distance: 64.1 ft. Grade: 0
Condition: Water Level
Remarks: N/A

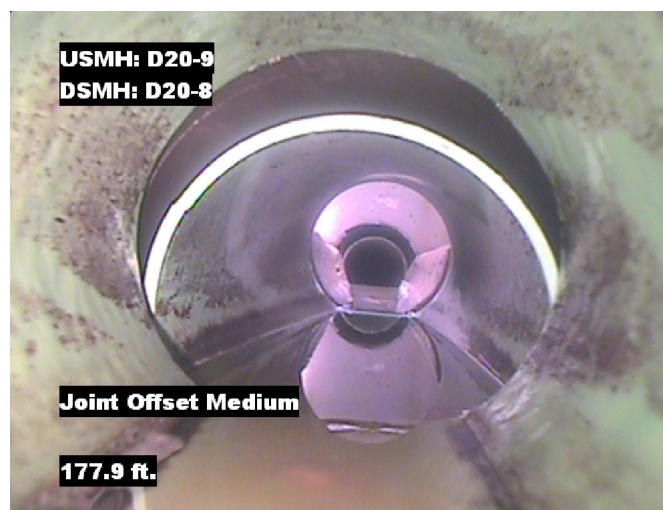
Distance: 177.9 ft. Grade: 1
Condition: Joint Offset Medium
Remarks: N/A

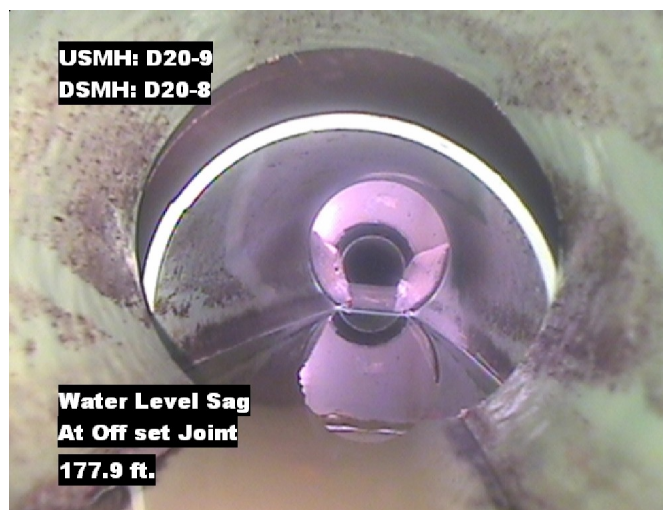
Distance: 177.9 ft. Grade: 2
Condition: Water Level Sag
Remarks: At Off set Joint

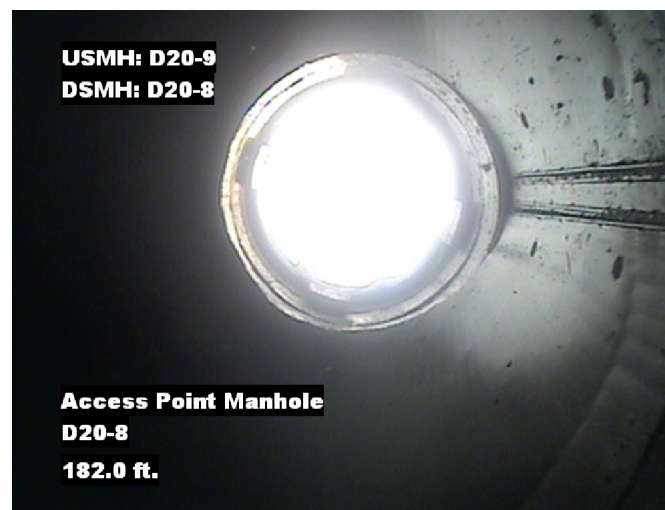
Distance: 182.0 ft. Grade: 0
Condition: Access Point Manhole
Remarks: D20-8
