Defect Listing

Pipe Segment Refere... D21-2_D23-1	City Oliver Springs	Street Duncan DR	Material Concrete Pipe (non-...	Location C... Light High...	Sewer Use Sanitary
Upstream MH D21-2	Total Length 233.5	Year Laid	Shape Circular	Location Details	
DS Manhole D23-1	Length surveyed 233.5	Year Renewed	Height 6	Width 6	Pipe Joint... 4

SPR 6	MPR 5	PO Number 4397-03	Customer GRW
SPRI 3	MPRI 2.5	Work Order 4397-02	Purpose Pre-Rehabilitation Survey
QSR 3200	QMR 3121		
OPR 11	Surveyed By Barry Rogers	Direction Upstream	Date 20150625
OPRI 2.8	Certificate Number U-1012-16405	Pre-Cleaning Jetting	Time 10:05
	Date Cleaned 20150625	End Time 10:09	Weather Dry
		Additional Info

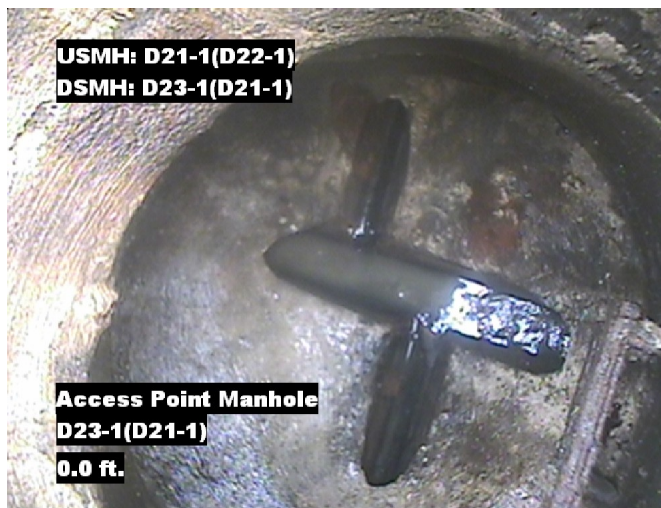
Distance: 0.0 ft. Grade: 0
Condition: Access Point Manhole
Remarks: D21-2

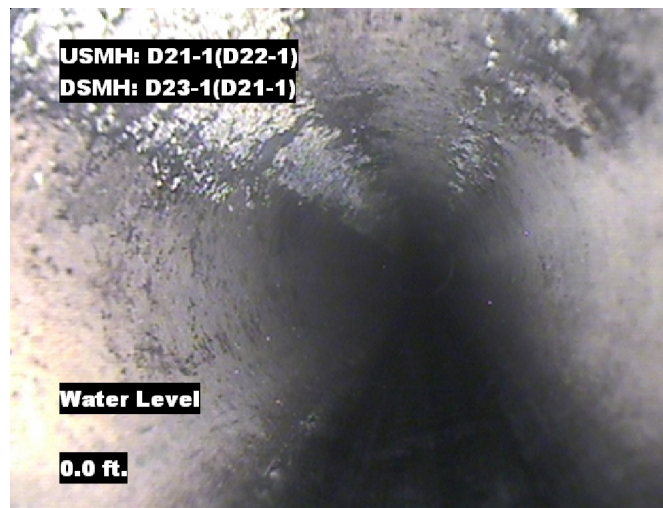
Distance: 0.0 ft. Grade: 0
Condition: Water Level
Remarks: N/A

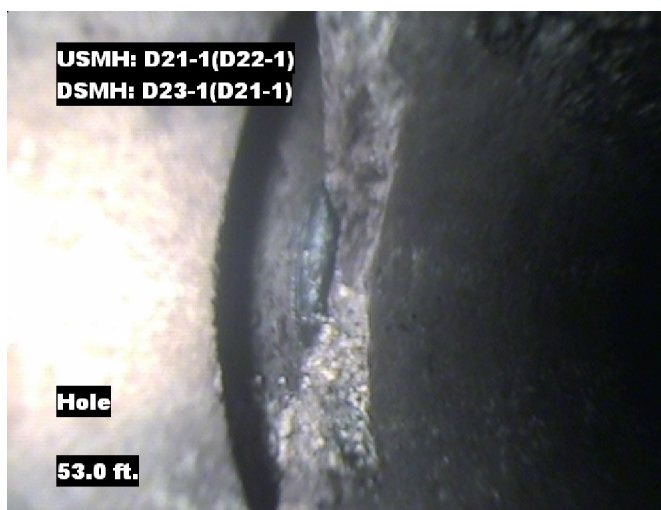
Distance: 53.0 ft. Grade: 3
Condition: Hole
Remarks: N/A

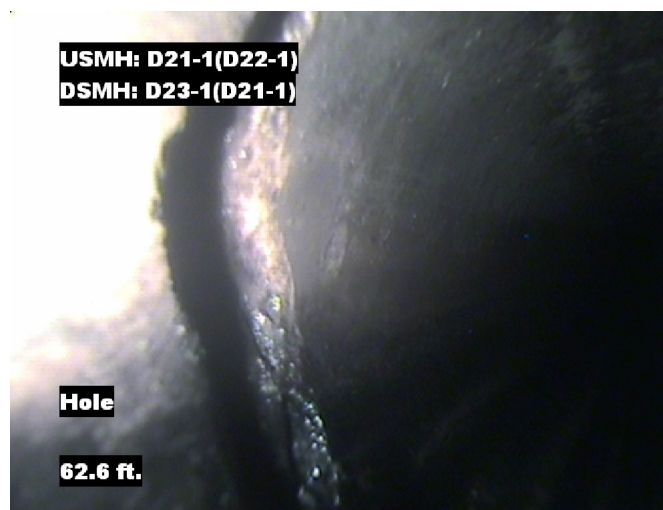
Distance: 62.6 ft. Grade: 3
Condition: Hole
Remarks: N/A

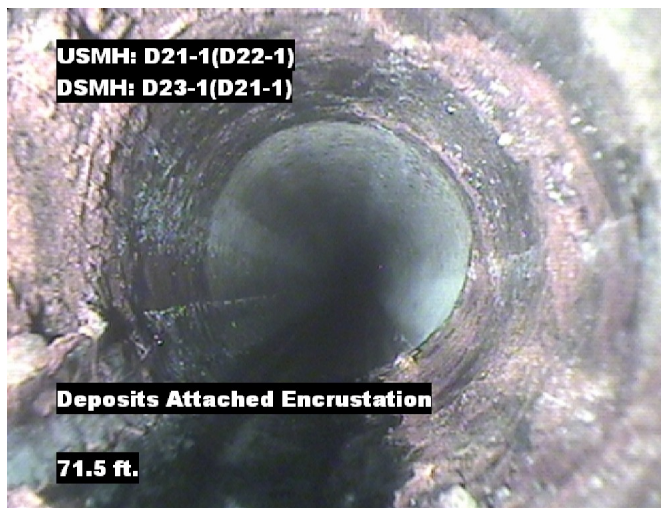
Distance: 71.5 ft. Grade: 3
Condition: Deposits Attached Encrustation
Remarks: N/A

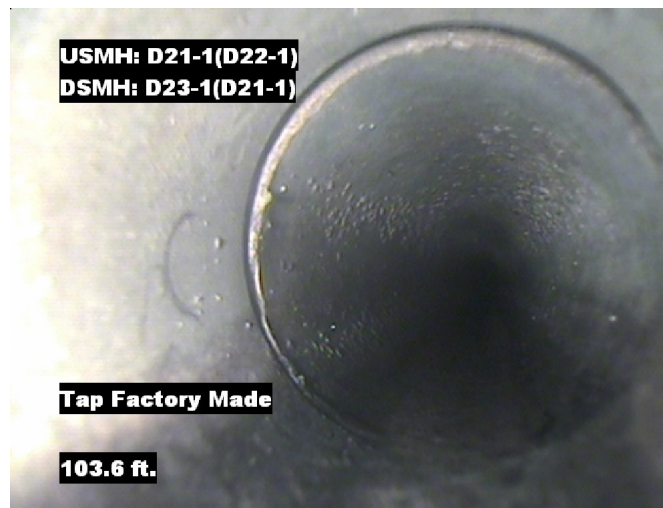
Distance: 103.6 ft. Grade: 0
Condition: Tap Factory Made
Remarks: N/A

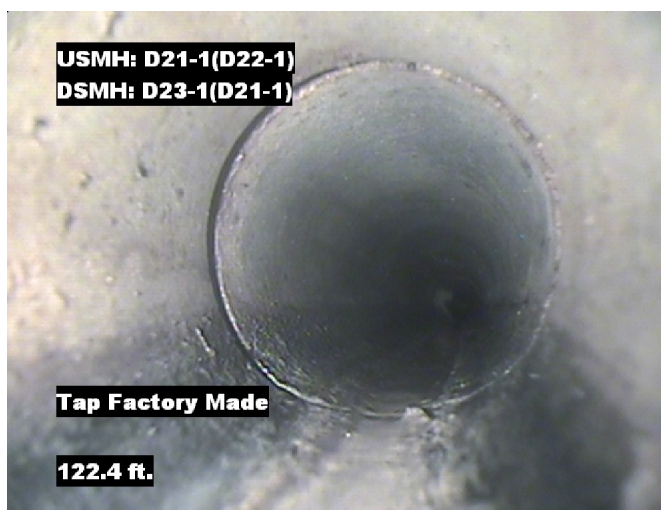
Distance: 122.4 ft. Grade: 0
Condition: Tap Factory Made
Remarks: N/A

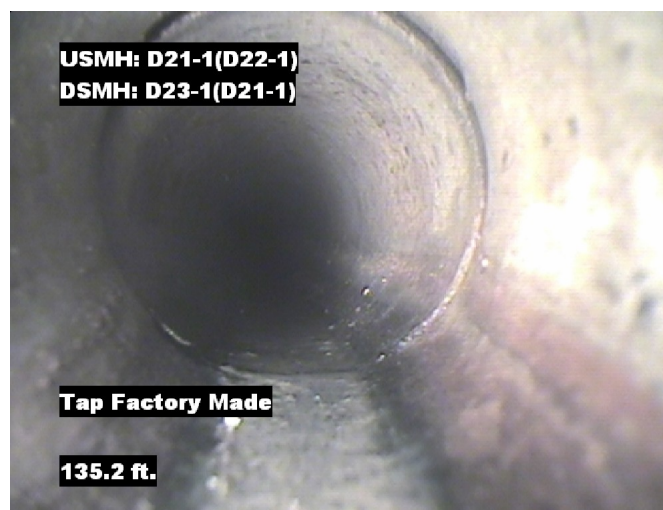
Distance: 135.2 ft. Grade: 0
Condition: Tap Factory Made
Remarks: N/A

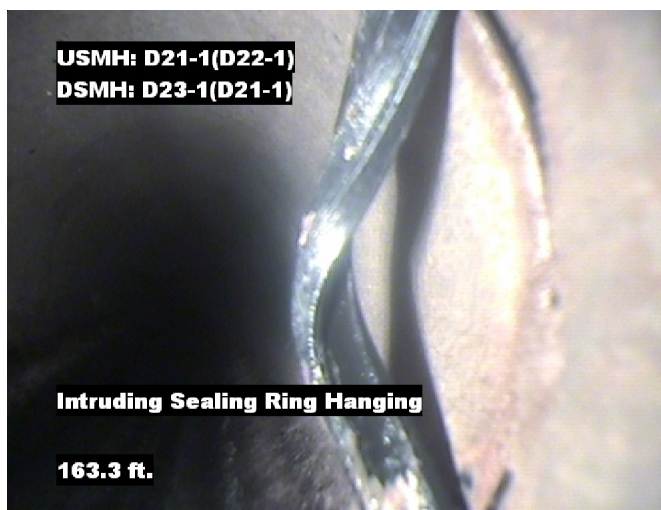
Distance: 163.3 ft. Grade: 2
Condition: Intruding Sealing Ring Hanging
Remarks: N/A

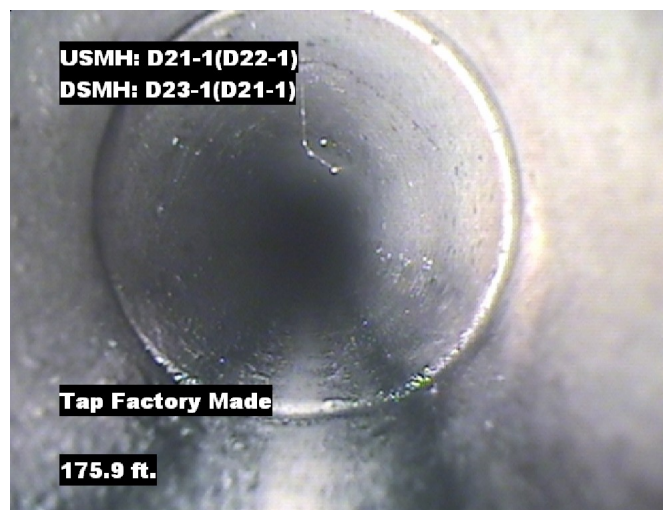
Distance: 175.9 ft. Grade: 0
Condition: Tap Factory Made
Remarks: N/A

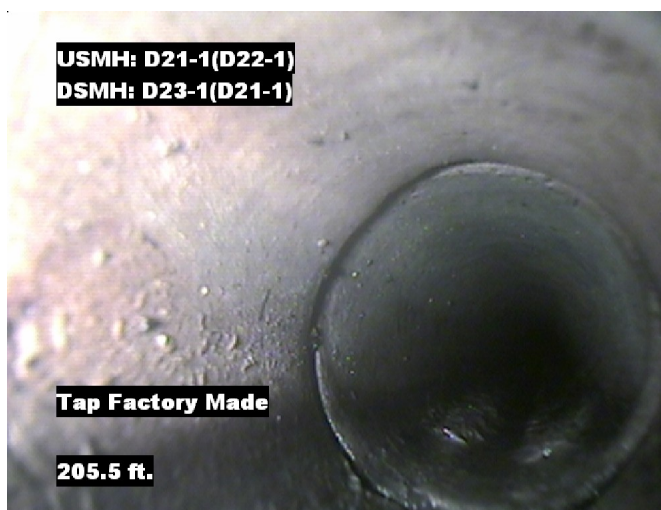
Distance: 205.5 ft. Grade: 0
Condition: Tap Factory Made
Remarks: N/A

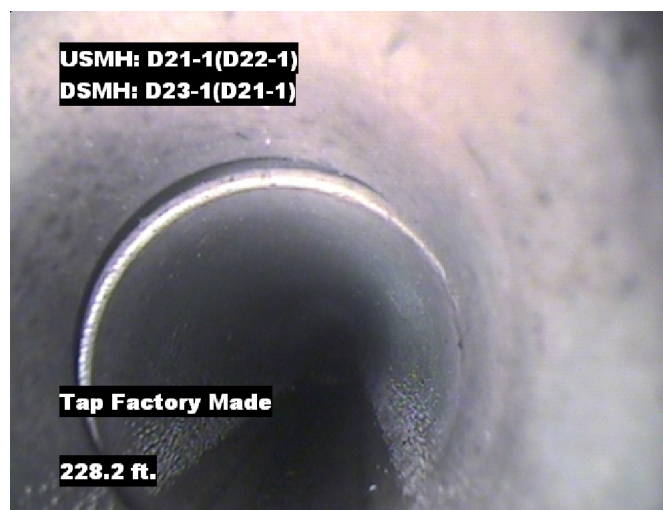
Distance: 228.2 ft. Grade: 0
Condition: Tap Factory Made
Remarks: N/A

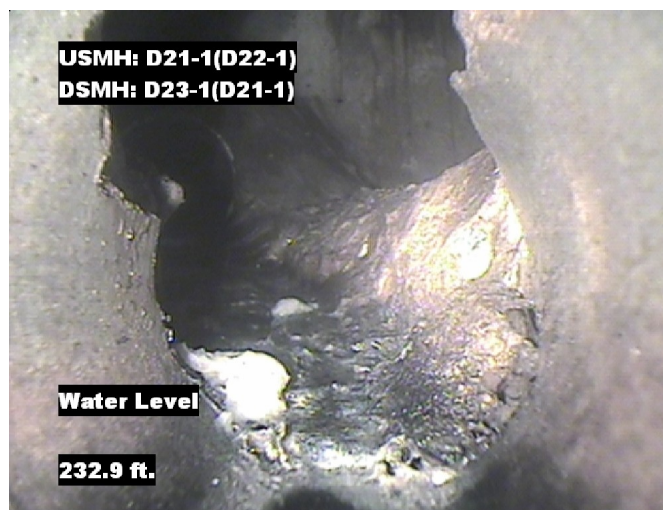
Distance: 232.9 ft. Grade: 0
Condition: Water Level
Remarks: N/A

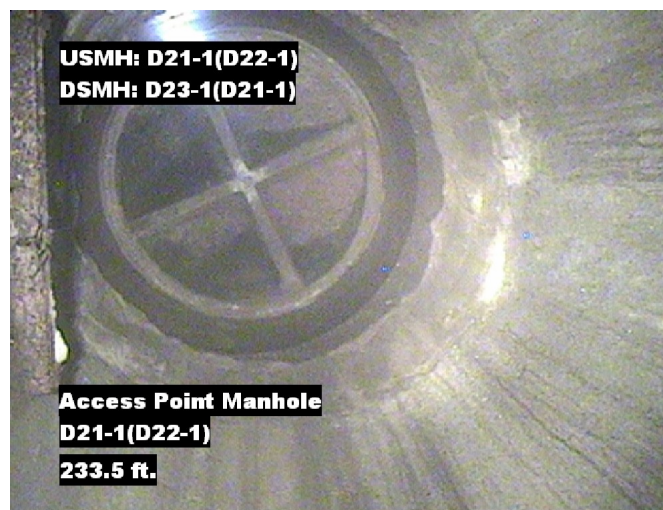
Distance: 233.5 ft. Grade: 0
Condition: Access Point Manhole
Remarks: D23-1
