Defect Listing

Image Report 4/Page

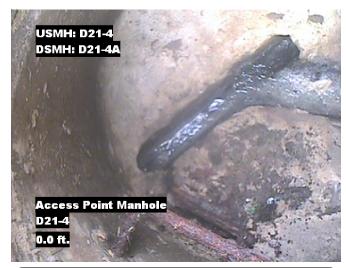
Distance: 0.0 ft. Grade: 0

Condition: Access Point Manhole

Remarks: D21-4

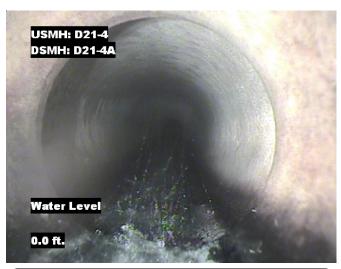
Distance: 0.0 ft. Grade: 0

Condition: Water Level

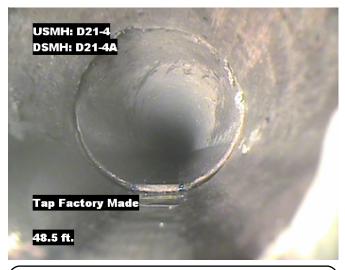
Distance: 48.5 ft. Grade: 0

Condition: Tap Factory Made

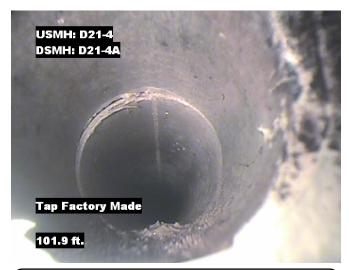
Distance: 101.9 ft. Grade: 0

Condition: Tap Factory Made

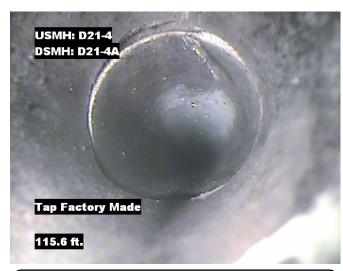
Distance: 115.6 ft. Grade: (

Condition: Tap Factory Made

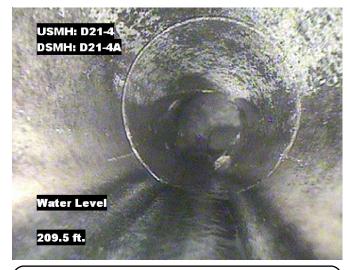
Distance: 209.5 ft. Grade: 0

Condition: Water Level

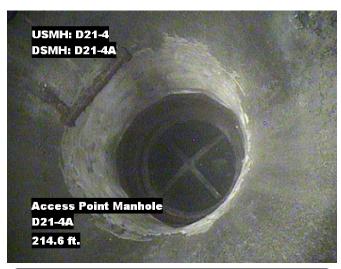
Distance: 214.6 ft. Grade: 0

Condition: Access Point Manhole

Remarks: D21-4A
