## Defect Listing

Pipe Segment Refere... <b>D21-4A_D23-1</b>	City <b>Oliver Springs</b>	Street <b>Duncan DR</b>	Material <b>Concrete Pipe (non-...</b>	Location C... <b>Light High...</b>	Sewer Use <b>Sanitary</b>
Upstream MH <b>D21-4a</b>	Total Length <b>117.3</b>	Year Laid	Shape <b>Circular</b>	Location Details	
DS Manhole <b>D23-1</b>	Length surveyed <b>117.3</b>	Year Renewed	Height <b>6</b>	Width <b>6</b>	Pipe Joint... <b>4</b>

## Image Report 4/Page

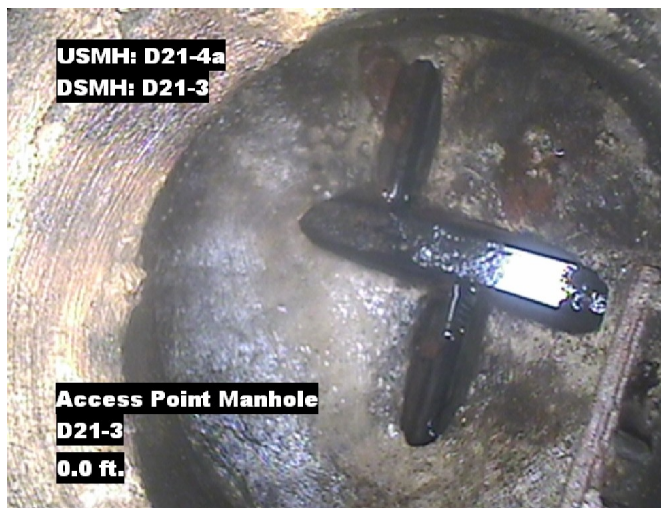
Distance: 0.0 ft. Grade: 0  
Condition: Access Point Manhole  
Remarks: D21-3

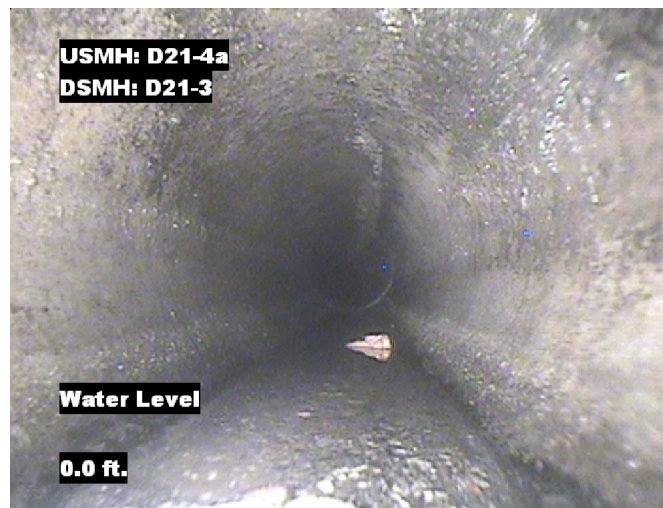
Distance: 0.0 ft. Grade: 0  
Condition: Water Level  
Remarks: N/A

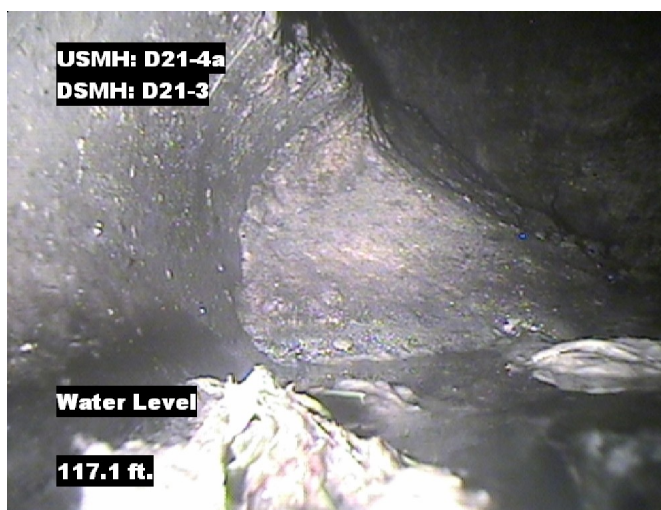
Distance: 117.1 ft. Grade: 0  
Condition: Water Level  
Remarks: N/A

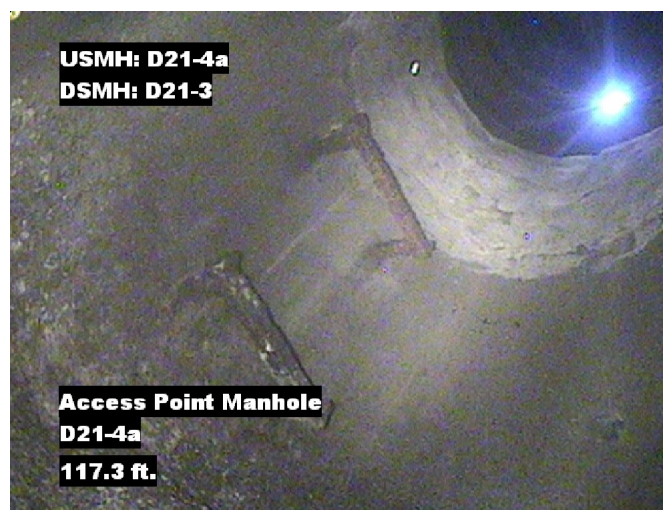
Distance: 117.3 ft. Grade: 0  
Condition: Access Point Manhole  
Remarks: D21-4a
