## Defect Listing

Pipe Segment Refere... <b>D21-5_D21-4</b>	City <b>Oliver Springs</b>	Street <b>Duncan DR</b>	Material <b>Concrete Pipe (non-...</b>	Location C... <b>Light High...</b>	Sewer Use <b>Sanitary</b>
Upstream MH <b>D21-5</b>	Total Length <b>22</b>	Year Laid	Shape <b>Circular</b>	Location Details	
DS Manhole <b>D21-4</b>	Length surveyed <b>22</b>	Year Renewed	Height <b>6</b>	Width <b>6</b>	Pipe Joint... <b>4</b>

## Image Report 4/Page

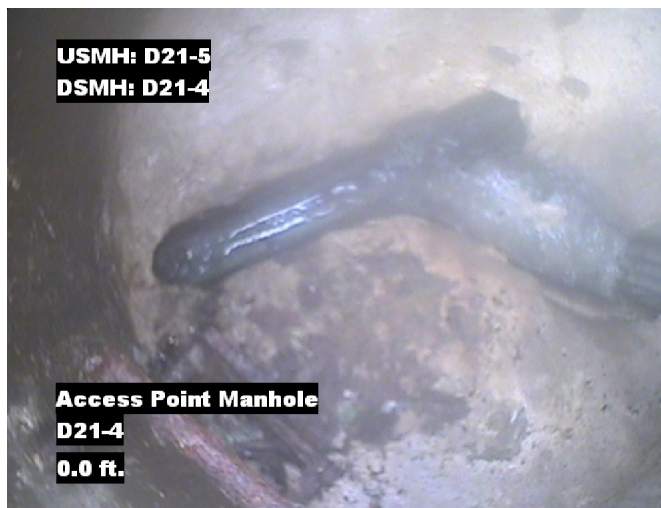
Distance: 0.0 ft. Grade: 0  
Condition: Access Point Manhole  
Remarks: D21-4

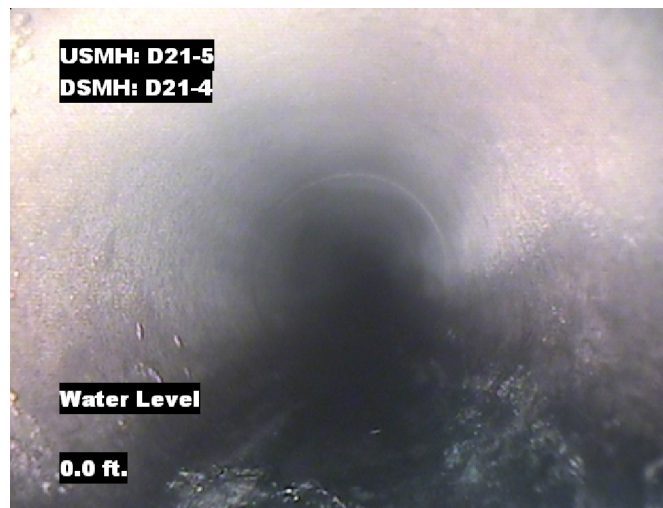
Distance: 0.0 ft. Grade: 0  
Condition: Water Level  
Remarks: N/A

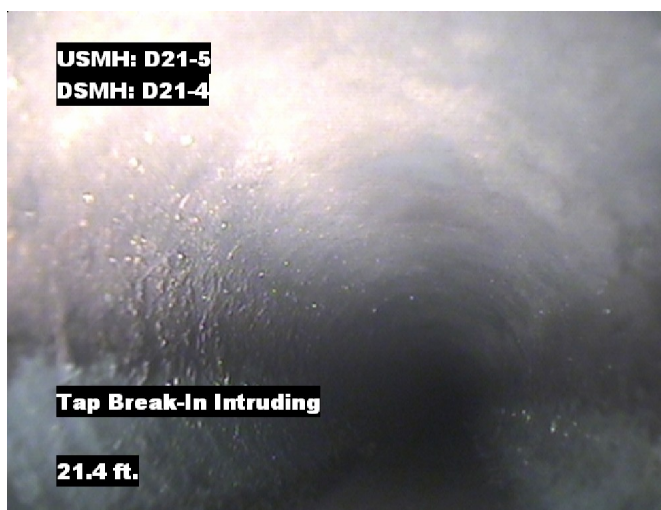
Distance: 21.4 ft. Grade: 2  
Condition: Tap Break-In Intruding  
Remarks: N/A

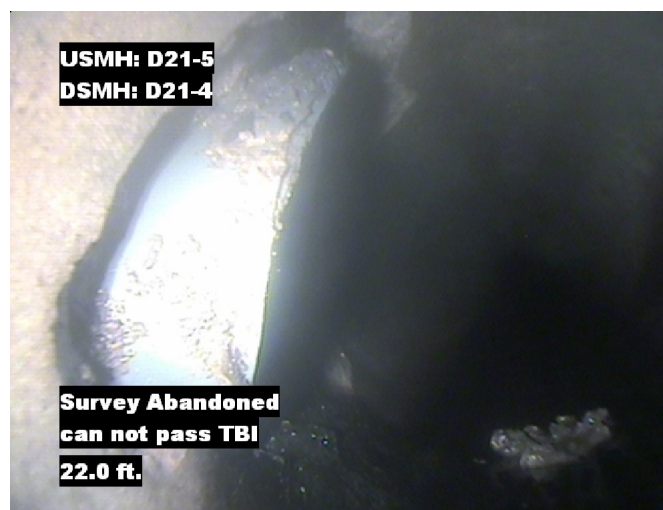
Distance: 22.0 ft. Grade: 0  
Condition: Survey Abandoned  
Remarks: can not pass TBI
