## Defect Listing

Pipe Segment Refere... <b>D21-5A_D21-5B</b>	City <b>Oliver Springs</b>	Street <b>Kries Circle</b>	Material <b>Concrete Pipe (non-...</b>	Location C... <b>Light High...</b>	Sewer Use <b>Sanitary</b>
Upstream MH <b>D21-5A</b>	Total Length <b>N/A</b>	Year Laid	Shape <b>Circular</b>	Location Details <b>105 Kries Cir</b>	
DS Manhole <b>D21-5B</b>	Length surveyed <b>N/A</b>	Year Renewed	Height <b>6</b>	Width <b>6</b>	Pipe Joint... <b>4</b>

SPR <b>N/A</b>	MPR <b>N/A</b>	PO Number <b>4397-03</b>		Customer <b>GRW</b>	
SPRI <b>N/A</b>	MPRI <b>N/A</b>	Work Order <b>4397-02</b>		Purpose <b>Pre-Rehabilitation Survey</b>	
QSR <b>N/A</b>	QMR <b>N/A</b>				
OPR <b>N/A</b>	Surveyed By <b>Barry Rogers</b>	Direction <b>Downstream</b>	Date <b>20150624</b>	Media label	
OPRI <b>N/A</b>	Certificate Number <b>U-1012-16405</b>	Pre-Cleaning <b>No Pre-Cleaning</b>	Time <b>08:42</b>	Weather <b>Dry</b>	
Date Cleaned			End Time <b>08:43</b>	Additional Info <b>Cannot access inver...</b>

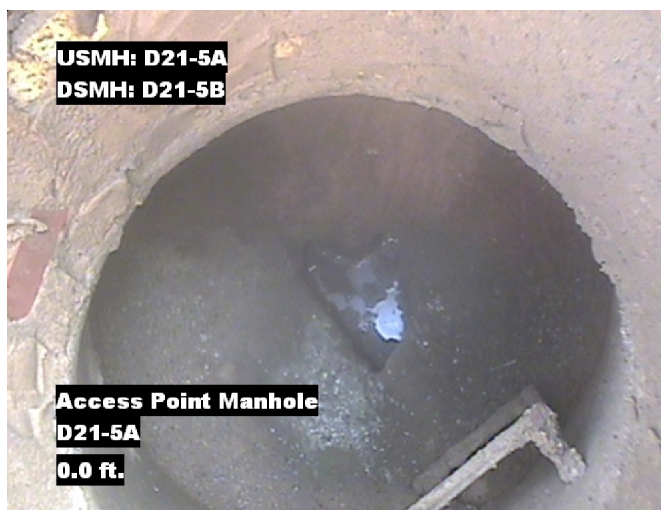
Distance: 0.0 ft. Grade: 0  
Condition: Access Point Manhole  
Remarks: D21-5A

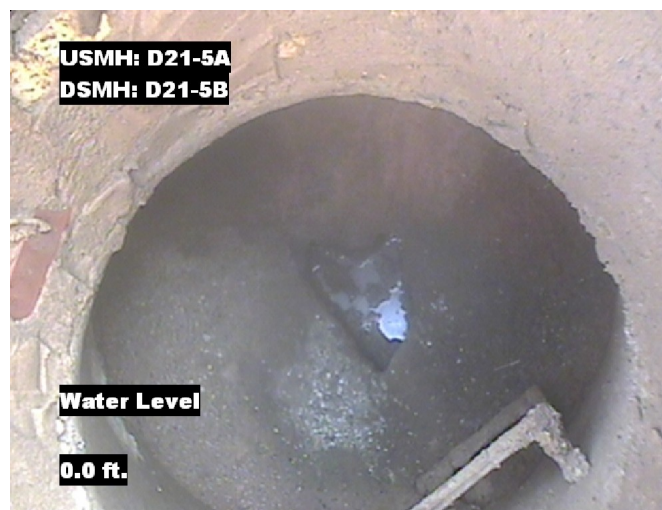
Distance: 0.0 ft. Grade: 0  
Condition: Water Level  
Remarks: N/A

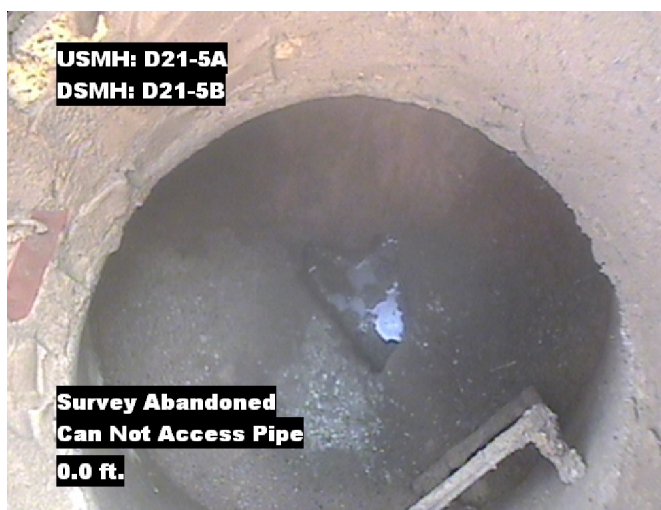
Distance: 0.0 ft. Grade: 0  
Condition: Survey Abandoned  
Remarks: Cannot Access Pipe
