## Defect Listing

Pipe Segment Refere...	City	Street	Material	Location C...	Sewer Use
<b>D21-5B_D21-5</b>	<b>Oliver Springs</b>	<b>Kries Cir</b>	<b>Concrete Pipe (non-...</b>	<b>Light High...</b>	<b>Sanitary</b>
Upstream MH	Total Length	Year Laid	Shape	Location Details	
<b>D21-5B</b>	<b>N/A</b>		<b>Circular</b>	<b>111 Kries Cir</b>	
DS Manhole	Length surveyed	Year Renewed	Height	Width	Pipe Joint...
<b>D21-5</b>	<b>N/A</b>		<b>6</b>	<b>6</b>	<b>4</b>

## Image Report 4/Page

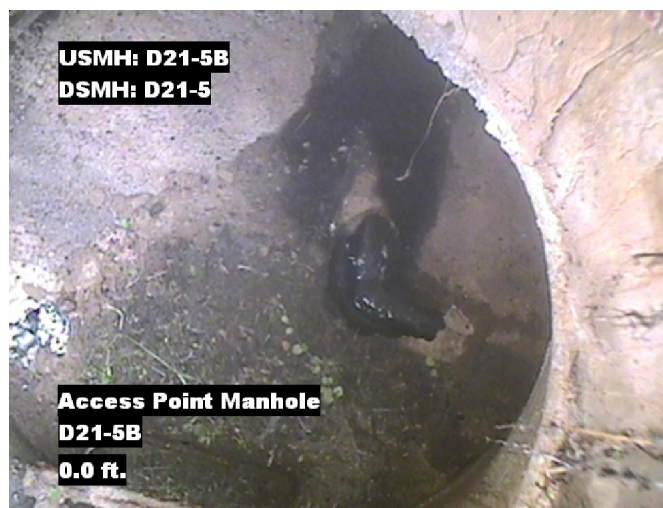
Distance: 0.0 ft. Grade: 0  
Condition: Access Point Manhole  
Remarks: D21-5B

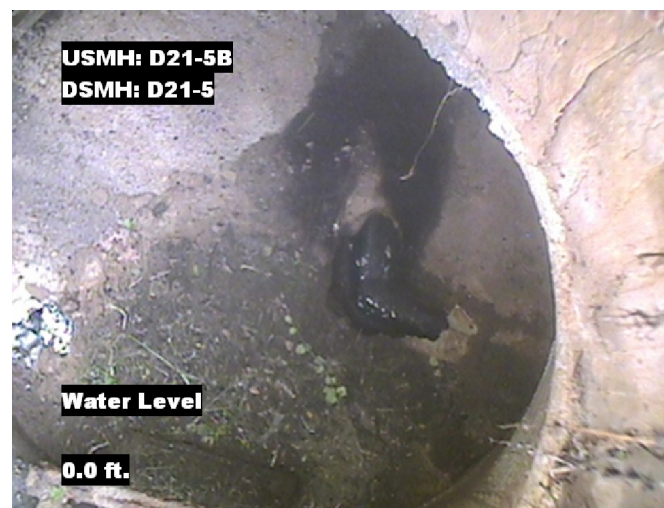
Distance: 0.0 ft. Grade: 0  
Condition: Water Level  
Remarks: N/A

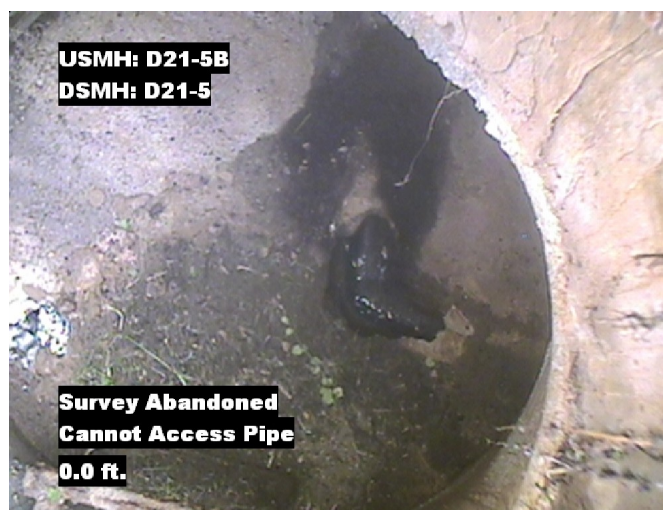
Distance: 0.0 ft. Grade: 0  
Condition: Survey Abandoned  
Remarks: Cannot Access Pipe
