Defect Listing

Pipe Segment Refere		City		Street	Material		Location C	Sewer Use	
D21-6	_D21-4	Oliver	Springs	Duncan Dr	Concrete F	Pipe (non	Light High	Sanitary	
Upstre	am MH	Total Length 340.3		Year Laid	Shape Circular		Location	Details	
D2	1-6						110 Duncan Dr		
DS M	anhole	Length s	surveyed	Year Renewed	Height	Width	Width Pipe Joint 8 4		
D2	1-4	34	0.3		8	8			
SPR	N/A	MPR	2	PO Number			Customer		
			_	4397-03			GRW		
SPRI	N/A	MPRI	2	Work Order			Purpose	Purpose	
QSR	N/A	QMR	2100	4397-02		Pre-	Rehabilitation S	urvey	
O	PR	Surve	yed By	Direction	Date		Media	alabel	
:	2	Barry_	Rogers	Downstream	20150624				
OF	PRI	Certificate Number		Pre-Cleaning	Time		Weather		
:	2		2-16405	Jetting	09:41		Dry		
		Date C	Cleaned		End Time		Additional Info		
		2015	0624	09:56

Image Report 4/Page

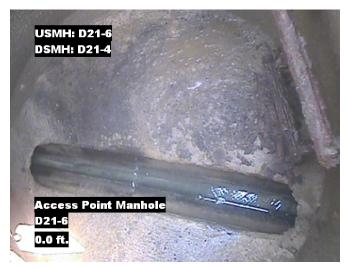
Distance: 0.0 ft. Grade: 0

Condition: Access Point Manhole

Remarks: D21-6

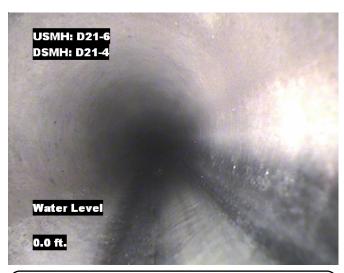
Distance: 0.0 ft. Grade: 0

Condition: Water Level

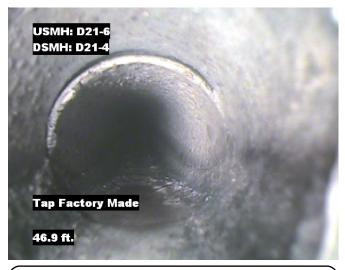
Distance: 46.9 ft. Grade: 0

Condition: Tap Factory Made

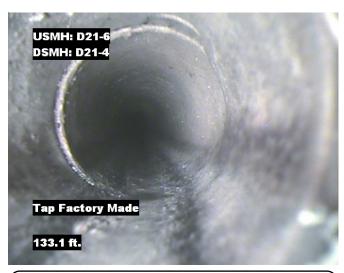
Distance: 133.1 ft. Grade: (

Condition: Tap Factory Made

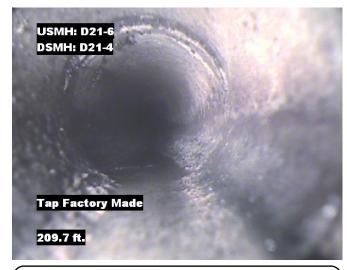
Distance: 209.7 ft. Grade: 0

Condition: Tap Factory Made

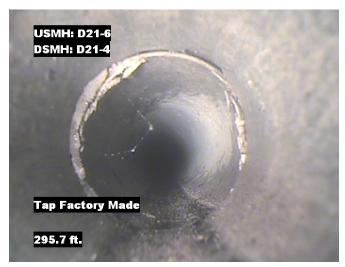
Distance: 295.7 ft. Grade: 0

Condition: Tap Factory Made

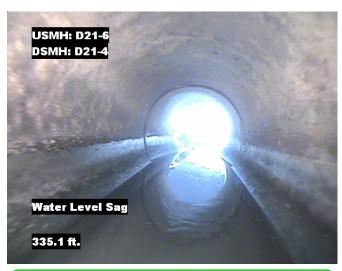
Distance: 335.0 ft. Grade: 2

Condition: Water Level Sag

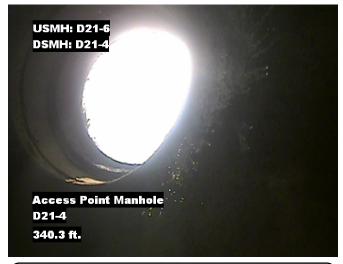
Distance: 340.3 ft. Grade: 0

Access Point Manhole

Remarks: D21-4
