## Defect Listing

Pipe Segment Refere... <b>D21-6A_D21-6</b>	City <b>Oliver Springs</b>	Street <b>Duncan</b>	Material <b>Concrete Pipe (non-...</b>	Location C... <b>Light High...</b>	Sewer Use <b>Sanitary</b>
Upstream MH <b>D21-6A</b>	Total Length <b>201.7</b>	Year Laid	Shape <b>Circular</b>	Location Details <b>107</b>	
DS Manhole <b>D21-6</b>	Length surveyed <b>201.7</b>	Year Renewed	Height <b>8</b>	Width <b>8</b>	Pipe Joint... <b>4</b>

SPR <b>N/A</b>	MPR <b>N/A</b>	PO Number <b>4397-03</b>	Customer <b>GRW</b>
SPRI <b>N/A</b>	MPRI <b>N/A</b>	Work Order <b>4397-02</b>	Purpose <b>Pre-Rehabilitation Survey</b>
QSR <b>N/A</b>	QMR <b>N/A</b>		
OPR <b>N/A</b>	Surveyed By <b>Barry Rogers</b>	Direction <b>Upstream</b>	Date <b>20150624</b>
OPRI <b>N/A</b>	Certificate Number <b>U-1012-16405</b>	Pre-Cleaning <b>No Pre-Cleaning</b>	Time <b>10:07</b>
	Date Cleaned	End Time <b>10:32</b>	Weather <b>Dry</b>
		Additional Info

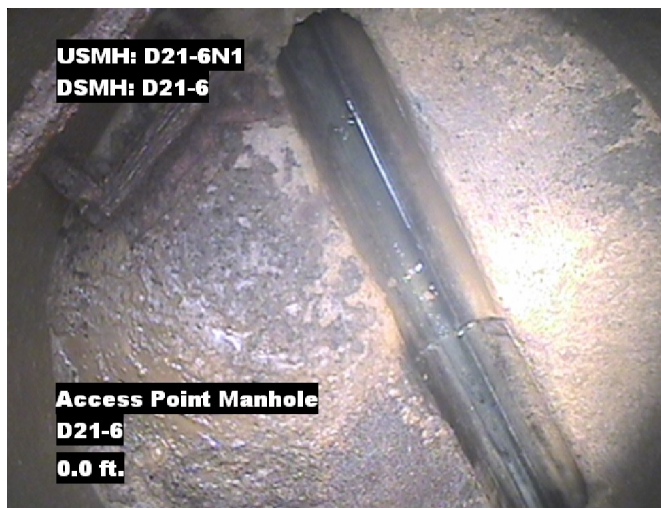
Distance: 0.0 ft. Grade: 0  
Condition: Access Point Manhole  
Remarks: D21-6

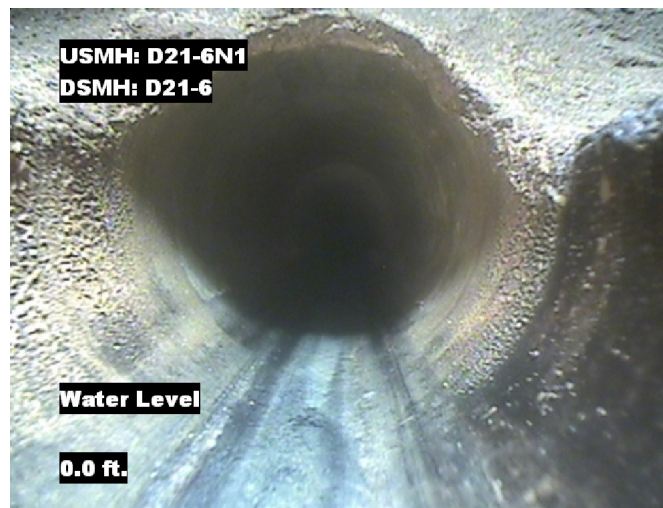
Distance: 0.0 ft. Grade: 0  
Condition: Water Level  
Remarks: N/A

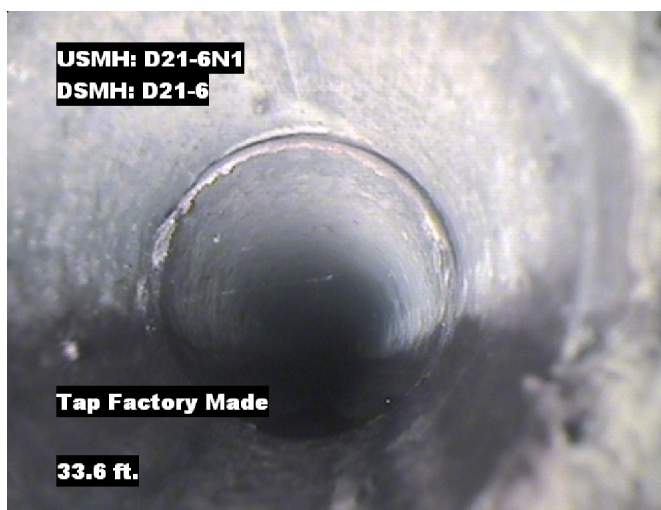
Distance: 33.6 ft. Grade: 0  
Condition: Tap Factory Made  
Remarks: N/A

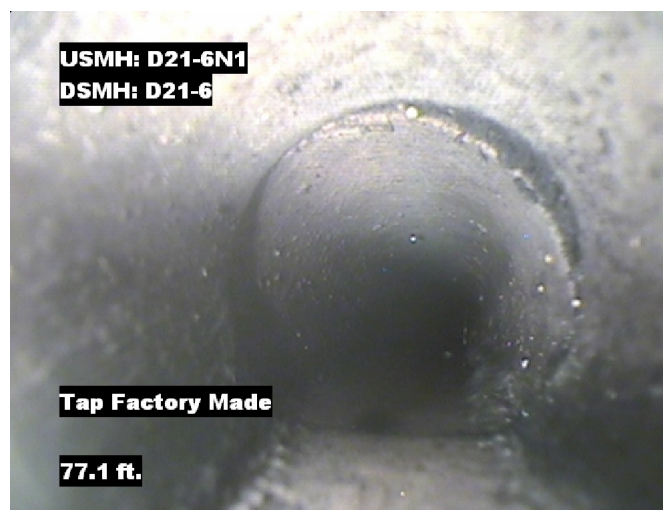
Distance: 77.1 ft. Grade: 0  
Condition: Tap Factory Made  
Remarks: N/A

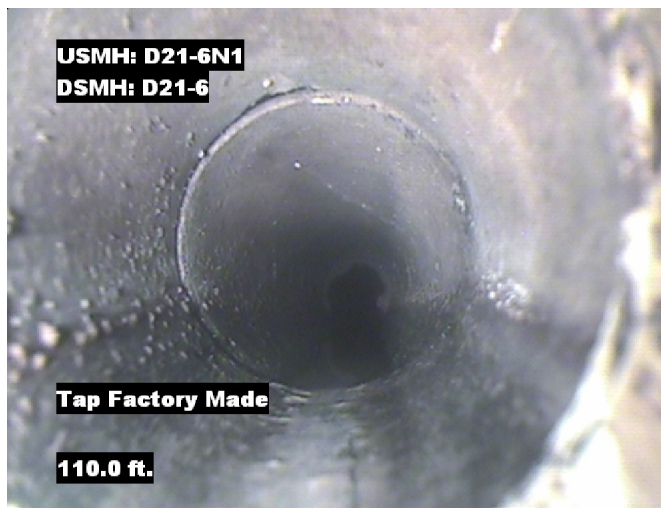
Distance: 110.0 ft. Grade: 0  
Condition: Tap Factory Made  
Remarks: N/A

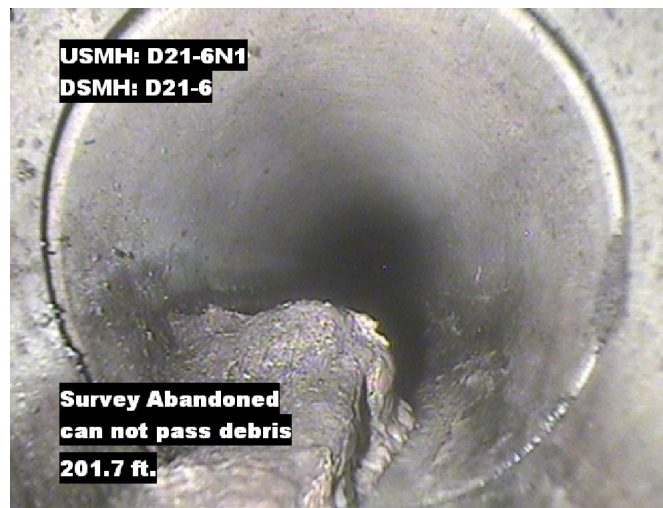
Distance: 201.7 ft. Grade: 0  
Condition: Survey Abandoned  
Remarks: can not pass debris
