Defect Listing

Pipe Segment Refere... D23-1_D-23	City Oliver Springs	Street Duncan Dr	Material Concrete Pipe (non-...	Location C... Light High...	Sewer Use Sanitary
Upstream MH D23-1	Total Length 144.2	Year Laid	Shape Circular	Location Details Intersection of Duk...	
DS Manhole D-23	Length surveyed 235.5	Year Renewed	Height 8	Width 8	Pipe Joint... 4

SPR 6	MPR 9	PO Number 4397-03	Customer GRW
SPRI 3	MPRI 3	Work Order 4397-02	Purpose Pre-Rehabilitation Survey
QSR 4121	QMR 4131		
OPR 15	Surveyed By Barry Rogers	Direction Upstream	Date 20150624
OPRI 3	Certificate Number U-1012-16405	Pre-Cleaning Heavy Cleaning	Time 12:50
	Date Cleaned 20150624	End Time 13:04	Weather Dry
			Media label
			Additional Info

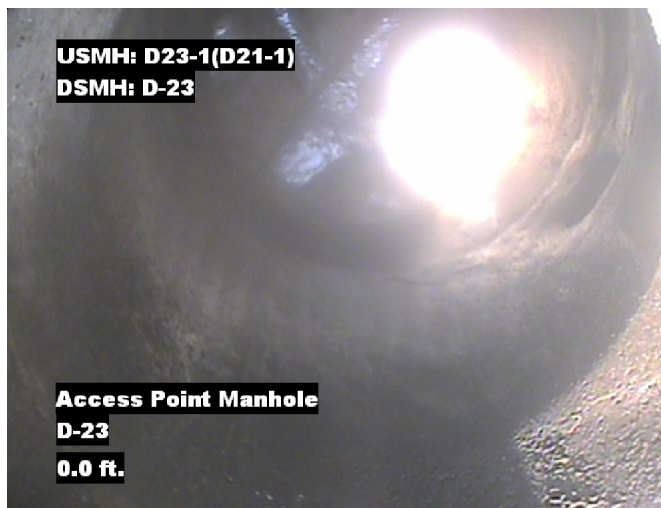
Distance: 0.0 ft. Grade: 0
Condition: Access Point Manhole
Remarks: D-23

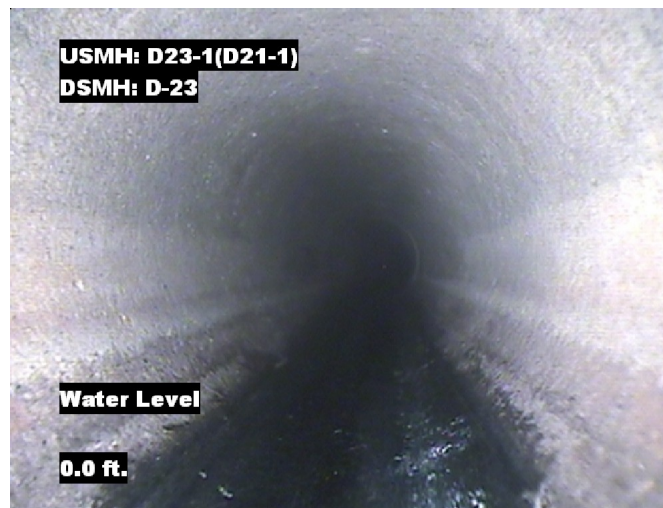
Distance: 0.0 ft. Grade: 0
Condition: Water Level
Remarks: N/A

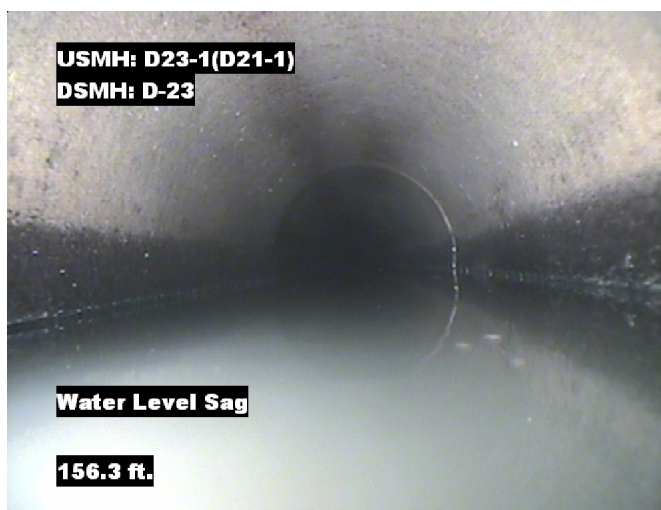
Distance: 156.3 ft. Grade: 2
Condition: Water Level Sag
Remarks: N/A

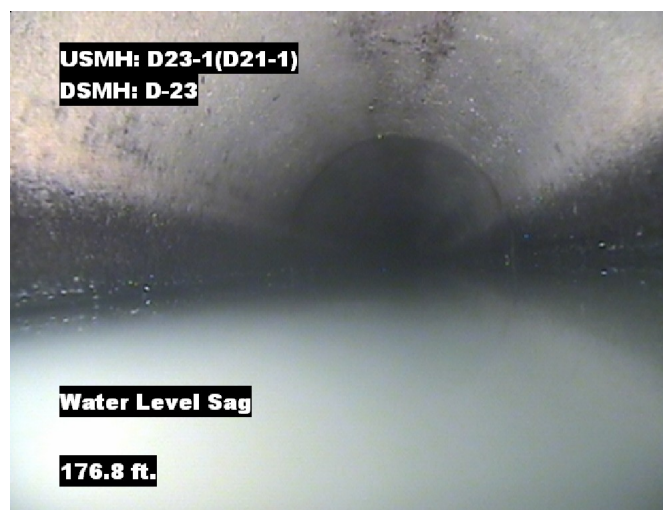
Distance: 176.8 ft. Grade: 3
Condition: Water Level Sag
Remarks: N/A

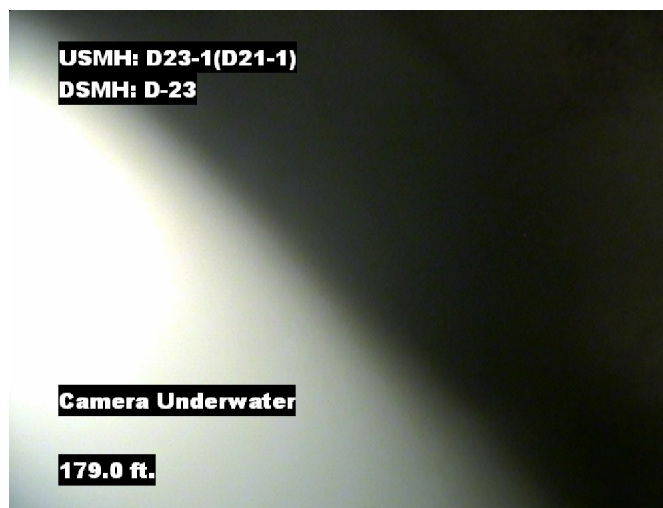
Distance: 179.0 ft. Grade: 4
Condition: Camera Underwater
Remarks: N/A

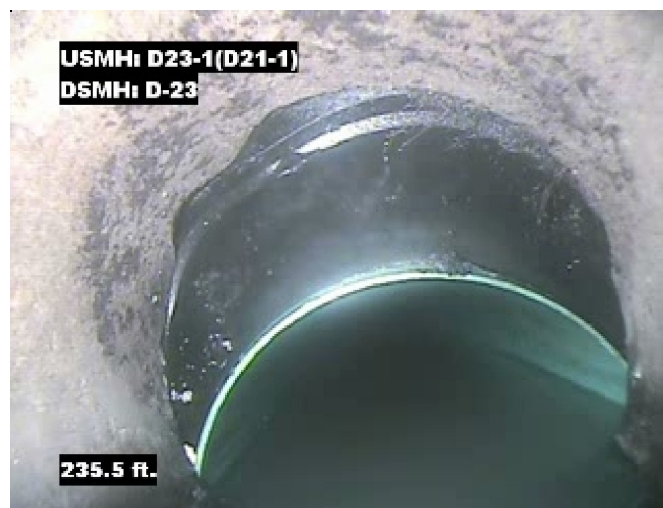
Distance: 235.4 ft. Grade: 4
Condition: Repair Point Defective
Remarks: pipe has fallen

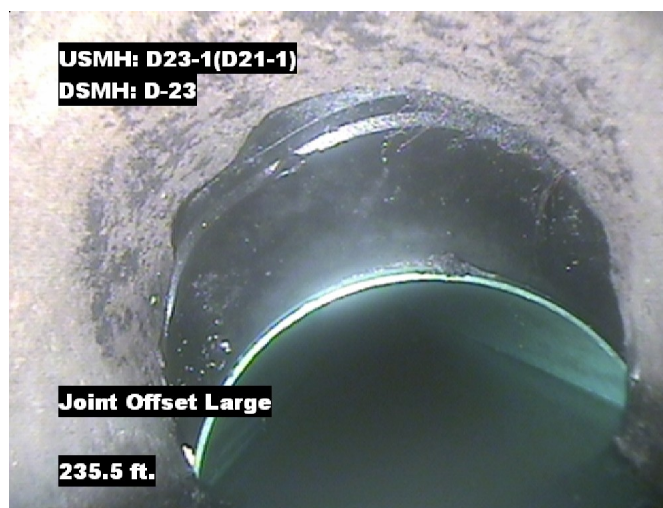
Distance: 235.5 ft. Grade: 2
Condition: Joint Offset Large
Remarks: N/A

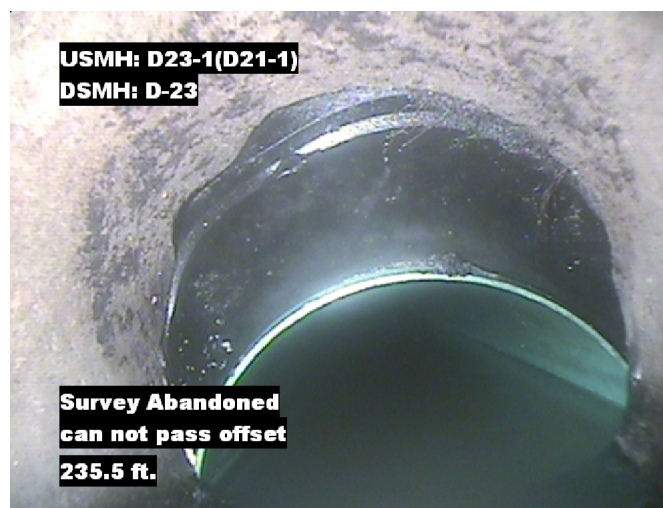
Distance: 235.5 ft. Grade: 0
Condition: Survey Abandoned
Remarks: can not pass offset
