## Defect Listing

| Pipe Segment Refere...<br><b>D23-1A_D23-1</b> | City<br><b>Oliver Springs</b> | Street<br><b>S. Duke Dr</b> | Material<br><b>Concrete Pipe (non-...</b> | Location C...<br><b>Light High...</b> | Sewer Use<br><b>Sanitary</b> |

| SPRI<br><b>N/A</b> | MPRI<br><b>3</b> | Work Order<br><b>4397-02</b> | Purpose<br><b>Pre-Rehabilitation Survey</b> |

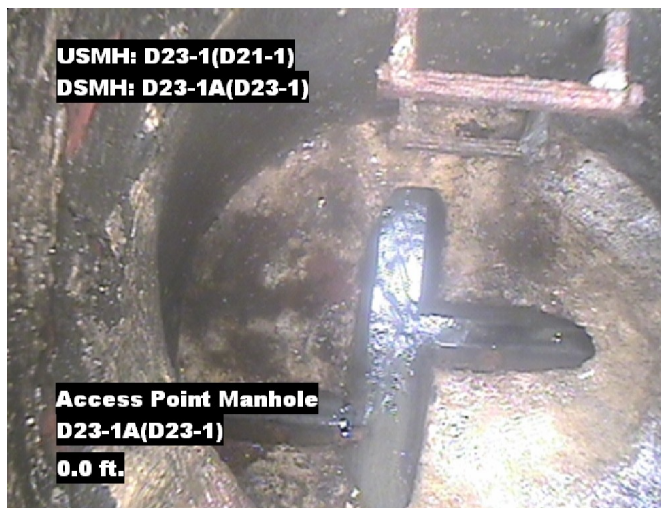
Distance: 0.0 ft. Grade: 0  
Condition: Access Point Manhole  
Remarks: D23-1A

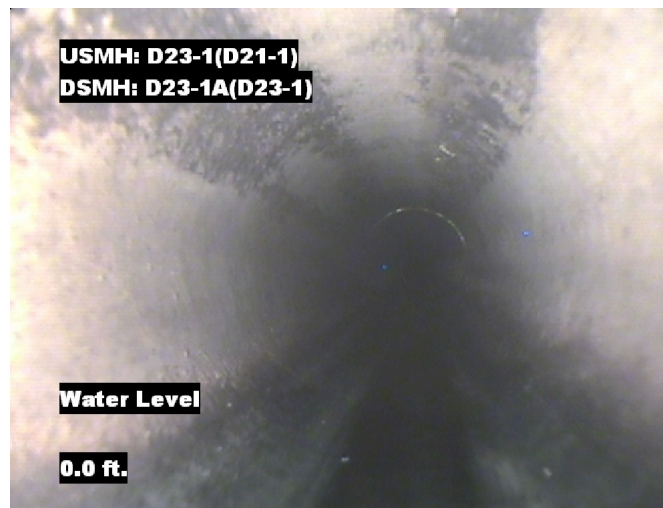
Distance: 0.0 ft. Grade: 0  
Condition: Water Level  
Remarks: N/A

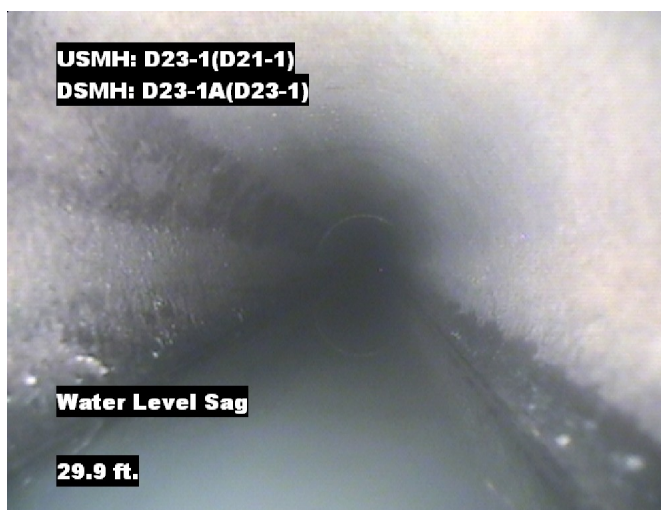
| Distance | Condition | Cont. Dfct. | Values | | | Joint | Clock Position | | Grade |
|---|---|---|---|---|---|---|---|---|---|
| 30.2 ft. | Water Level Sag | | | | 15 | <input type="checkbox"/> | | | 2 |

Distance: 30.2 ft. Grade: 2  
Condition: Water Level Sag  
Remarks: N/A

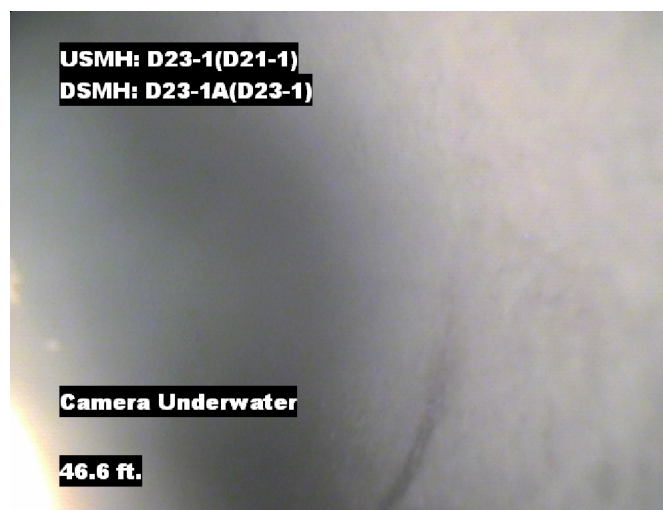
| Distance | Condition | Cont. Dfct. | Values | | | Joint | Clock Position | | Grade |
|---|---|---|---|---|---|---|---|---|---|
| 46.6 ft. | Camera Underwater | | | | 0 | <input type="checkbox"/> | | | 4 |

Distance: 46.6 ft. Grade: 4  
Condition: Camera Underwater  
Remarks: N/A

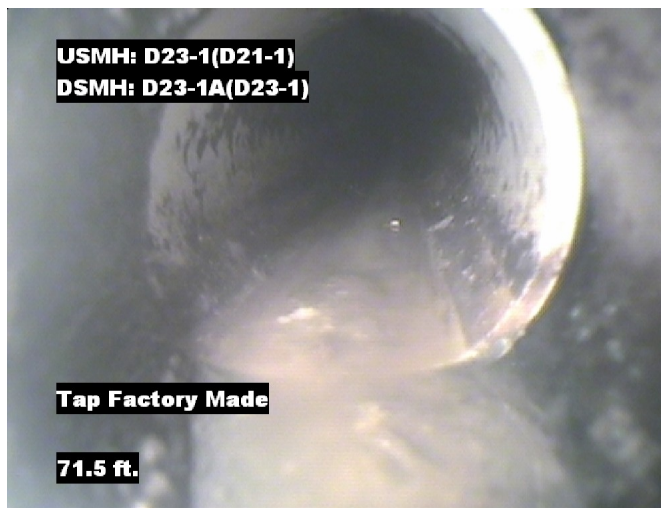
Distance: 71.5 ft. Grade: 0  
Condition: Tap Factory Made  
Remarks: N/A

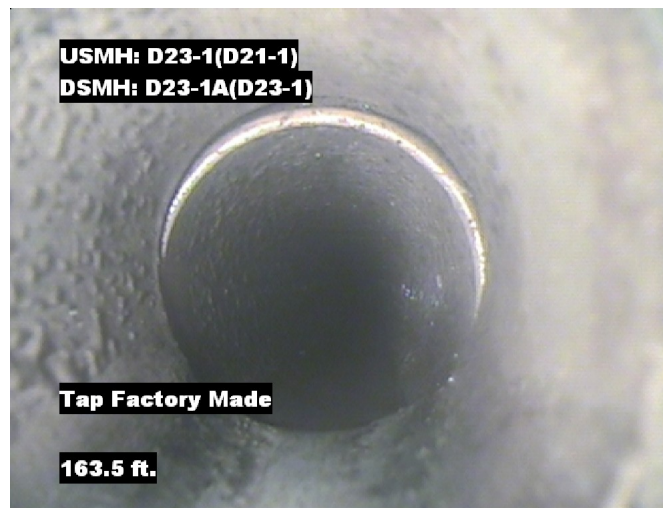
Distance: 163.5 ft. Grade: 0  
Condition: Tap Factory Made  
Remarks: N/A

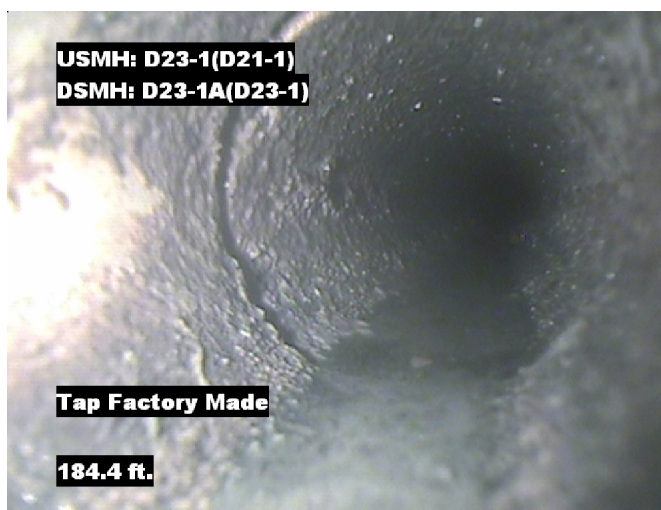
Distance: 184.4 ft. Grade: 0  
Condition: Tap Factory Made  
Remarks: N/A

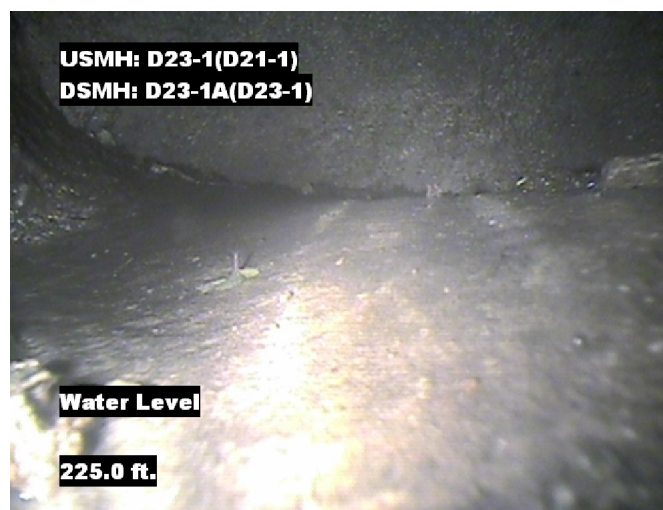
Distance: 225.0 ft. Grade: 0  
Condition: Water Level  
Remarks: N/A

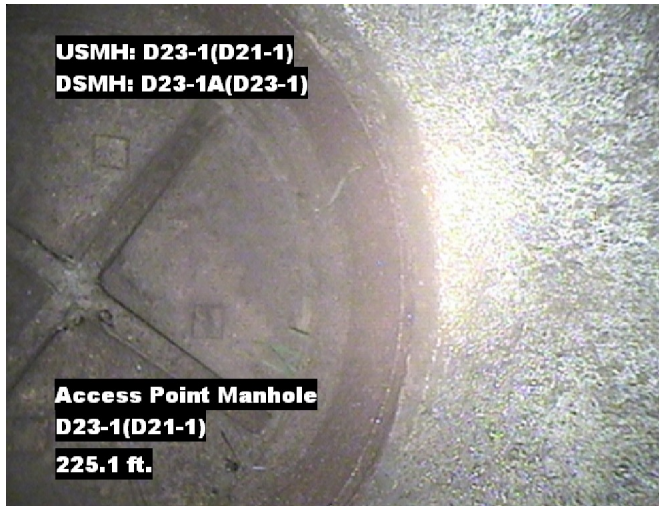
Distance: 225.1 ft. Grade: 0  
Condition: Access Point Manhole  
Remarks: D23-1
