Defect Listing

Pipe Segment Refere...	City	Street	Material	Location C...	Sewer Use
D3-1_D1-4	Oliver Springs	Bennett Rd	Concrete Pipe (non-...	Easement/R...	Sanitary
Upstream MH	Total Length	Year Laid	Shape	Location Details	
D3-1	366.5		Circular	At end of First Dri...	
DS Manhole	Length surveyed	Year Renewed	Height	Width	Pipe Joint...
D1-4	366.5		8	8	4

SPR	N/A	MPR	17	PO Number	Customer
SPRI	N/A	MPRI	2.1	4397-03	GRW
QSR	N/A	QMR	3127	Work Order	Purpose
			4397-02	Pre-Rehabilitation Survey	
OPR	Surveyed By	Direction	Date	Media label	
17	Barry Rogers	Downstream	20150708		
OPRI	Certificate Number	Pre-Cleaning	Time	Weather	
2.1	U-1012-16405	Heavy Cleaning	09:43	Damp	
Date Cleaned			End Time	Additional Info	
20150708			10:31

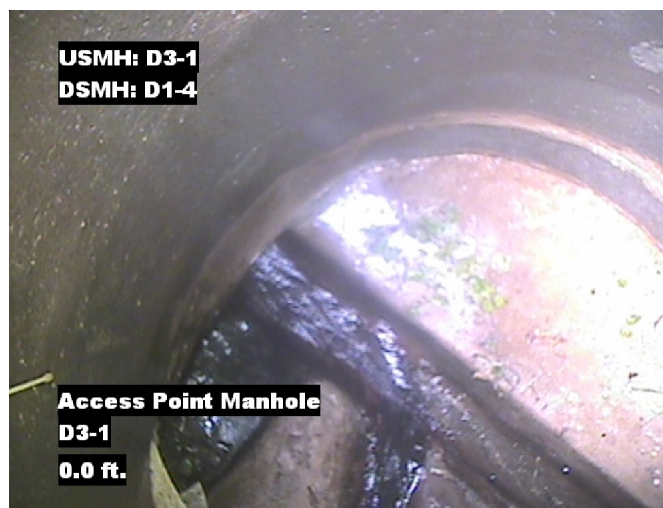
Distance: 0.0 ft. Grade: 0
Condition: Access Point Manhole
Remarks: D3-1

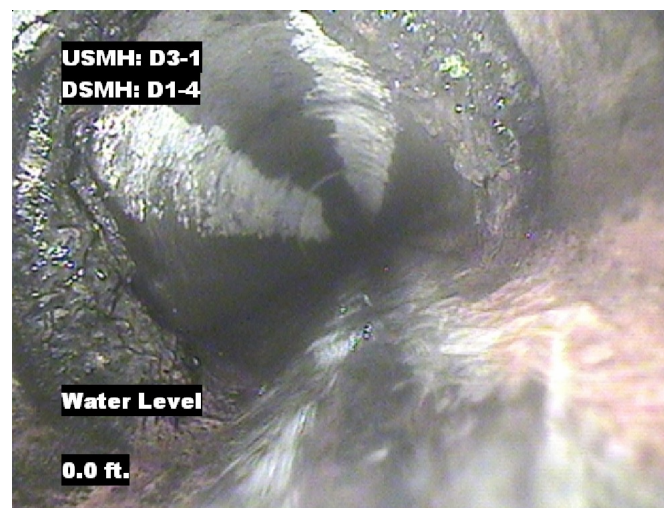
Distance: 0.0 ft. Grade: 0
Condition: Water Level
Remarks: N/A

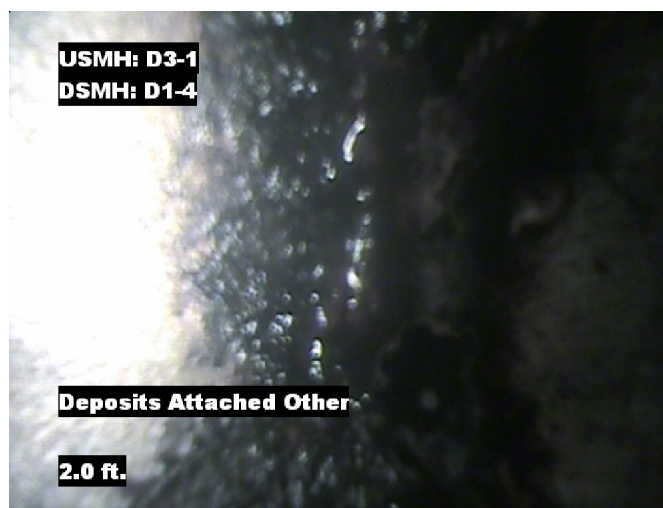
Distance: 2.0 ft. Grade: 2
Condition: Deposits Attached Other
Remarks: N/A

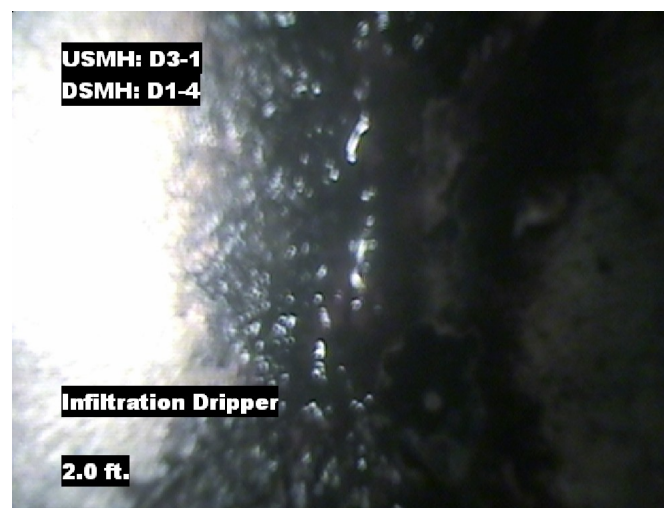
Distance: 2.0 ft. Grade: 3
Condition: Infiltration Dripper
Remarks: N/A

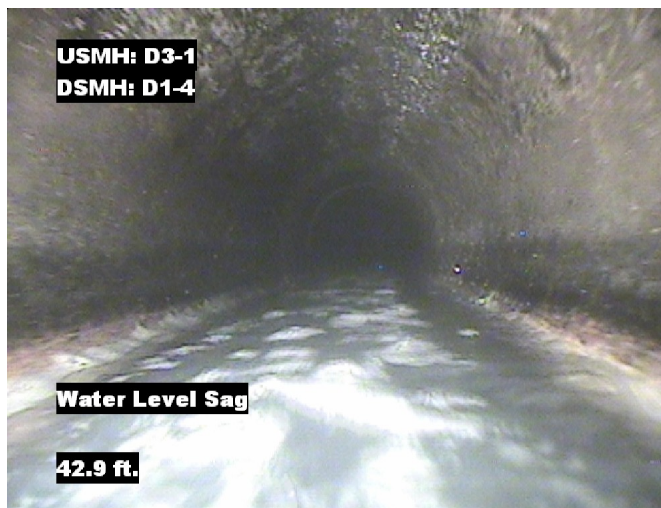
Distance: 42.9 ft. Grade: 2
Condition: Water Level Sag
Remarks: N/A

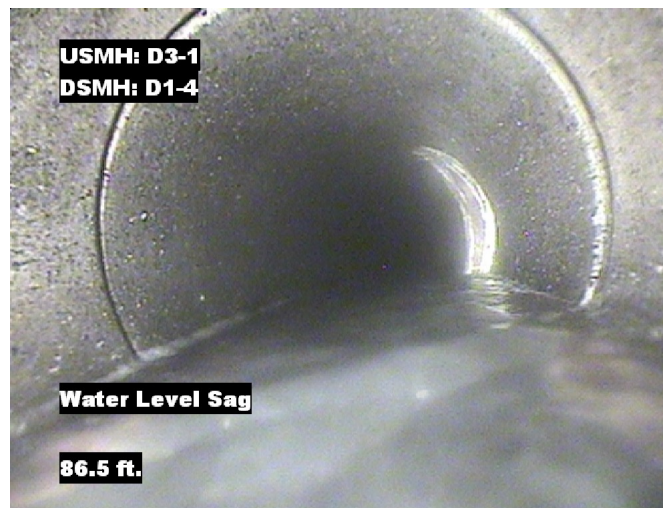
Distance: 86.5 ft. Grade: 2
Condition: Water Level Sag
Remarks: N/A

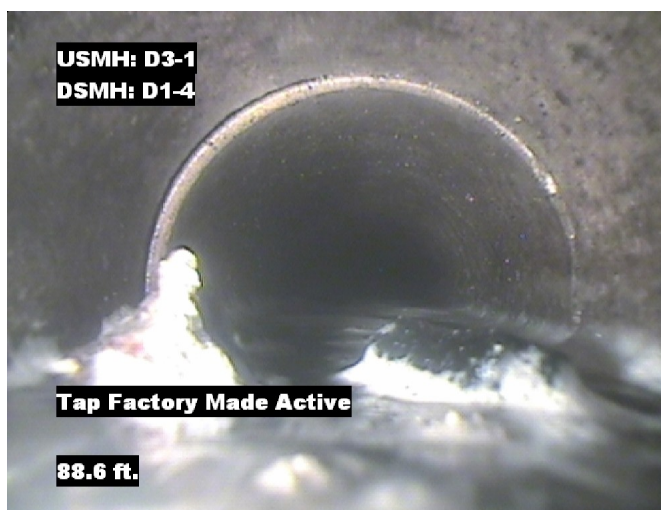
Distance: 88.6 ft. Grade: 0
Condition: Tap Factory Made Active
Remarks: N/A

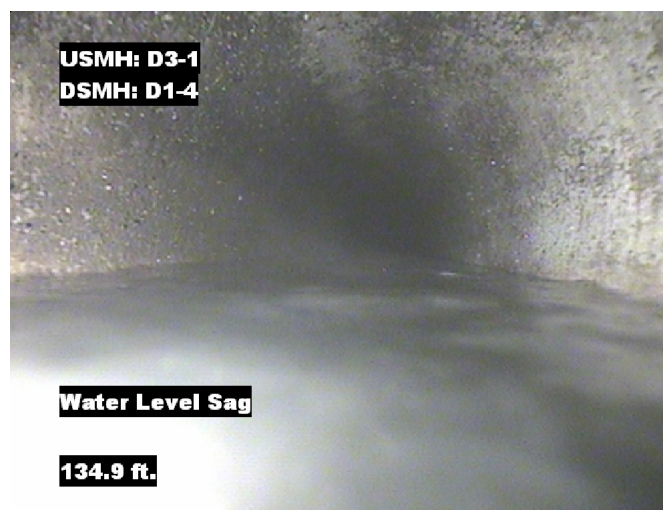
Distance: 134.9 ft. Grade: 2
Condition: Water Level Sag
Remarks: N/A

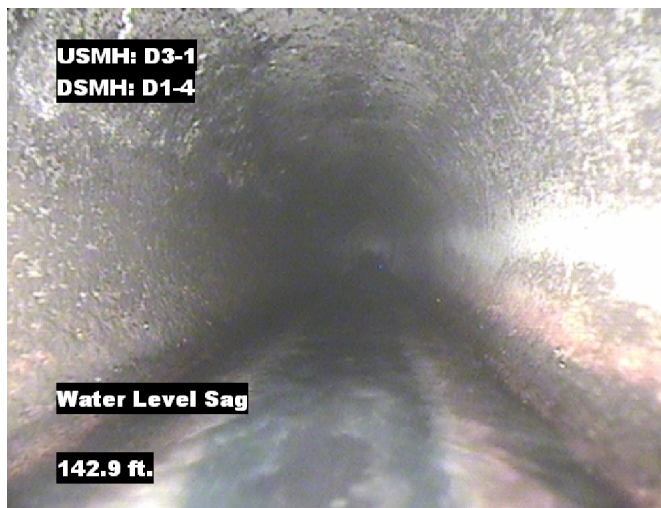
Distance: 142.9 ft. Grade: 2
Condition: Water Level Sag
Remarks: N/A

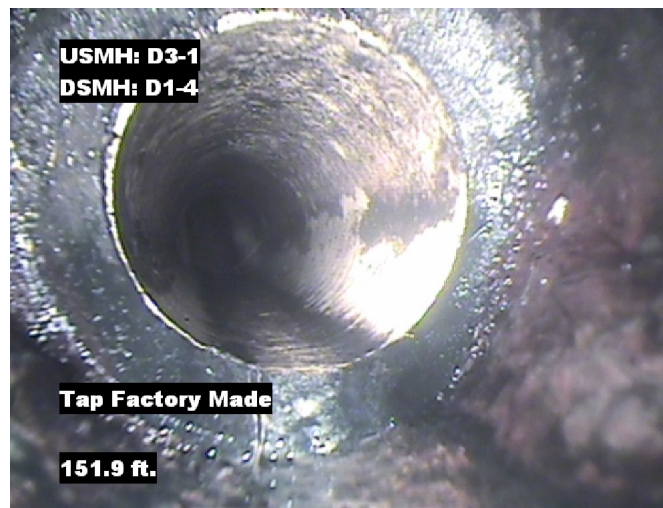
Distance: 151.9 ft. Grade: 0
Condition: Tap Factory Made
Remarks: N/A

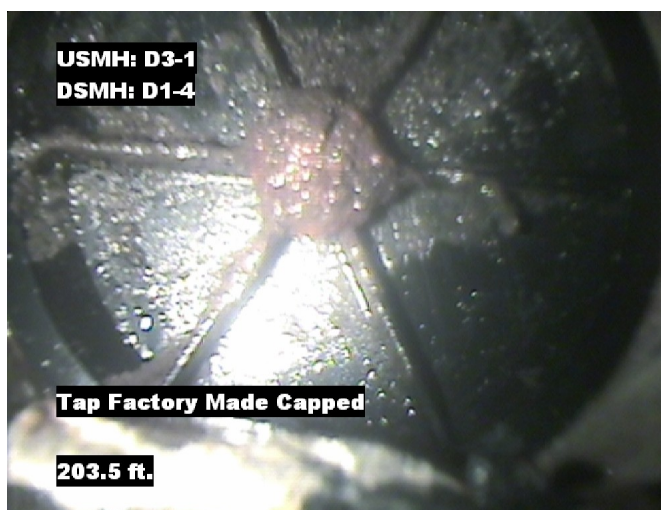
Distance: 203.5 ft. Grade: 0
Condition: Tap Factory Made Capped
Remarks: N/A

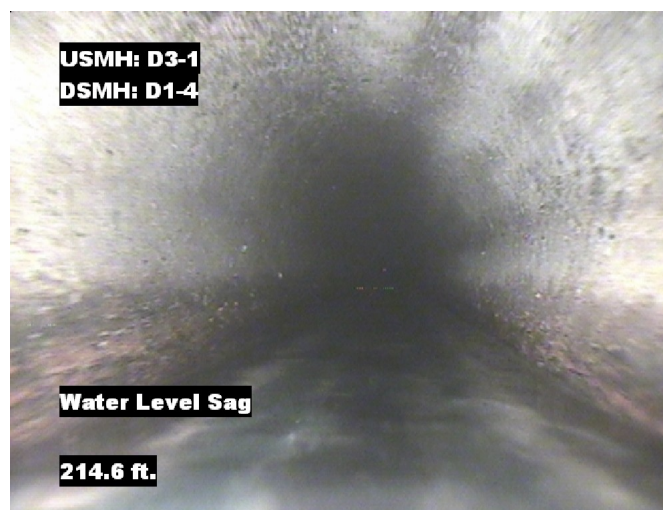
Distance: 214.5 ft. Grade: 2
Condition: Water Level Sag
Remarks: N/A

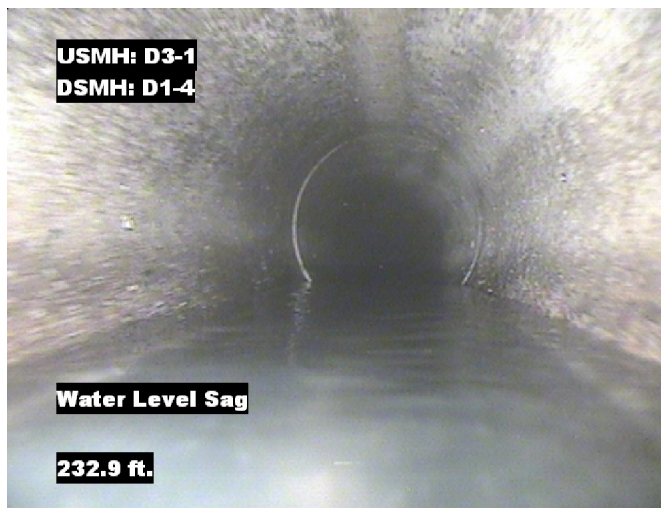
Distance: 232.6 ft. Grade: 2
Condition: Water Level Sag
Remarks: N/A

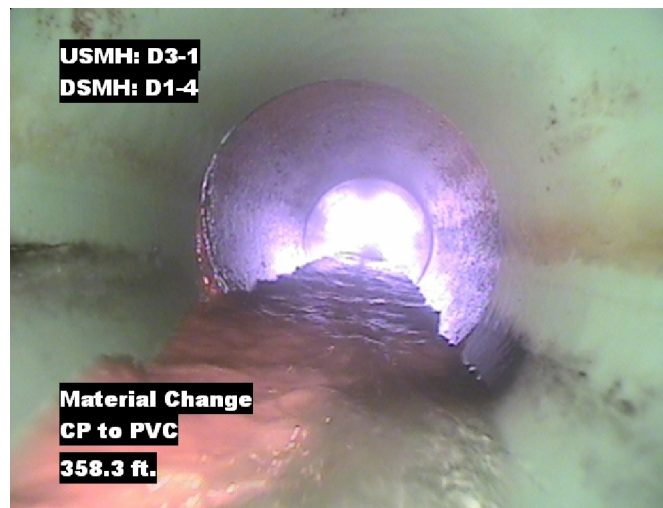
Distance: 358.3 ft. Grade: 0
Condition: Material Change
Remarks: CP to PVC

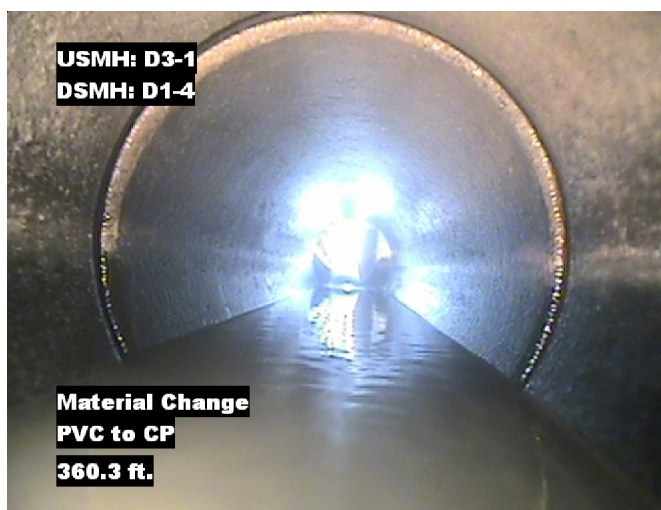
Distance: 360.3 ft. Grade: 0
Condition: Material Change
Remarks: PVC to CP

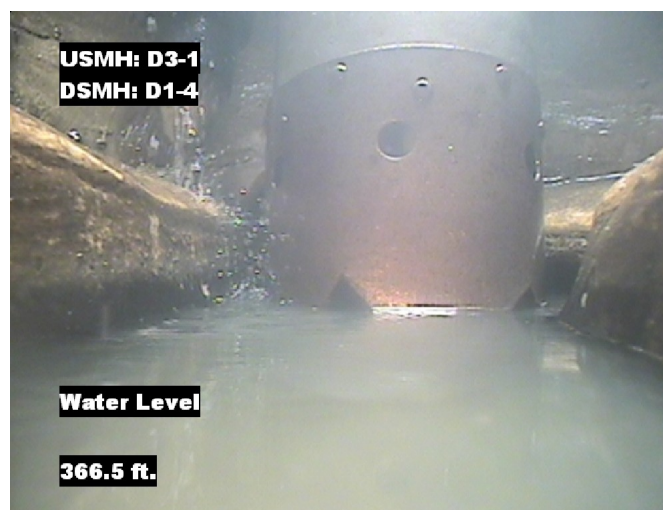
Distance: 366.5 ft. Grade: 0
Condition: Water Level
Remarks: N/A

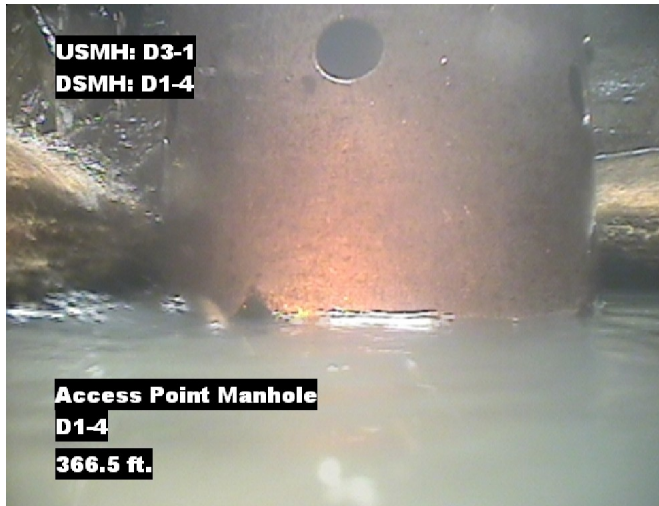
Distance: 366.5 ft. Grade: 0
Condition: Access Point Manhole
Remarks: D1-4
